**Identification of pathological manifestations through the design of
damage maps of facades from a historic building in the city of Recife, PE:
Case study of Block A of the Polytechnic School of Pernambuco**

Thus, this study aims to conduct a comprehensive survey about primary pathological manifestations affecting Block A of the Polytechnic School of Pernambuco. This investigation involves meticulous preparation of damage maps detailing this historic building's facades. Ultimately this endeavor seeks to contribute valuable insights that can inform future more sustainable maintenance and restoration efforts for the analyzed building.

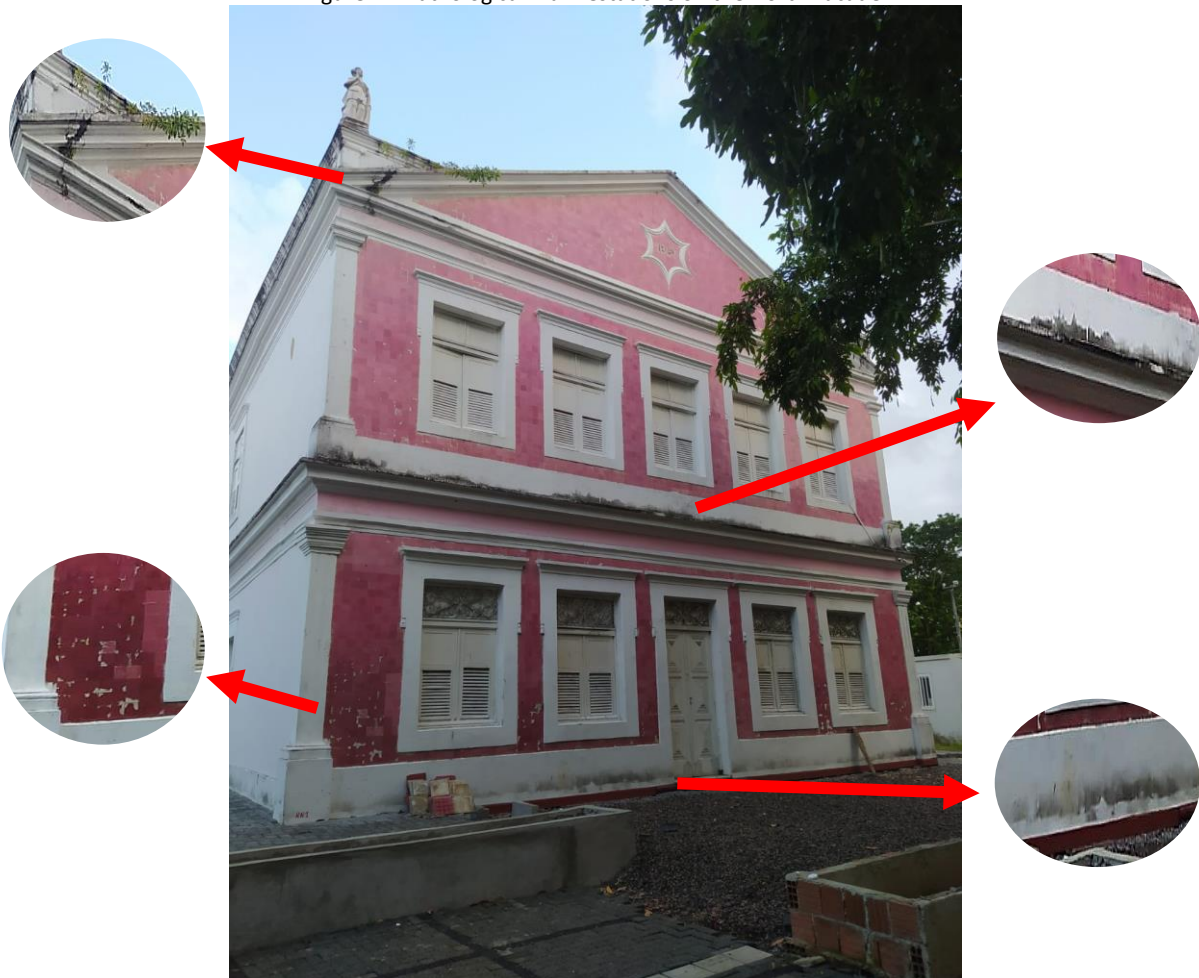
Figure 4 – Pathological manifestations on the North Facade.

As it is visually noticeable on Figure 4 it is possible to observe a higher prevalence of pathological manifestations at the top and bottom of the facade, confirming the analysis of Bersch *et al.* (2020), who stated that most pathological manifestations generally occur in these areas due to humidity and the increased incidence of rain and wind.

Vegetation growth can also be observed in the upper part of the facade, attributed to humidity and the presence of birds inadvertently transporting seeds to these areas. According to Rodrigues *et al.* (2021), the presence of vegetation is not considered a severe pathological manifestation, however, over time, it can weaken the structure and facilitate the penetration of water and other harmful agents into the concrete.

Another area where a significant presence of pathological manifestations can be observed is the cornice, located between the upper and lower windows of the building. Due to its larger surface area, it is more susceptible to the accumulation of water and debris, which leads to the formation of the black spots seen in the image.

Furthermore, the detachment of the coating in several areas of this facade, especially those closest to the bottom of the building, is likely related to the humidity present in this region. Following this, the damage map of this facade can be consulted, which identifies all pathological manifestations found (Figure 5).

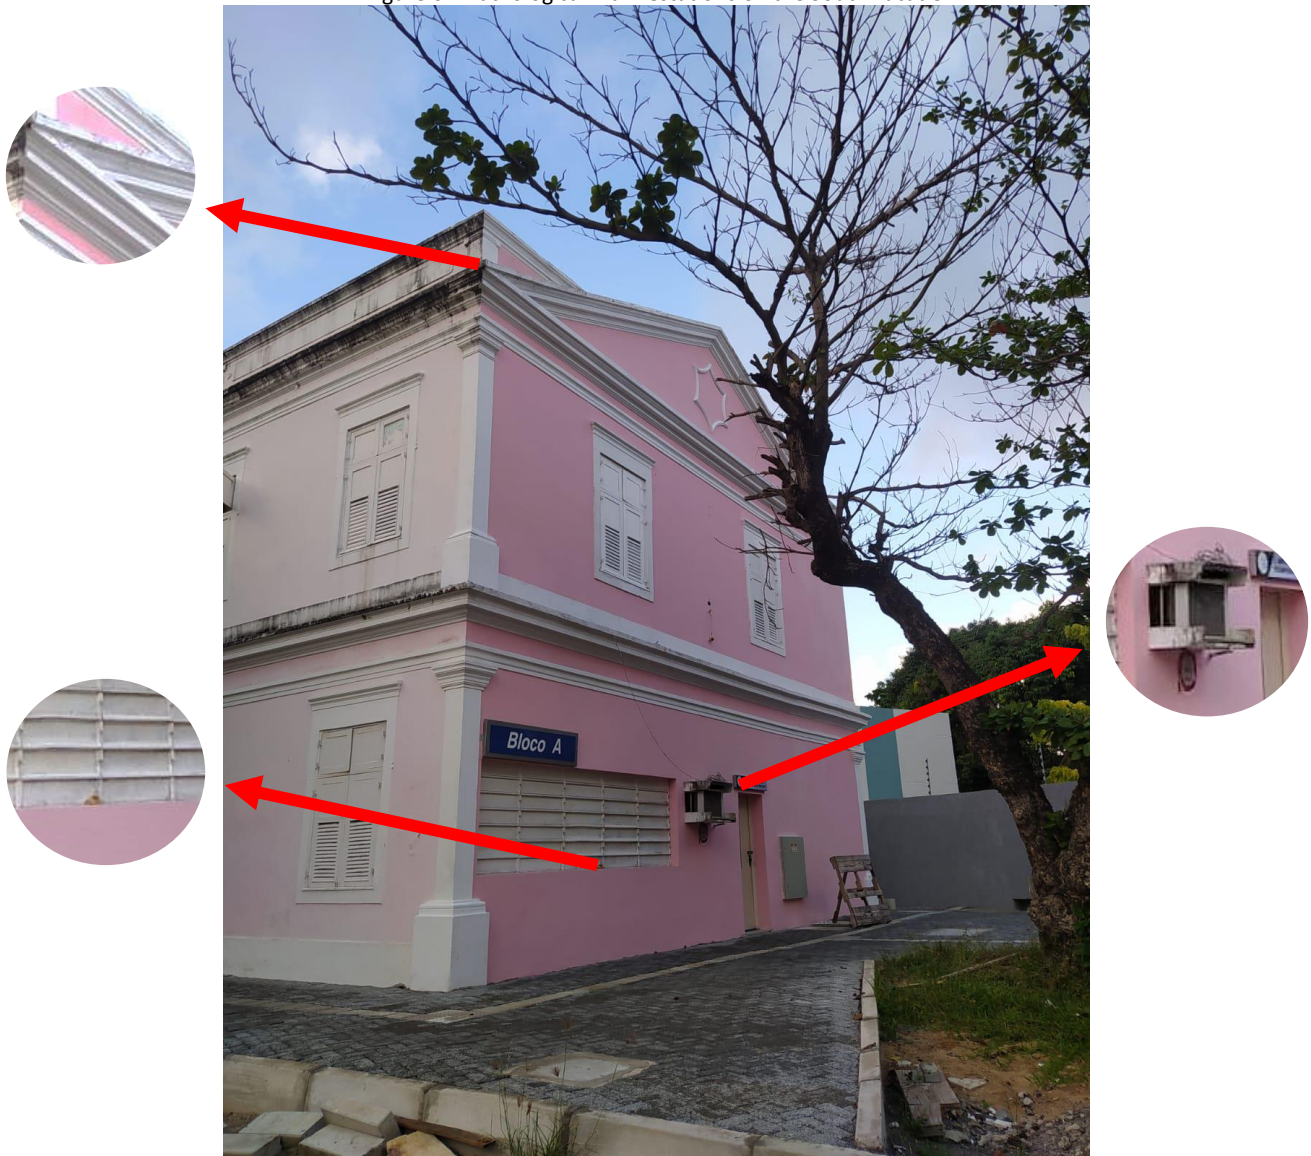
Figure 6 – Pathological manifestations on the South Facade.

Through the image, it can be seen that this facade presents few pathological manifestations, as it recently underwent renovation. Nevertheless, it is still possible to identify some black stains on the building's pediment and on the cornice located in the middle. Similar to the North facade, these stains are caused by the presence of humidity and the influence of wind and rain.

A difference observed on this facade compared to the North is the presence of brises in place of windows in the lower part, in addition to an air conditioning unit between the brises and the access door to the internal environment. It is noteworthy that the brises have dark spots indicating dirt and also show a slight degradation of the wood at the bottom, probably due to humidity. Furthermore, the air conditioning unit is covered in infiltration stains, likely from water running from the condenser. Below is a damage map for this facade, with the identification of all pathological manifestations found (Figure 7).

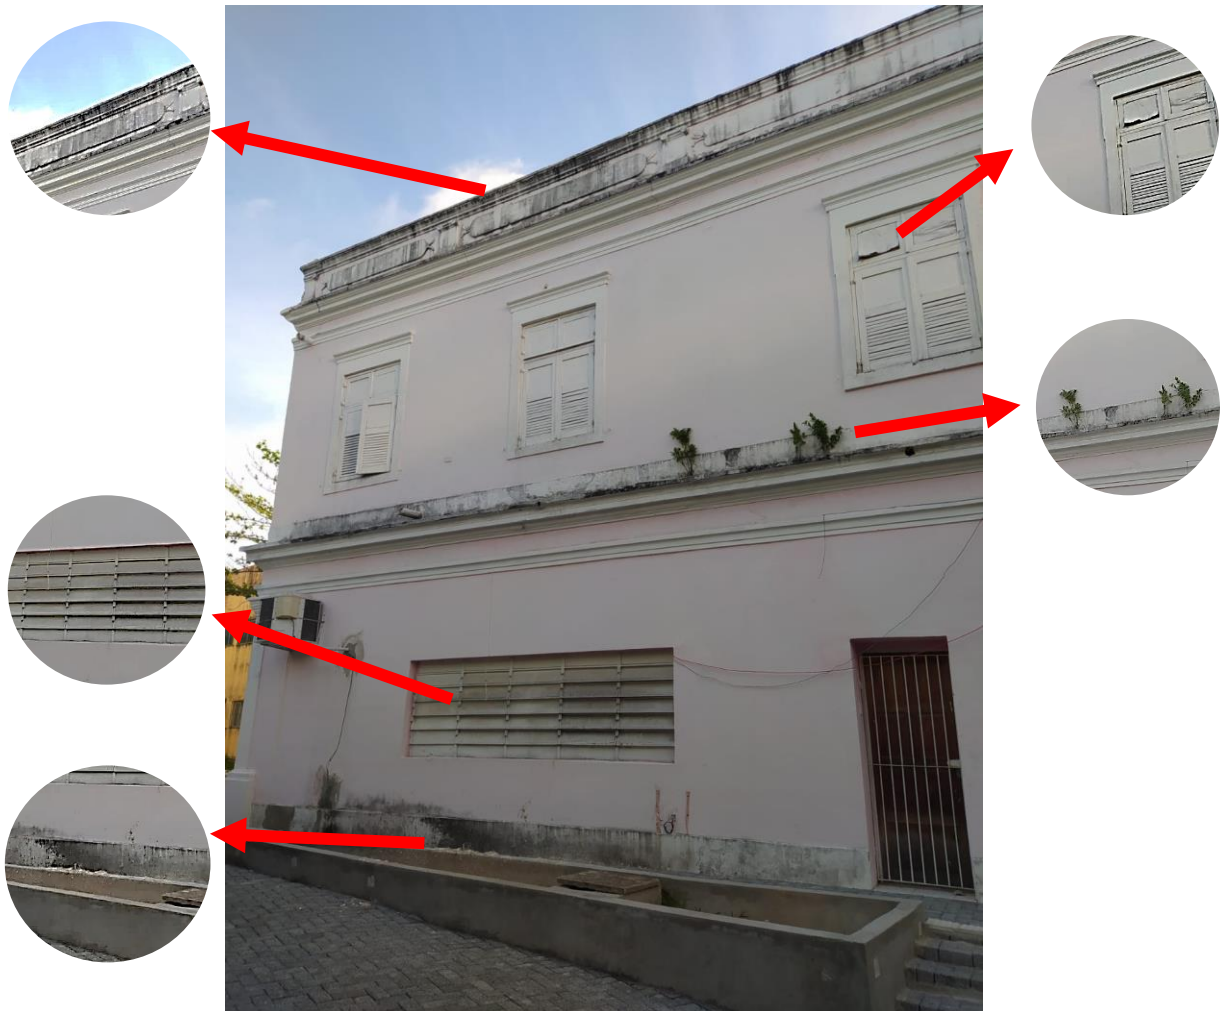
Figure 8 – Pathological manifestations on the East Facade.

It can be seen from the image that this facade is significantly affected, starting with the presence of several dirt spots in the upper and lower areas, due to humidity from rainwater. The presence of moisture can also be observed on the cornice, which is completely covered by black stains. Furthermore, the sunshades are completely dirty, and some windows at the top are broken or have some aesthetic defects, indicating a lack of appropriate maintenance.

Similar to the North facade, vegetation growth can be seen on the cornice, probably due to the transport of seeds by birds that frequent the site. Due to the sun's exposure, the tone of the painting is lighter compared to the paintings on the North and South facades, as this side faces the sunrise.

Finally, some areas with the presence of plaster can be observed, as a consequence of the works carried out to conceal the hoses coming from the air conditioning condensers installed in the building. The damage map of this facade is presented below, with the identification of all pathological manifestations found (Figure 9).

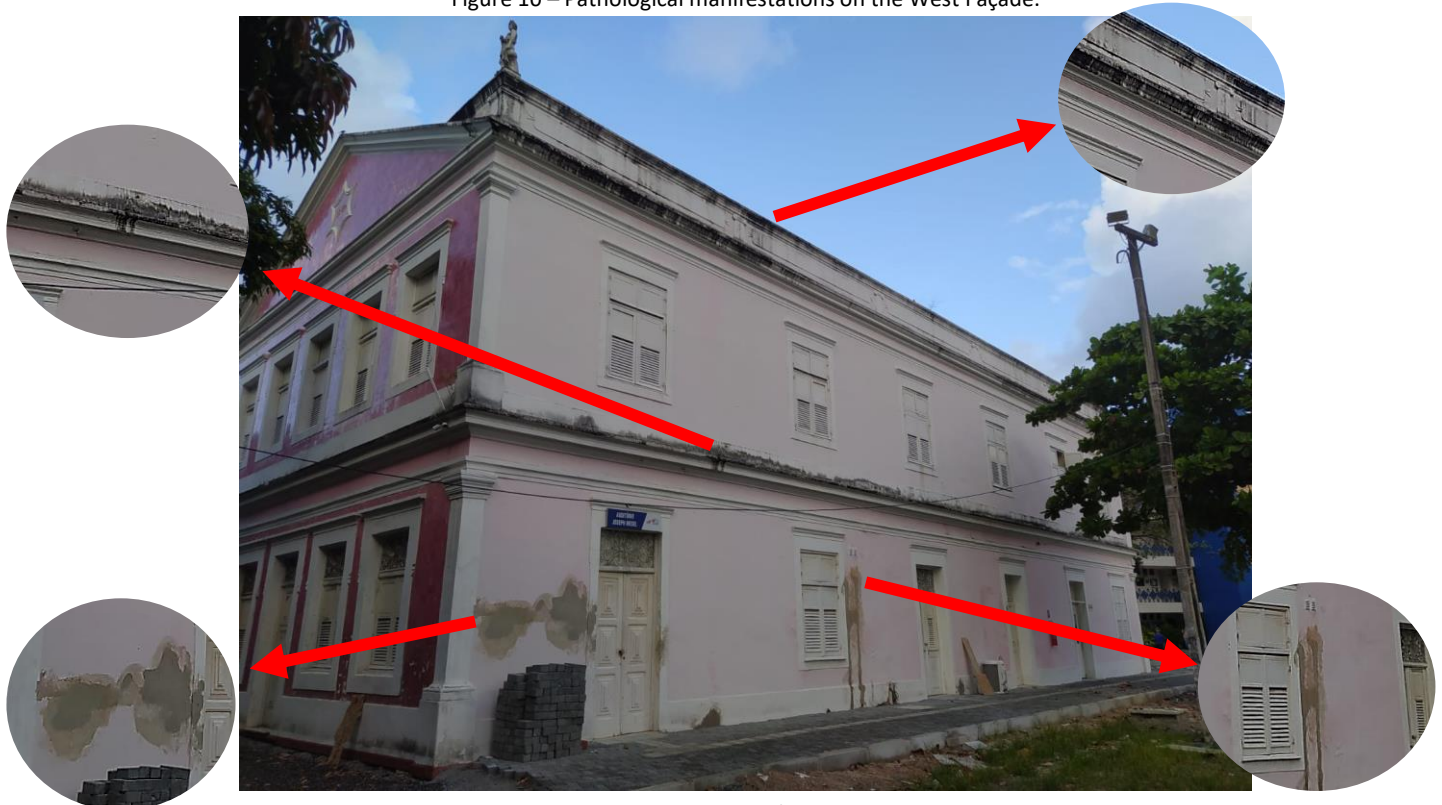
Figure 10 – Pathological manifestations on the West Façade.

Similar to the East facade, this side also exhibits dark spots in the upper areas and on the cornice, likely caused by moisture from rainwater. However, the lower part lacks dark spots at the base, instead, infiltration stains can be observed on its walls, along with some patched areas resulting from previous restoration works. Similarly to the East facade, the West side also displays a difference in paint tone, attributable to its exposure to the setting sun. The damage map of this facade, identifying all pathological manifestations found, is shown in Figure 11.
