Structural Recovery of the *Ponte da Torre*: Identification and Analysis of Pathological Manifestations, Testing, and Adopted Solutions.

This article presents the main pathological manifestations identified in the *Ponte da Torre* (Tower Bridge), the destructive and non-destructive tests conducted for accurate diagnoses that confirm the structural compromise, as well as the methods adopted for the recovery of this Special Engineering Structure (OAE). Tests performed include core extraction, corrosion potential, surface electrical resistivity, carbonation, rebar scanning, chloride profile, and compressive strength testing. The Tower Bridge is a structure of high architectural and infrastructural importance for the city of Recife, serving the traffic demands of the northern zone of the capital of Pernambuco. Recognizing its significance, it is evident that preserving this OAE for future generations is necessary, incorporating principles of conservation, recovery, restoration, and more recently, sustainability. This study is part of the practice and execution of projects, interventions, and requalification efforts in the contemporary city, where the influence of the environmental agg

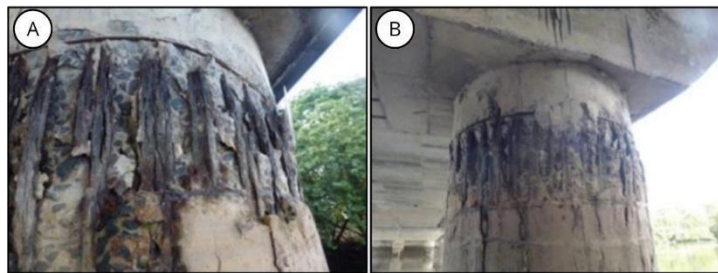
According to Bertolini (2010), the most common type of corrosion is triggered by contact with water, known as wet corrosion, which is prevalent in environments exposed to water due to the presence of chlorides. Wet corrosion is the primary pathological manifestation that contributes to the reduction in durability and load-bearing capacity of the concrete structure's reinforcements. Figure 3 shows the corrosion and spalling of concrete due to the loss of adhesion between the steel and concrete as the corrosion process progresses.

Figure 3 – Reinforcement Corrosion. (A) Caisson reinforcement exposed and section loss due to corrosion; (B) Area with exposed reinforcement and concrete cracking due to corrosion

The structural reinforcement of the caissons began with "apicoamento," which involves drilling or cutting away a layer of concrete to remove damaged material. This was followed by protective painting to shield the concrete structures from external damage, such as moisture and atmospheric pollutants, thereby extending their service life. Subsequently, new reinforcement was installed, hydro blasting was performed, grout was applied, and a 15 cm jacket was added. For work below the water level, temporary water diversion using cofferdams was essential, as shown in Figure 9.

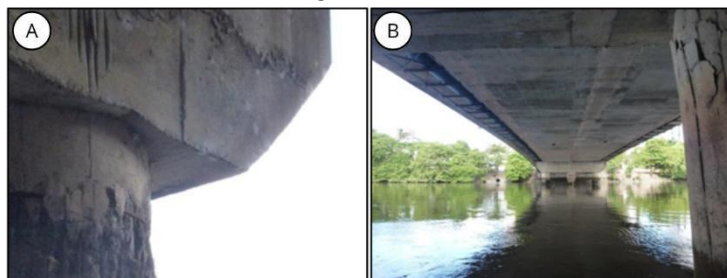
White stains, characteristic of a phenomenon known as efflorescence, were also observed on the crossbeams and the lower slab of the deck of the OAE, as shown in Figure 4. According to Ribeiro et al. (2018), efflorescence results from the formation of saline deposits on the concrete surface, caused by its exposure to water, whether from infiltration through cracks or from the hot and humid environmental conditions. In some cases, the salts that make up these deposits can be aggressive and cause deep degradation of the material.

Figure 4 – Pathological manifestations found along the bridge. (A) Presence of white stains on the crossbeam; (B) Efflorescence on the deck slab, cracking, and detachment of the caisson's concrete cover

After analyzing the results, structural recovery and reinforcement services for the caissons, crossbeams, and deck were carried out. The adopted solutions included cleaning and removal of existing stains, protective painting, replacement of support devices, and replacement of drains on the walkway slabs and the expansion joint between the structure and access.

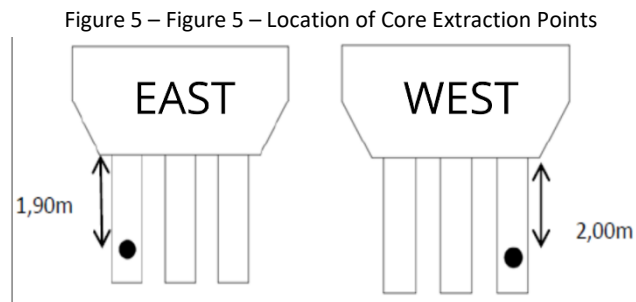
Core extraction is the initial testing method, which involved taking a sample from a caisson on each side, as shown in Figure 5. According to NBR 7680 (2015), the results obtained through this procedure can be used for the acceptance of concrete in case of non-conformities, for evaluating the structural safety of an ongoing project, or for verifying the structural safety of an existing structure. The analysis of the core samples revealed the existence of two internal layers that were possibly constructed at different times, as the concretes do not show any bond between them, despite having the same mix design.

The compressive strength tests of the core samples were conducted based on NBR 7680-1 (2015). On the east side, the minimum strength was 24.3 MPa, and on the west side, it was 33.2 MPa. Pieces 1 and 5 represent the west side, and pieces 2 and 3 represent the east side. To obtain the test results, correction factors stipulated in NBR 7680 were applied: K1 is the ratio of height to diameter of the core; K2 pertains to the effect of the extraction process using the drill, meaning that the greater the effect, the smaller the diameter of the core; K3 relates to the direction of the extraction model in relation to the placement of the concrete, orthogonal to the structural element; and K4 pertains to the effect of moisture in the core, where $K4 = -0.04$ is considered for dry or air-dry testing, and $K4 = 0$ for saturated testing. Table 1 displays the test results.

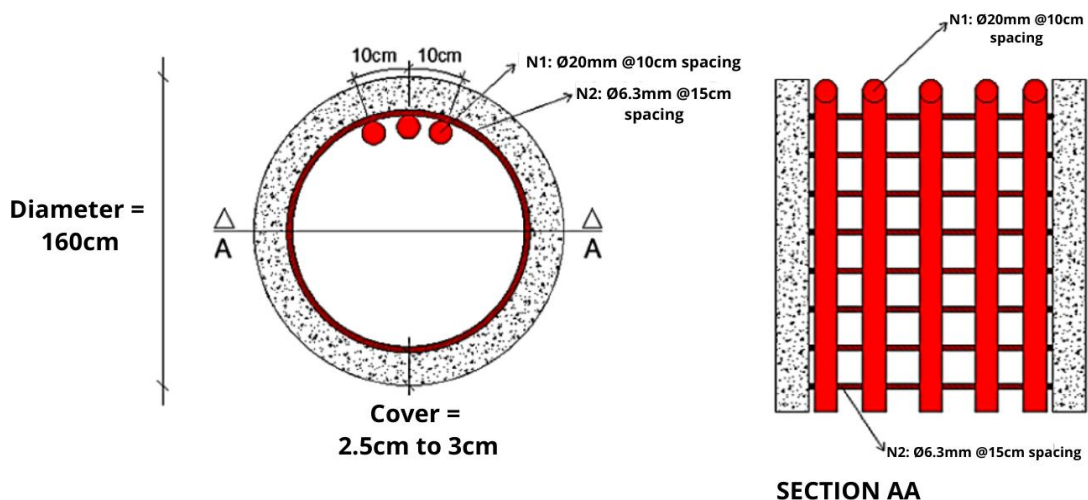
Figure 6 – Detailing of the Reinforcement Bars Inside the Caissons

To verify whether the concrete cover meets the requirements of NBR 6118 (2023) and to determine the position of the reinforcement in the caissons, a rebar scanning procedure was performed. According to Carvalho et al. (2017), this is a non-destructive and non-invasive method that identifies the location of reinforcement bars, as well as their diameter and concrete cover thickness. The equipment used was the Ferroskan PS35, and this method is based on the principles of electromagnetism. Figure 6 illustrates the result obtained using this tool.

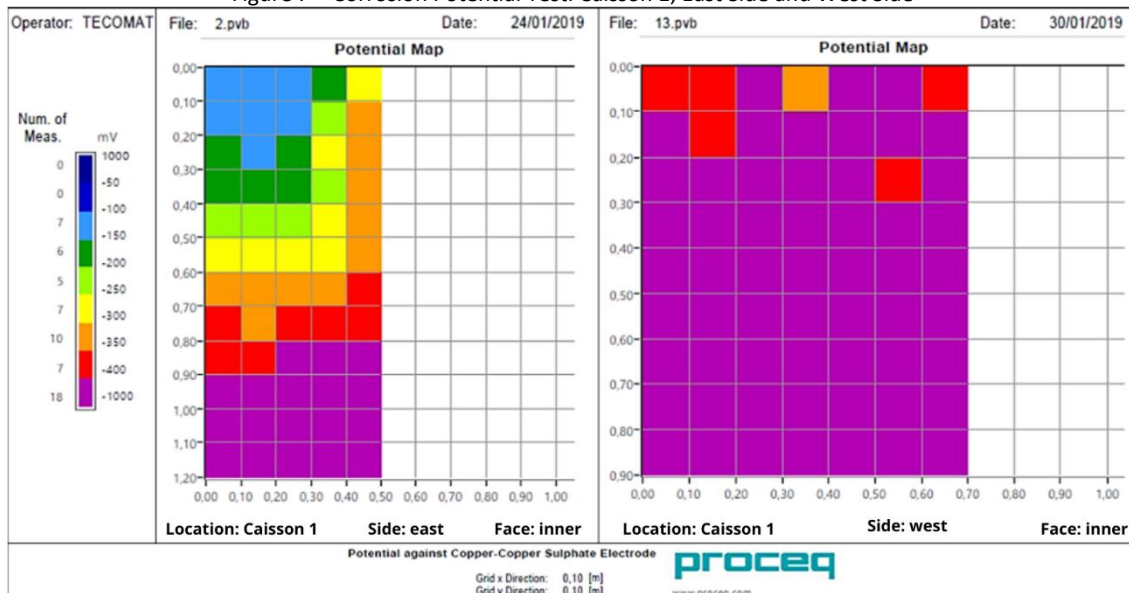
The survey established by the equipment readings, interpreted by its software, indicates that the reinforcement bars in the caissons on the west side have a higher corrosion potential in all three elements compared to the other three on the east side. Figure 7 presents the software's readings for Caisson 1 on both sides, generally representing the collected data. According to the criteria of ASTM C 876-09, the probability of corrosion is less than 10% for readings greater than -200mV, with an uncertain probability of 50% if the readings are between -200mV and -350mV. The probability of corrosion is greater than 90% if the readings are below -350mV.

Figure 7 – Corrosion Potential Test. Caisson 1, East Side and West Side

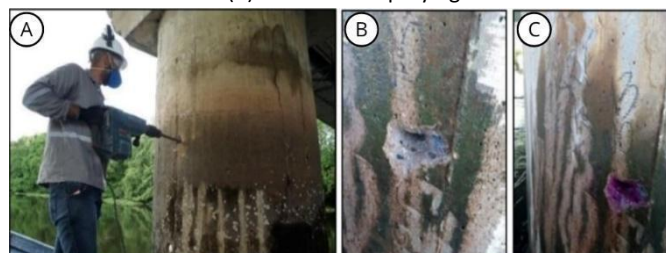
The purpose of the carbonation test was to assess the potential for reinforcement corrosion and was conducted only on the 3 caissons on the east side, on both internal and external faces, following the recommendations of RILEM TC056 CPC 18. This is a partially destructive and low-cost method, requiring only a sprayer filled with a solution of phenolphthalein and ethanol. According to Silva (2012), phenolphthalein is an organic compound used as an indicator in a 2% ethanol solution. When in contact with the medium, it remains colorless at acidic pH <7.0 and turns pink at basic or alkaline pH >7.0, as shown in Figure 8.

Figure 8 – Carbonation Test. (A) Concrete fracture;; (B) Cleaning the area with water; (C) Result after spraying

According to the depth of the test and observed cover, Table 5 estimates the deactivation and remaining time for the reinforcements. It can be observed that the external face of Tubulão 2 is the most critical regarding these aspects.

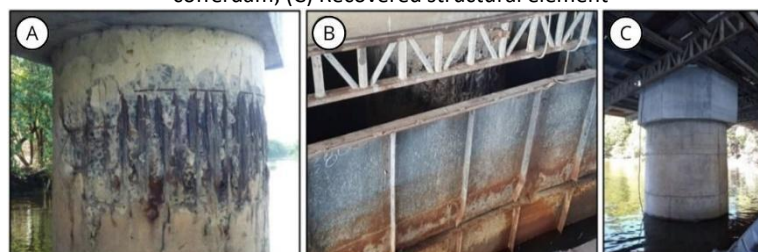
Figure 9 – Caisson Recovery Process. (A) Caisson of the bridge in a deteriorated state; (B) Recovery process inside a cofferdam; (C) Recovered structural element

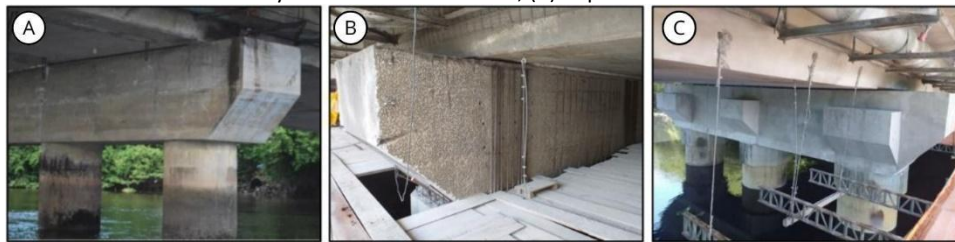
Figure 10 – Process of recovery of the crossbeam. (A) Crossbeam of the bridge without maintenance; (B) Execution of the recovery of the crossbeam block; (C) Repaired structural element

For the crossbeam blocks, the recovery techniques were similar, as shown in Figure 10.

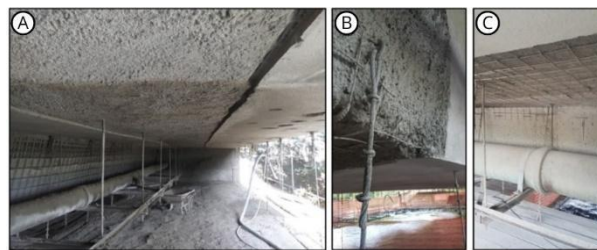
Figure 11 – Deck recovery process of the bridge. (A) Scabbling on the deck; (B) Projected concrete; (C) Installation of reinforcements on the deck

For the deck, the solution differed only in the thickness of the projected concrete for covering, which was seven centimeters, as shown in Figure 11.

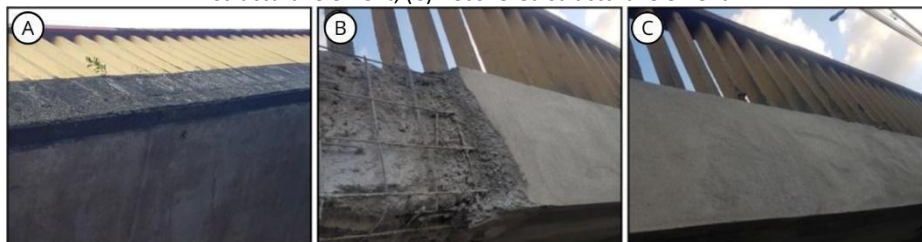
Figure 12 – Walkway slab recovery process. (A) Condition of the walkway slab before recovery; (B) Covering of the structural element; (C) Recovered structural element

Figure 12 – Recovery of the walkway slab also considered a preventive measure.
