Damage Map of Facades of Historic Buildings: Case Study of the Madre de Deus Church in Recife-PE

SUMMARY

KEY-WORDS: Damage Map. Historical Buildings. Pathological Manifestations.

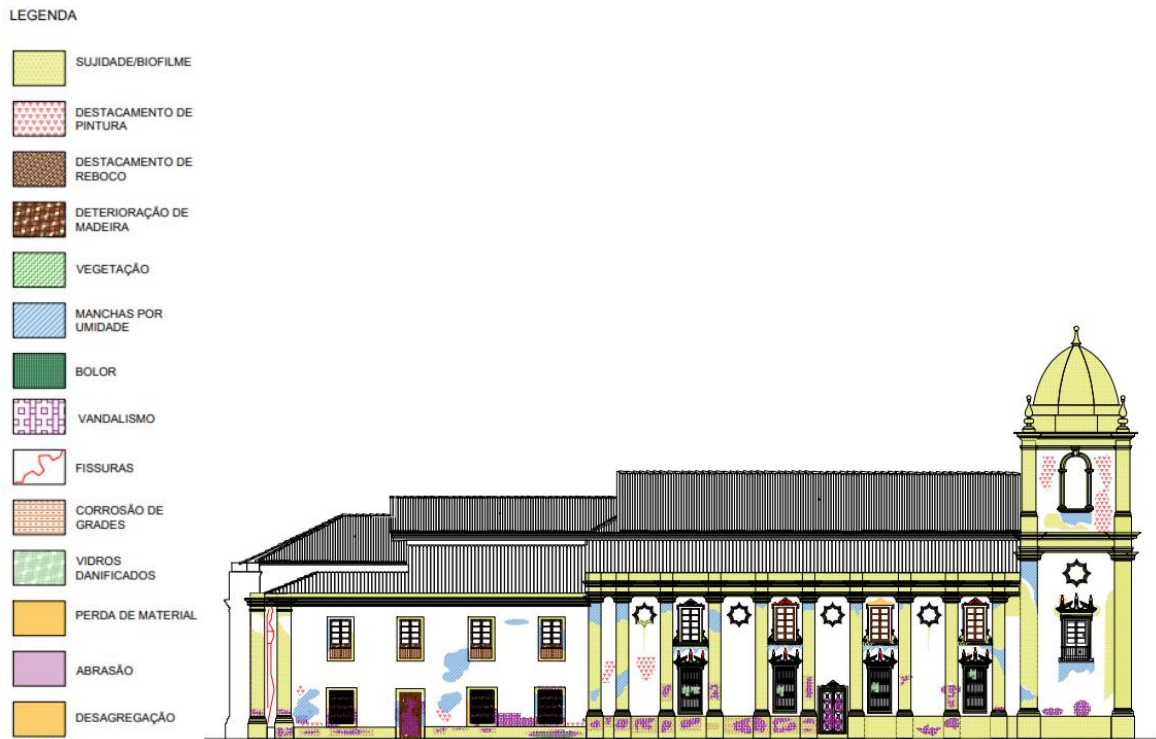
Figure 3 - Damage Map of the South Façade of the Church of Madre de Deus

The building's South Facade is exposed to rain and sea breezes, which explains the significant percentage of dirt/biofilm (42.63%) and moisture stains (3.35%) in this orientation (Figure 3). Vandalism is also a flaw that affects a considerable part of this facade, which has the highest percentage of compromised area and a wide variety of flaws (Figure 4). Both vandalism and dirt/biofilm are found more expressively in the lower regions of the facade, including on doors and stonework. The loss of material represents a risk to passers-by and damage to the historical value of the building.

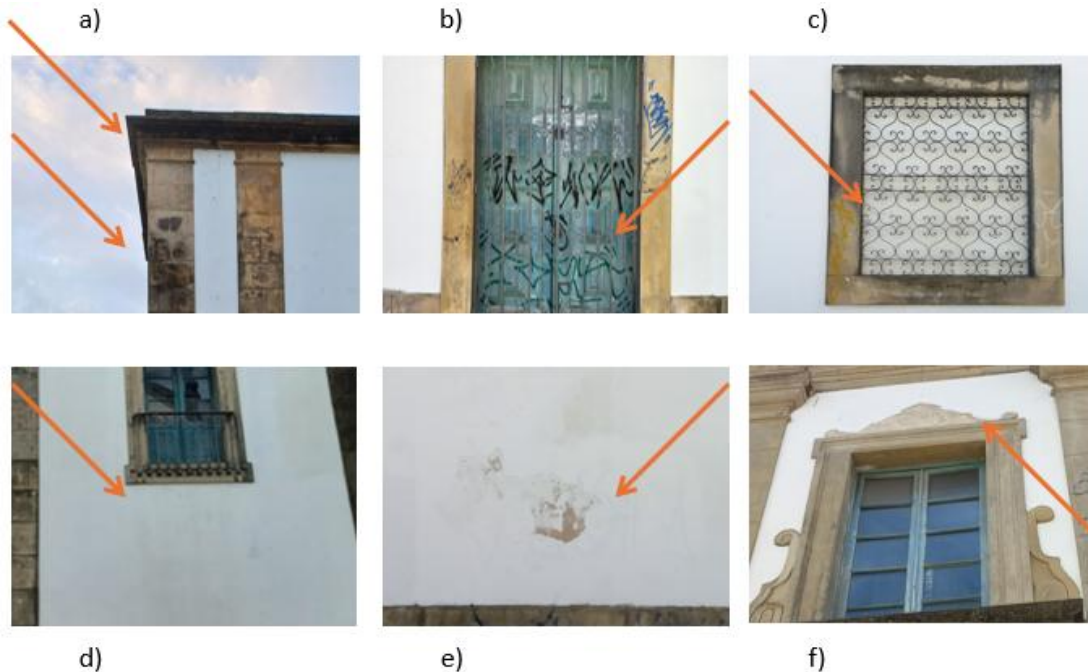
Figure 4 - Pathological manifestations identified on the South Facade of the Madre de Deus Church

a) Dirt/biofilm b) Vandalism c) Loss of material d) Moisture stains
e) Peeling paint f) Loss of material

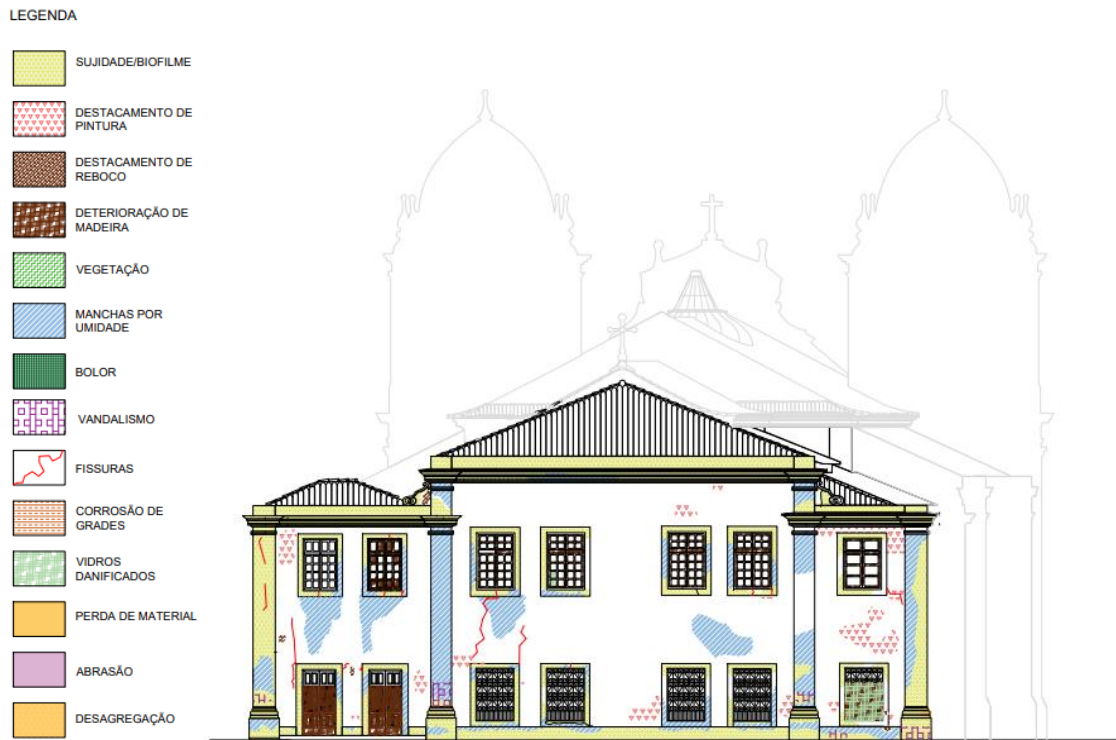
Figure 5 - Damage Map of the West Facade of the Madre de Deus Church

The rear facade of the Madre de Deus Church faces the Capibaribe River (west). The damage found was: dirt/biofilm, moisture stains, deterioration of wood frames, damaged glass, peeling paint and plaster, vandalism, cracks and loss of material (Figure 5). Figure 6, shown below, indicates the most frequent occurrence.

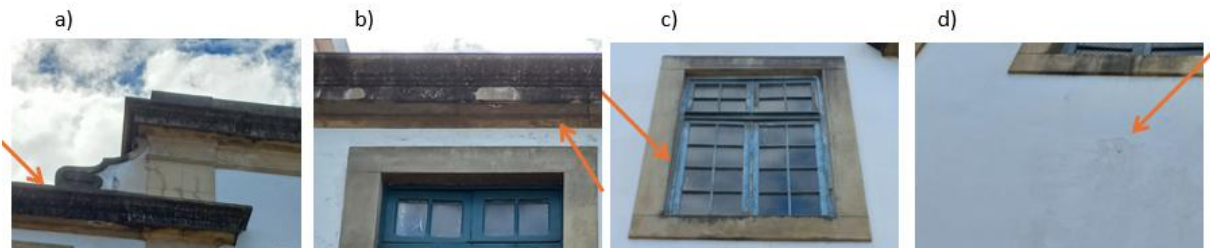
Figure 6 - Pathological manifestations identified on the West Facade of the Madre de Deus Church

a) Dirt/biofilm b) Dirt/biofilm c) Wood deterioration d) Moisture stains

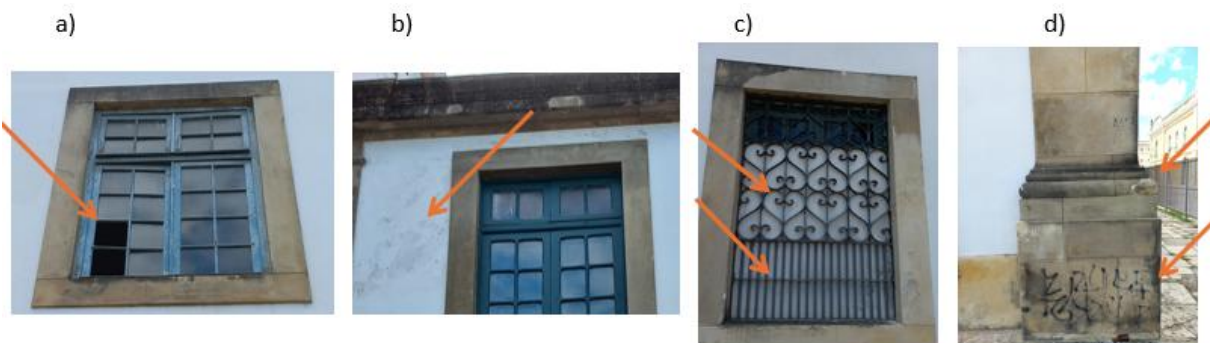
Figure 7 - Other manifestations identified on the West Facade of the Madre de Deus church

It can be seen that the identification of peeling paint (Figure 7) occurred in specific regions of this facade. Most of the wooden frames show significant deterioration (the abundance of sunlight from the west certainly contributed to this). Corrosion of grilles was found on the elements that make up the doors and one of the windows, which is no longer completely original, assuming a partial closure with the gap with a white finishing element.

a) Damaged glass b) Peeling paint c) Loss of material and corrosion of railings d) Loss of material and vandalism

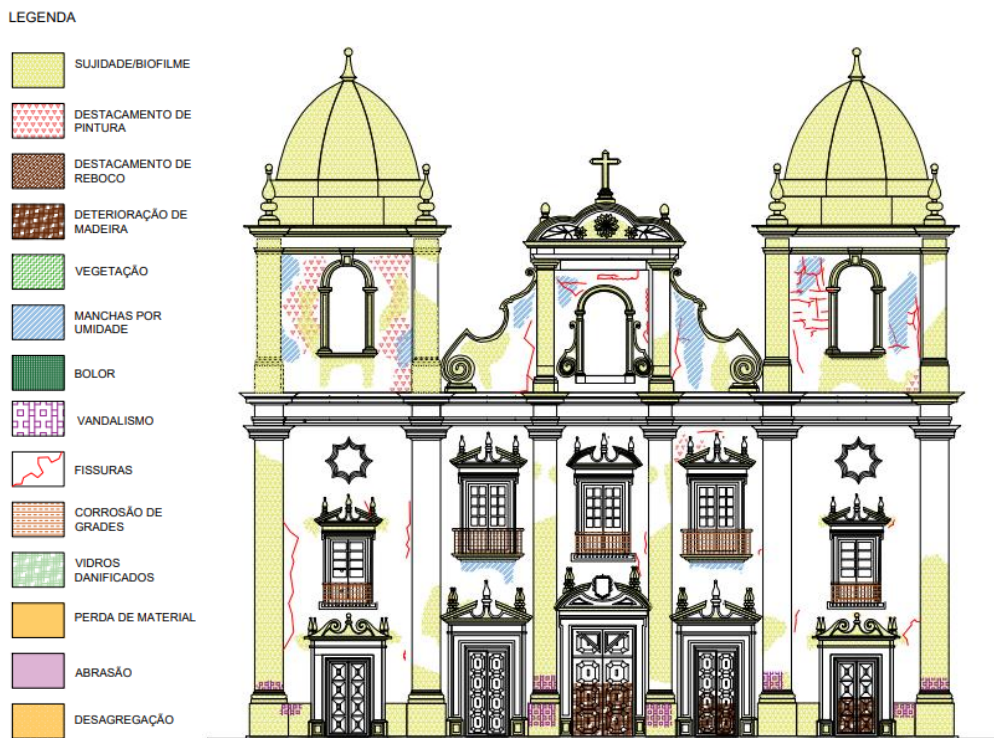
Figure 8 - Damage Map of the East Facade of the Madre de Deus church

The front facade (East Facade) of the church, like the South Facade, is exposed to rain and winds from the sea, therefore, the occurrence of dirt/biofilm and moisture stains are the most significant in this orientation (Figure 8). The protrusions resulting from the architectural configuration, mainly in the upper part, which is difficult to access for cleaning and maintenance activities, contribute to the accumulation of moisture and residues and the emergence of these pathological manifestations in this region (Figure 9).

It can be seen that the damage caused by vandalism is located in the lower parts of the facade, as well as the areas of the doors that show deteriorated wood. The grilles with corrosion on this facade are the window guardrails that are located just above the doors, directly affected by the weather.

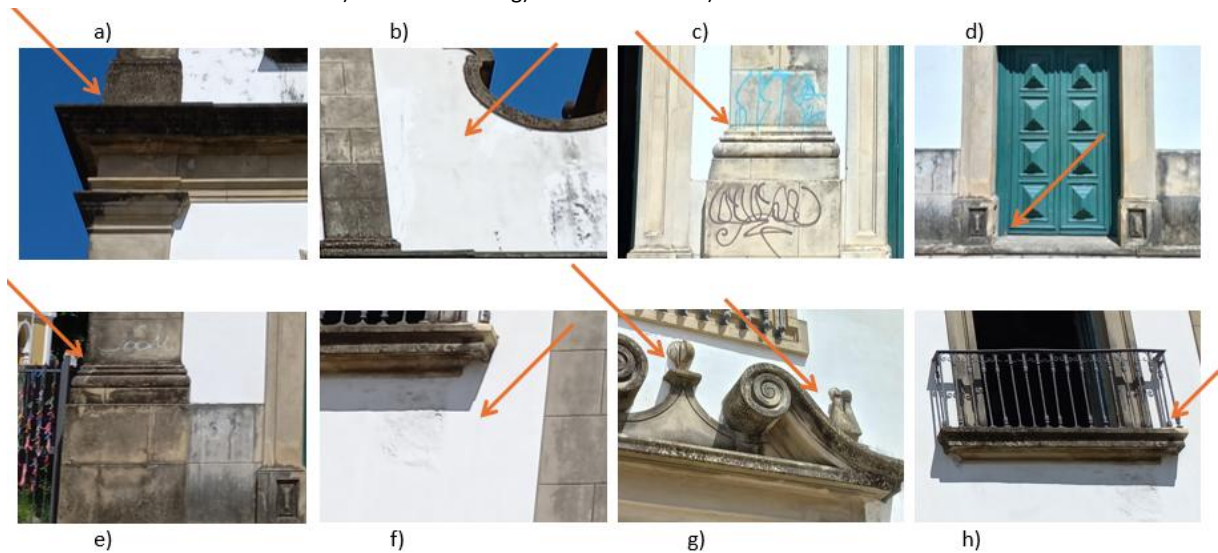
Figure 9 - Manifestations identified on the East Facade of the Madre de Deus Church

- a) Dirt/biofilm b) Moisture stains c) Vandalism d) Wood deterioration e) Dirt/biofilm
f) Moisture stains g) Loss of material h) Corrosion

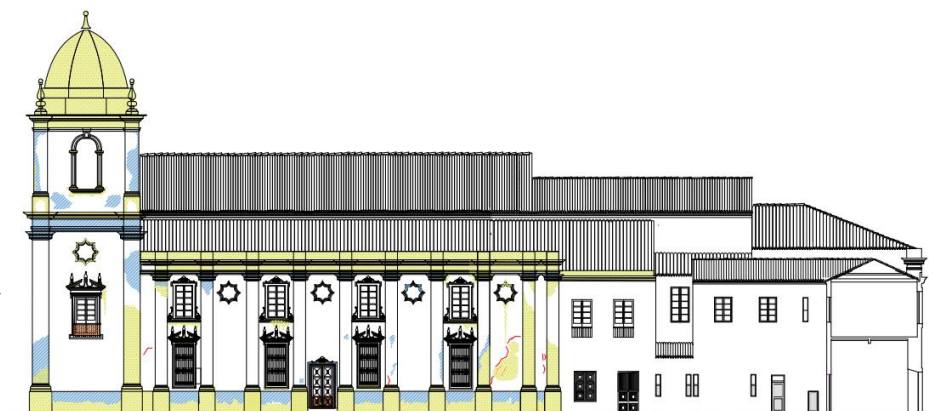
Figure 10 - Damage Map of the North Façade of the Madre de Deus church

The north facade was in a better state of conservation, with few and isolated pathological manifestations (Figure 10). No vandalism was found, certainly due to the existence of a wall that limits access for passers-by.

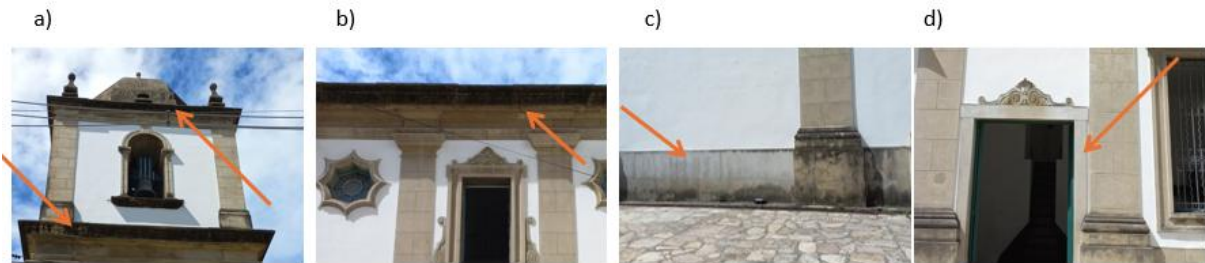
Figure 11 - Main manifestations identified on the North Façade of the Madre de Deus Church

The most significant manifestations were dirt/biofilm and moisture stains in the lower regions of the facade and on the building's ornaments, as shown in Figure 11.

a) Dirt/biofilm b) Dirt/biofilm c) Moisture stains d) Moisture stains
