**Walkability evaluation surrounding university campus: case study in Marília (SP)**

This paper aims to present the results of the assessment of the quality of walking in the surroundings of three universities in the city of Marília/SP.

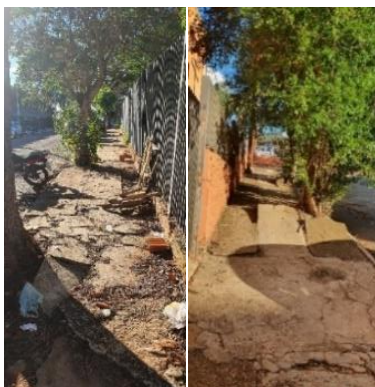
Only two indicators obtained the ideal maximum value, minimum sidewalk elements and public lighting. Although the lighting item had a high score, it was observed that the lighting in the place seemed to be dim. As most of the activities on these campuses take place at night, due to the score obtained, it can be inferred that this indicator deserves an adjustment in its form of assessment. Other indicators also received high scores: location of the service lane, width of the free lane and afforestation on the roads. Some details observed in the defined stretch, which there are no indicators to assess, such as holes in the surface, lack of maintenance or cleaning (Figure 2). The indicators that received the classification considered “bad” were the longitudinal and transversal inclination as a function of the topography of the studied area. The best sidewalk face (12), in front of UNESP, is the only one that has a tactile floor throughout the entire lot, but it is the same color as the floor, so it is in disagreement with the recommendations of NBR9050/2020, which guides the use of contrasting colors.

**Figure 2: Some problems related of the Sidewalk theme - faces 02 and 04.**

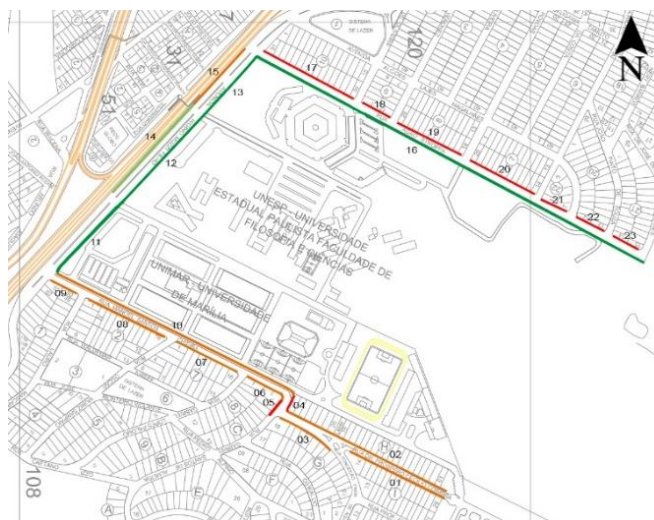
*Sidewalk theme* – The analysis of the sidewalk theme indicators (Table 9) shows that the indicators that contributed to obtaining a final index of 37.8% are related to ease of surface replacement, obstacle-free height, unobstructed and interference-free strip, Height of the curb and Leveling with the sidewalk of the contiguous lot, considered poor for accessibility on the sides of the block evaluated.

**Figure 3: Result of the Sidewalk theme.**

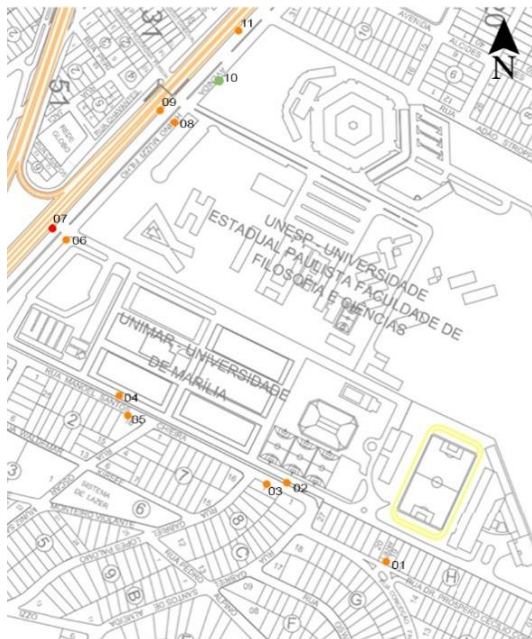
*Bus stop theme* - The bus stop theme obtained a score close to sidewalks, with 38.5%, considered as bad. In this item, the indicators for the presence of stall, trash tree, trash and lighting, presence of fixed seats were evaluated. An observation involving the themes sidewalk and bus stop, in one of the bus stops, considered number 7 (Figures 4 and 5) is located in an area where there is no sidewalk.

**Figure 1: Result of the Bus stop theme.**

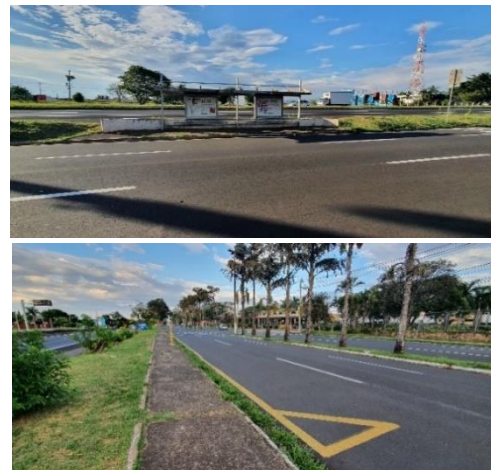
Many indicators were not present at any of the 11 Bus stops evaluated, such as the presence of a stall, information panel, access ramp, garbage dump and all items associated with accessibility for people with wheelchairs. And the tactile warning signs along the curb (9.1%) and the presence of a bus stop signboard (18.2%) also need attention. The few positive points of this theme, classified as excellent, were minimum sidewalk length (90.9%), presence of curbs (81.8%), presence of public lighting (100%), presence of delimiting markings on roads (100%) and minimum sidewalk width (90.9%).

**Figure 5: Some problems related of the Bus stops theme - points 01 and 07.**

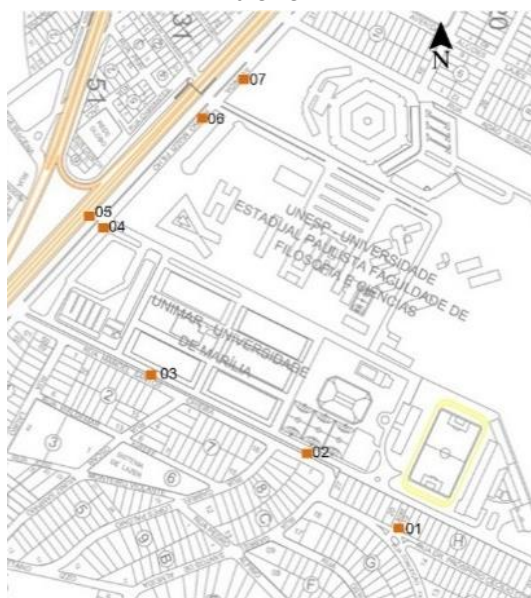
*Passenger Shelter (Bus stop) Theme* - is associated with the presence of a bus stop in the assessed area. It was observed that not all bus stops have shelter for passengers, only two of the indicators were considered in the evaluation of this item and received maximum score, presence of fixed seats for rest and presence of cover. And the other indicators did not score.

**Figure 6: Result of the passenger shelter (Bus stop) theme.**

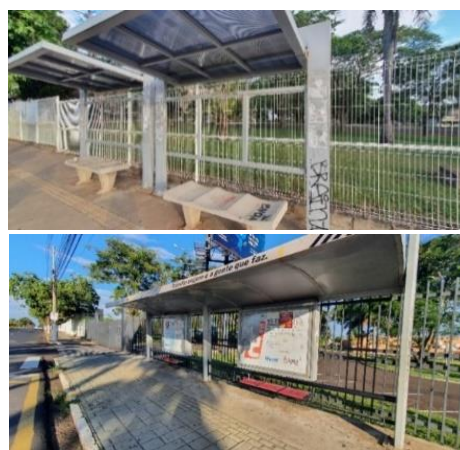
**Figure 7: Some problems related to the passenger shelter (Bus stop) theme— points 04 and 06.**

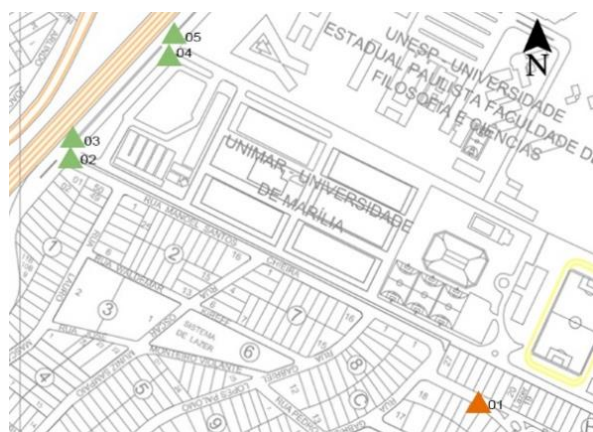
*Curb ramp Theme* - As established by NBR 9050, most sidewalk lowerings were built in the direction of the pedestrian crossing flow (ABNT, 2020). Despite this theme having a score of 56.3%, classified as "Good", in the entire analyzed stretch, only 5 Curb ramps were identified, one of them located in front of the university hospital, it seems an "adaptation" (RC number 01), as the ramp is fitted to the curb (Figures 8 and 9). The other sidewalk lowerings (RC numbers 02, 03, 04 and 05) are all located on Avenida Higino Muzi Filho, just on the face of Unimar Campus. All Curb ramps lack a tactile warning floor, the curb height is irregular, sometimes lower or higher than indicated by technical standard NBR 9050. Another parameter in disagreement with

NBR 9050 refers to the minimum distance that the sidewalk recesses must be from the vehicle curve points (CERNA, 2014; ABNT, 2020).

**Figure 8: Result of the Curb ramp theme.**

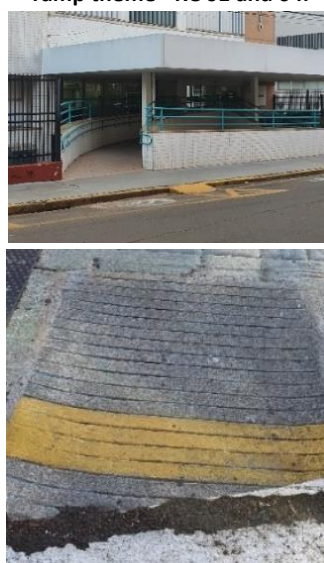
**Figure 9: Some problems related to the Curb ramp theme - RC 01 and 04.**

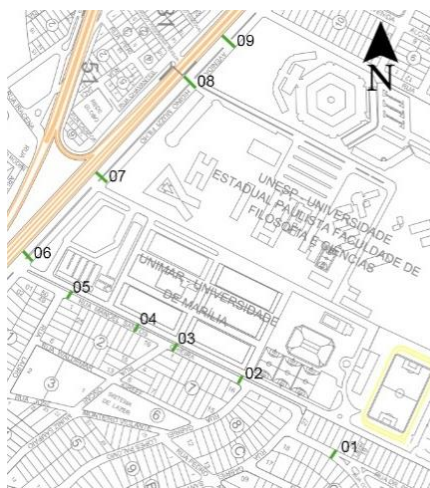
**Crosswalk Theme** - Of the themes evaluated, the crosswalk obtained the best evaluation. It was observed that the existing crosswalks were within the minimum dimension

recommended by the technical standard, painted in white color, presence of public lighting, but not all are in a good state of maintenance. However, it was identified that many crossings located around the three university campuses do not have crosswalks, such as the one on Adão Stroppa Street (located on the side of Univem).

**Figure 10: Result of the Crosswalk theme.**

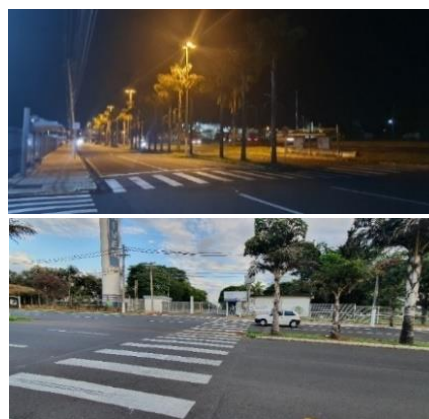
**Figure 11: Some problems related to crosswalks.**

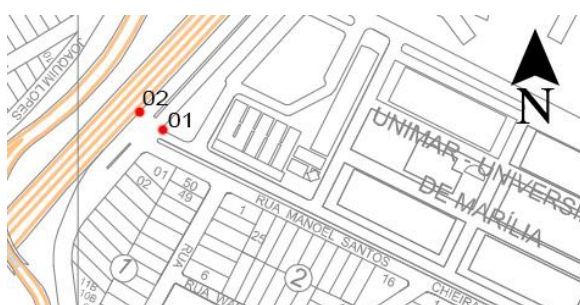
*Traffic light Theme* - The worst theme evaluated, Traffic light (25%), correspond to the evaluation of two traffic lights in the entire evaluated section, which are located on Higino Muzi Filho Avenue, in front of Unimar Campus, possibly because it receives a greater number of students. Its location does not make it difficult for pedestrians to circulate in the place, but at a traffic light (number 02) one side does not have a sidewalk face, but has a bus stop (number 07), a fact that negatively contributes to this assessment and impairs quality space of this location. The other indicators obtained the minimum score, as there is no manual device and sound signal in the evaluated area.

**Figure 12: Result of the Traffic light theme.**

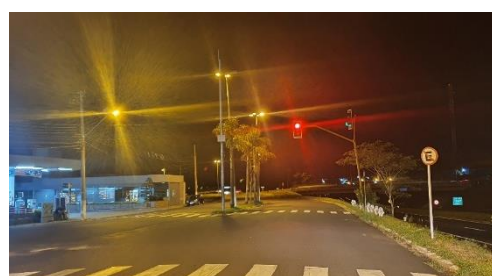
**Figure 13: Some problems related to the Traffic light theme – point 02.**
