Pathological manifestations on hospital unit facades: case study at the appointment center of the Oswaldo Cruz University Hospital, Recife - PE

KEYWORDS: Pathology in Civil Construction. Damage Map. Hospital facade.

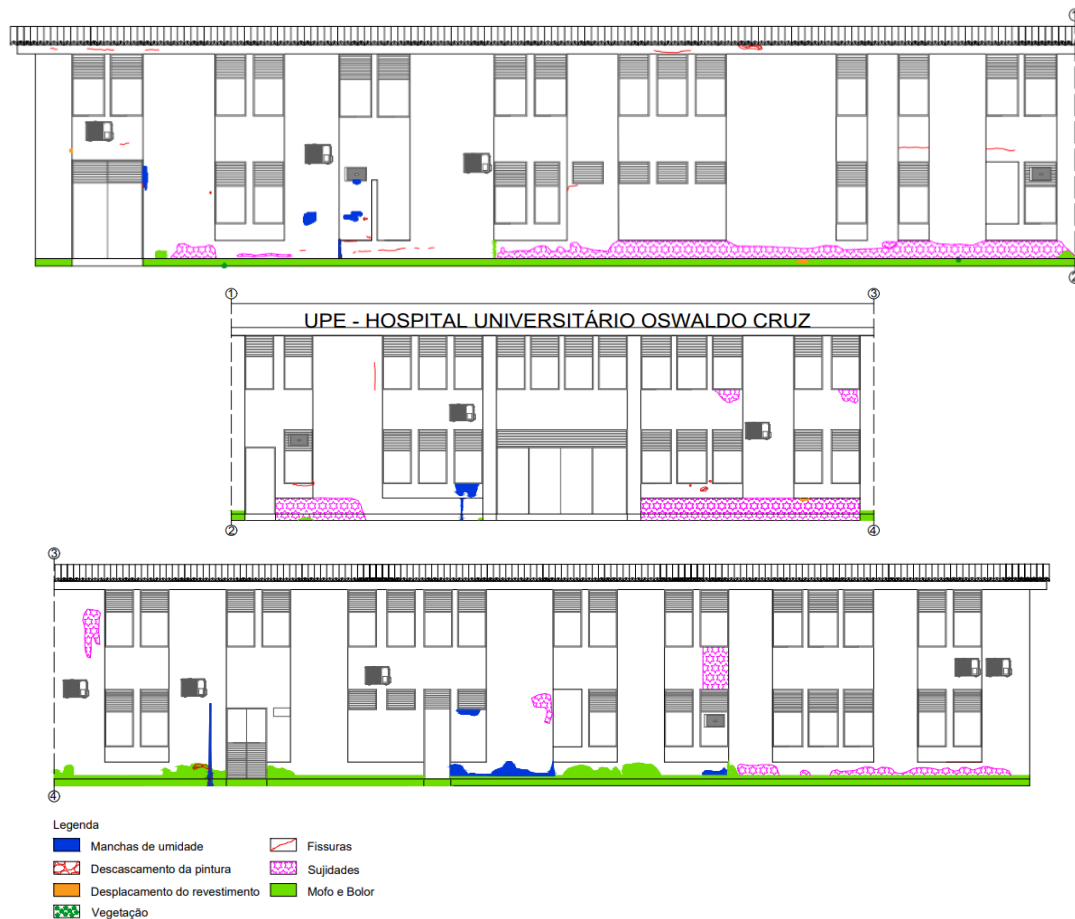
Figure 5 - Damage Map of the Southeast Facade

Due to its significant horizontal dimension, the Southeast Facade Damage Map, shown in the following figure, was divided into three parts for better visualization, with cut lines indicated as 1-2 and 3-4.

On the Southwest Facade, the most commonly observed pathological manifestation was mold and mildew. Two sources of humidity that contribute to this issue are rain running down the facade and splashing on the baseboard, and pipes transporting wastewater from the building's air conditioning condensers. It was noted that the ends of these pipes either point directly towards the facade or leak at the connection with the destination pipe, creating consistently damp areas. This is evident from the accumulation of water on the walls and

sidewalks, providing a favorable environment for microorganism growth. The porosity and roughness of mortar coatings also play a role in this problem, as they allow water absorption and retention, facilitating microorganism adhesion (OLIVEIRA JÚNIOR et al., 2021).

Two types of cracking were observed. One type occurs at the junction between the masonry of the continuous wall and the pavement slab, while the second type is attributed to reinforcement corrosion. Despite the building predominantly consisting of walls made of approximately 30 cm thick ceramic masonry, when using a pacometer, metal was detected along a crack with an opening of 0.45 mm. This indicates a pathological manifestation resulting from the expansion of the coating due to reinforcement corrosion in the structure.

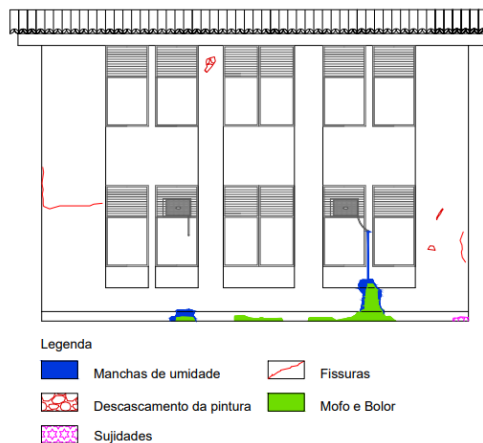
Figure 6 - Damage Map of the Northwest Facade

The Northeast Facade, located on the left side of the building facing the Faculty of Medical Sciences of the University of Pernambuco, does not have any access doors. Pathological manifestations similar to those found on the Southwest Facade were identified here as well. Particularly noteworthy is the issue of inadequate disposal of wastewater from refrigeration equipment, which leads to water puddles on the sidewalk, causing inconvenience to hospital users. Additionally, paint peeling and cracking were observed, albeit to a lesser extent. The cracking is attributed to the building's proximity to another structure, resulting in deformations caused by thermal variations and the movement of different materials.

The Damage Map below provides a summary of the pathological manifestations identified on this facade.

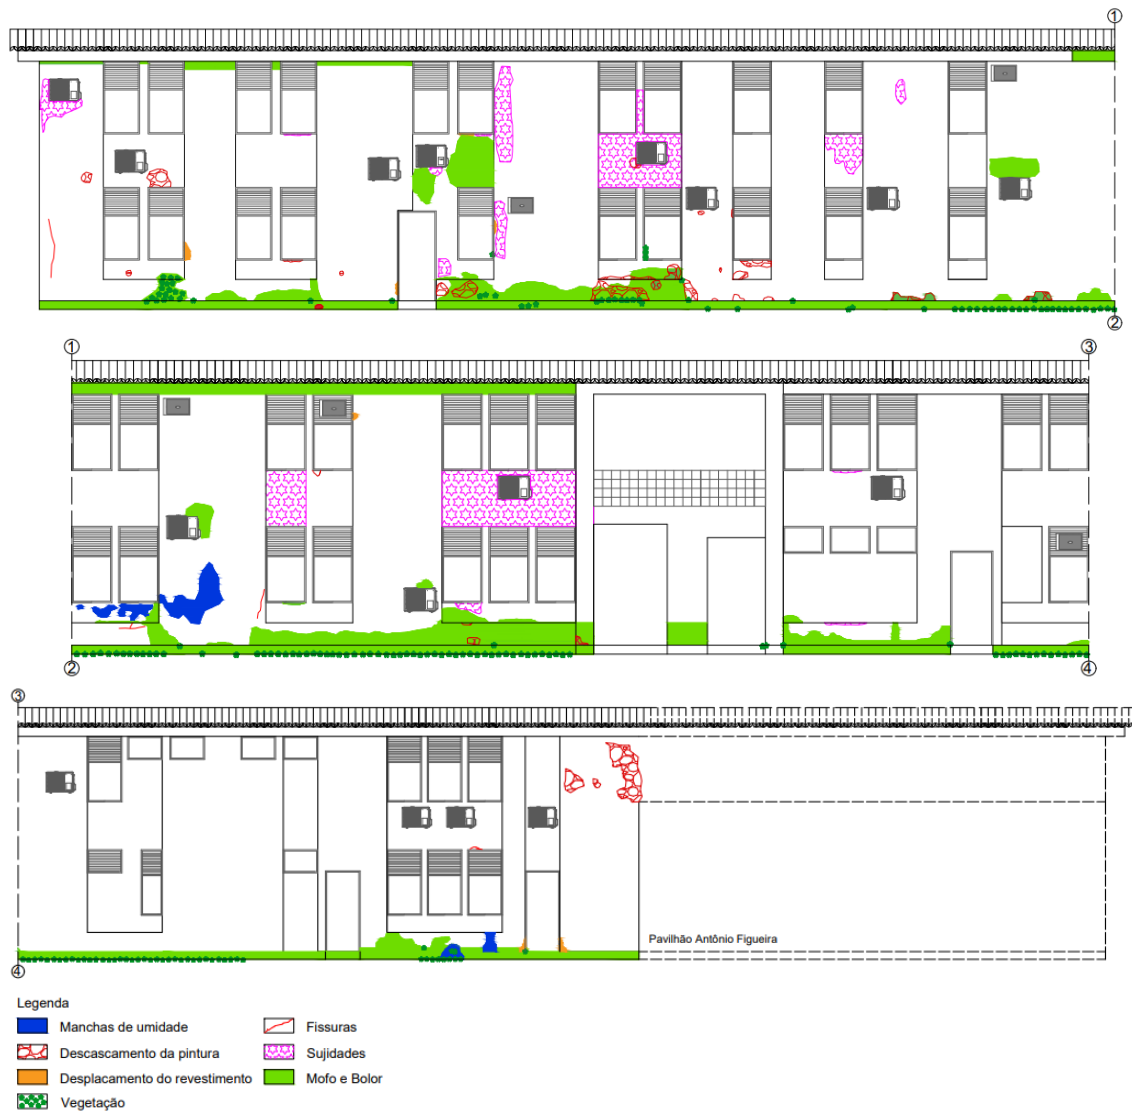
Figure 7- Damage Map of the Northeast Facade

Similar to the southeast facade, the northeast facade damage map was divided into three parts in order to provide better visualization.

There is a presence of large amounts of mold, parasitic vegetation, and pigeon droppings on this facade, in addition to the lack of maintenance. It is worth mentioning that the building is a health unit, and the presence of this biological material can directly interfere with the health of its users, both patients and employees. In the case of parasitic vegetation, the roots grow inside the coating, generating tensions that impair adhesion, in addition to the constant presence of a source of humidity from air conditioning, which causes the segregation of the layers that make up the coating.

Peeling paint, peeling of the coating, and cracks along the coating were also observed. After analyzing these manifestations, it is possible to indicate that there are large amounts of paint accumulated on the facade and that the substrate is in a powdery state,

indicating that during the intervention actions there was no adequate preparation of the surface, such as removing non-adherent material, before receiving a new coating.

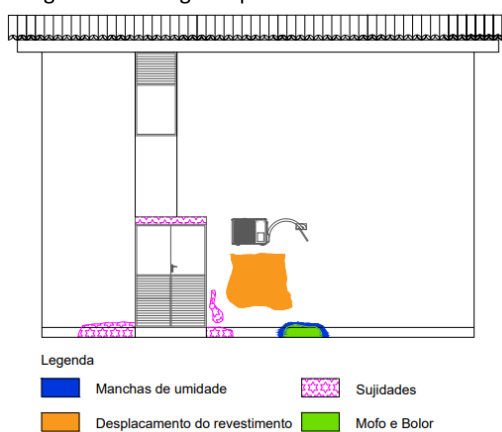
Figure 8 - Damage Map of the Southeast Facade

The southeast facade is the right-side facade of the building, facing the main board building and serving as the access to a collection point. This facade exhibits dirt, mold, mildew, and peeling of the coating, which can also be attributed to the constant presence of humidity generated by rain and a refrigeration device. Above the access door, there is a canopy which, being the most prominent element of the facade, receives direct environmental exposure along its length, resulting in an accumulation of dirt. Figure 8 shows the Damage Map of the facade, summarizing the pathological manifestations identified.

On the Southeast Facade, the pathological manifestation with the highest FDrc was dirt on the balcony (Table 2), with 100% presence in this region. This issue may be associated with the architectural design. The cantilevered element is the most prominent on the facade, thus being the first to endure the effects of the environment, such as wind and rain. When combined with the lack of periodic cleaning, this promotes the accumulation of dirt, a concern also noted by E. Bauer *et al.* (2015).
