**Assessment of the conservation status of reinforced concrete viaducts: a case study of the Recife/Gravatá-PE railroad**

The present study aims to analyze the structural, functional, and durability conditions of railway viaducts located in the municipality of Gravatá-PE, which are part of the Central Railway of Pernambuco (Central Trunk Line), and determine their state of conservation.

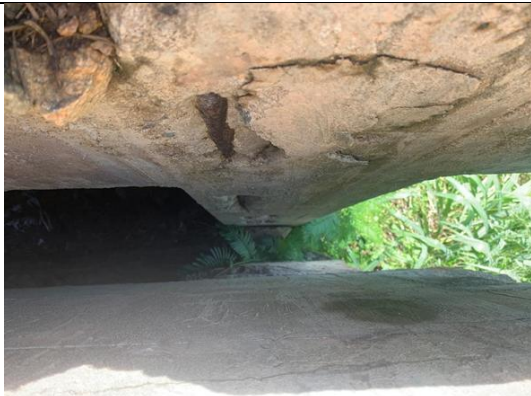
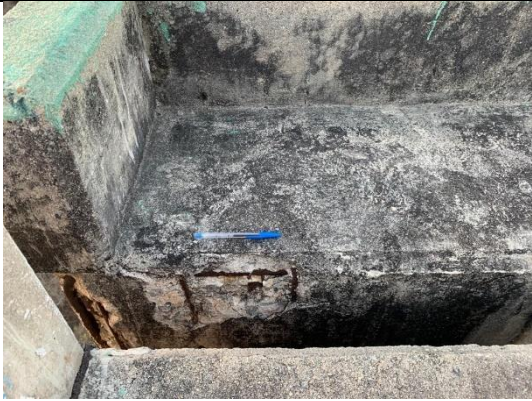
Location	Pathological manifestation	Figure
Expansion joints:	They are not sealed. There was no access for the examination of the concrete elements under the joints.	
Superstructure	Advanced stage corrosion of reinforcements in the spans (I) and in the region of the intermediate supports of the longitudinal beams (II). Cracks and detachment of concrete. Deteriorated concrete and exposed reinforcements at the bottom of the longitudinal beams in all viaducts.	I - Advanced stage corrosion of reinforcements in the spans of V1.
		II - Advanced stage corrosion of reinforcements in the central spans of V3.

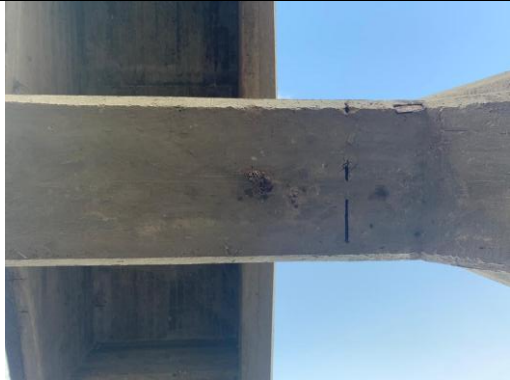
<p style="writing-mode: vertical-rl; transform: rotate(180deg);"><b>Midstructure</b></p>	<p>Deteriorated concrete and presence of vegetation, mold, and mildew. Reticulated structure pillars with exposed reinforcement due to lack of cover (III).</p>	<p>III - Exposed reinforcement due to concreting error, insufficient cover for steel in V3.</p>

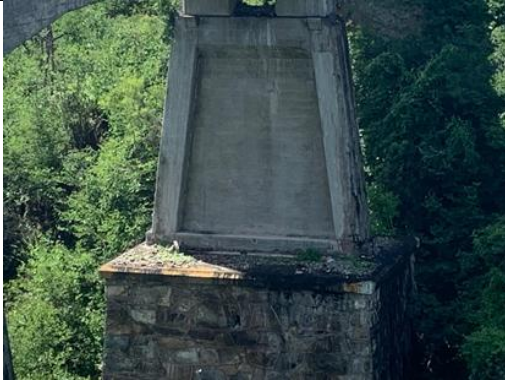
Loc.	Pathological manifestation	Figure
Substructure	Presence of vegetation and white stains indicative of leaching (IV). Advanced stage corrosion of reinforcements in the blocks. Cracks and detachment of concrete. Deteriorated concrete and exposed reinforcements.	IV - Presence of vegetation and white stains indicative of leaching in V2.

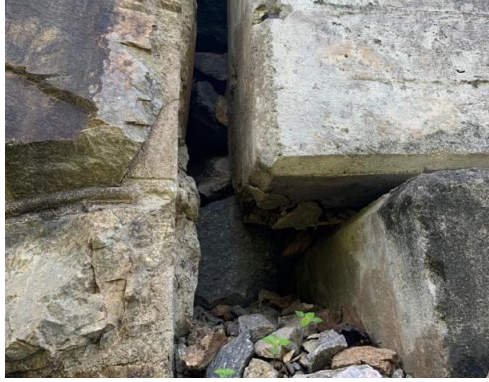
Support devices	The movable support devices are completely crushed (V), in some cases making it impossible to visualize and identify them. Deteriorated concrete and presence of vegetation, mold, and mildew	V – Crushed support devices in V2.

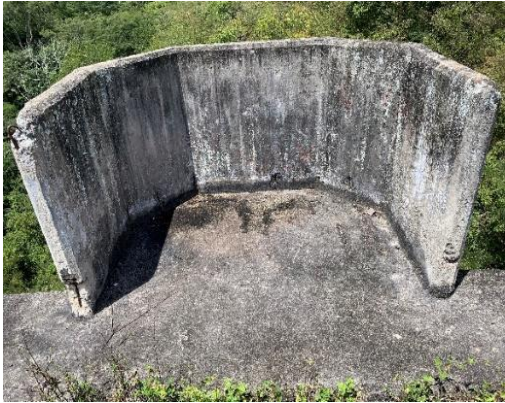
Accessories	The refuge structures show cracks and fissures on the sides, with concrete detachment, deteriorated concrete, and exposed reinforcements (VI). Crack at the connection between the refuges and the longitudinal beam	VI - Refuges showing cracks and exposed reinforcements in V4.

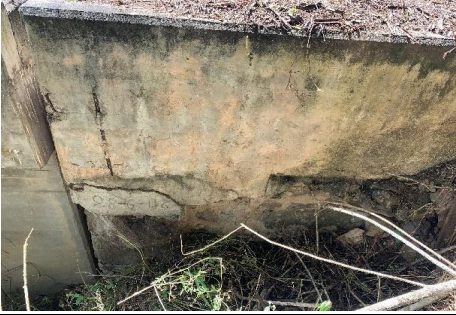
Loc.	Pathological manifestation	Figure
<p style="text-align: center;"><b>Abutments</b></p>	<p>The retaining structures of the embankments at the abutments show cracks and fissures in the upper part of the side walls, with moisture presence (VII and VIII), and the abutment slopes are in good condition.</p>	<p>VII - Abutments with cracking, detachment, and exposed reinforcement in V5.</p>

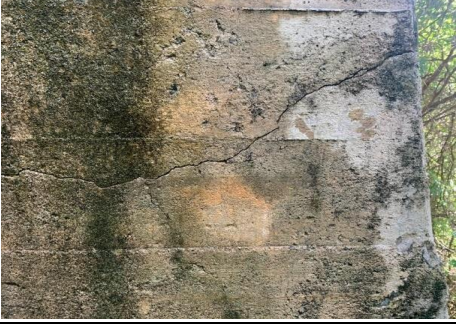
<p>VIII - Cracking in the structures of the abutments of V2.</p>

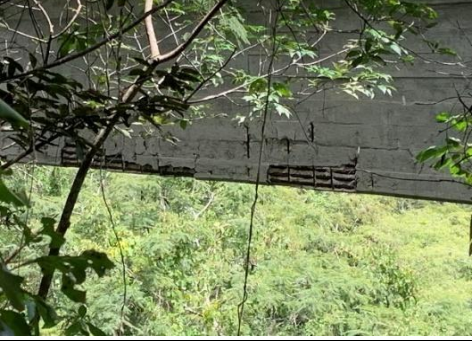
<p style="text-align: center;"><b>Drainage</b></p>	<p>The tubes installed at the bottom of the slab do not appear to be obstructed, but there are moisture stains and fungi around the drainage holes and in nearby areas, revealing the inefficiency of the system (IX and X).</p>	<p>IX - Bottom of the slab with cracking, detachment, and exposed reinforcement in V5, caused by infiltration.</p>

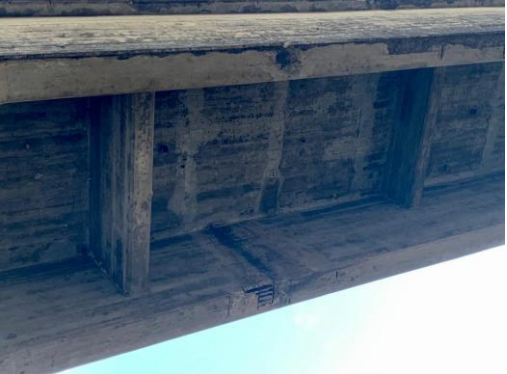
<p>X - Moisture stains and fungi in the drainage holes of V3.</p>
