**Proposal for intervention for the conservation and restoration of the  
Brum Chapel (Recife/PE)**

This study aims to diagnose the pathological manifestations of the Brum Chapel, using four methodological steps, namely: characterization of the area, diagnosis, damage mapping, and guidelines for the restoration project. The case study was carried out at the Brum Chapel, located in the city of Recife/PE, in the northeast region of Brazil between 2020 and 2021. In this way, the research was able to guarantee the preservation and dissemination of facts and historical achievements of the Brazilian Army (responsible for the property), extolling the participation of the northeastern soldier in all historical episodes in the state of Pernambuco, providing culture and knowledge to visitors, in addition to recognition at the regional level, as a preservation agency and an example of conservation of military-religious architecture from the 17th century. The results obtained demonstrated the natural process of evolution of pathological manifestations, raising awareness of heritage management for planning and carrying out maintenance, enabling the compatibility of the building's needs with th

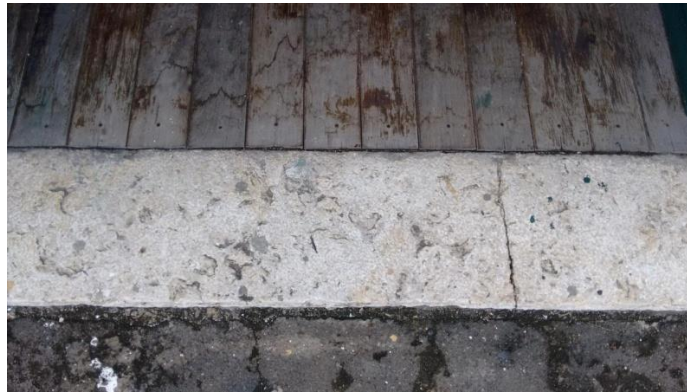
Figure 5: Marble door frame of the Chapel. Note the wear on the floor due to the rain.

At the entrance to the Chapel, where the floor is lowered to allow the doors to open, the proposal is to replace the wood with a material that is more resistant to rain – a small section of travertine marble with a non-slip finish (Figure 5). A fixed ramp was not suggested, as this would unnecessarily alter the configuration of the monument. Since the difference in level is small, it can be overcome by a movable ramp.

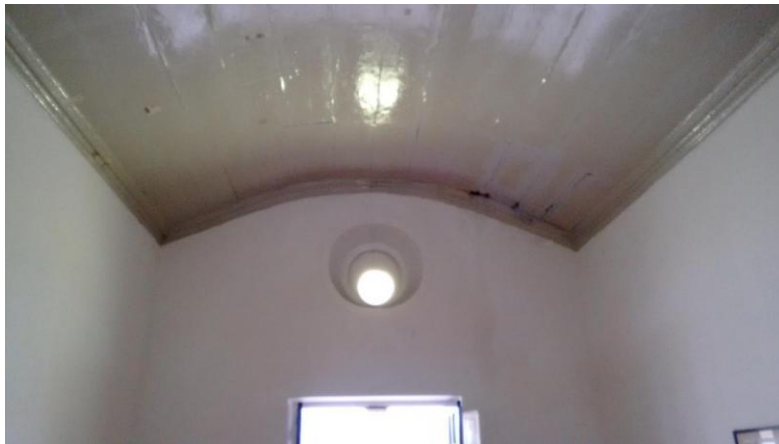
Figure 6: The ceiling seen from the altar. Note its deformation, giving the impression of a barrel vault rather than the bowl shape observed in the opposite direction.

In the chapel ceiling (Figure 6), an old work made of bowl-shaped boards, the proposal is to restore the woodwork, the original shape, which is slightly deformed in some areas, and the original paintwork through a careful stripping process, since previous surveys revealed several layers of paint. Also, due to the small area surveyed, it was not possible to determine which phase would be the most relevant for historical and aesthetic purposes. Removing the synthetic enamel covering the ceiling will be one of the first steps.

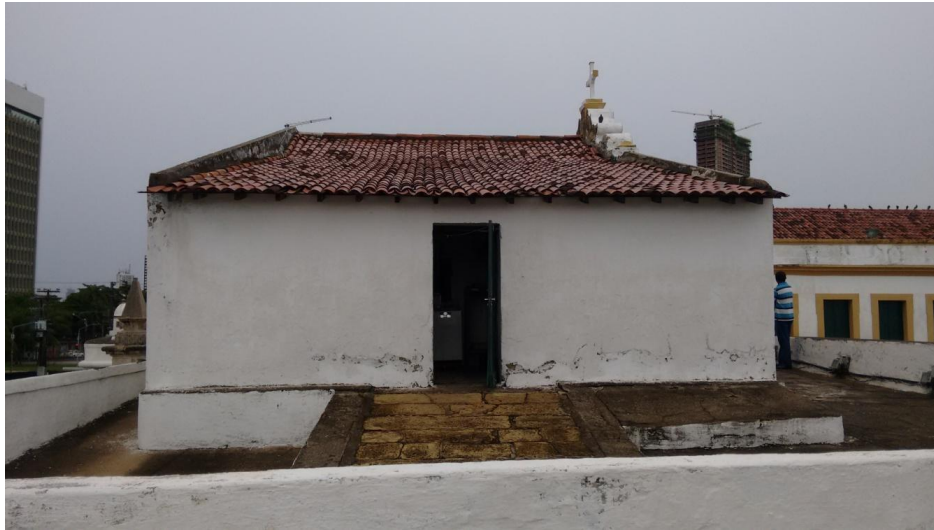
Figure 7: Current situation of the woodwork and roofing of the Brum Chapel

As for the roof (Figure 7), the proposal is to restore the woodwork, maintaining the use of sawn wood, which has already been incorporated into the genius loci of the Chapel. Returning to the use of round wood would be an anachronism that no longer makes sense today. A thermal-acoustic blanket should be placed under the woodwork and above the ceilings in order to protect the building from infiltration, large temperature variations and noise. Under no circumstances should the blanket be visible internally or externally. All internal and external painting of the Chapel and adjoining rooms will be done with white lime-based paint. Any repairs to the plaster will be done with lime and sand mortar.

Attention should be paid to the stonework on the chapel's frontispiece and the borders of the elliptical oculi on its façades, which are currently covered by several layers of paint (Figure 7). The idea is to completely remove the paint, leaving the carved stone exposed as it was originally. This procedure will restore the beauty of the original composition, including bringing to light certain details that are currently hidden, especially the volutes and counter-volutes. The paint on the stonework should be removed using surgical scalpels and then washed with a nylon fiber brush, water and neutral soap. Please note that only the chapel's doorway is made of stonework; other elements such as the volutes on the frontispiece, the oculi and the bases are made of mortar, and therefore must maintain the same paint standard adopted in the fort. The doors to the weight room and the technical reserve only have sandstone lintel, and the borders are made of hand-laid bricks with lime and sand mortar plaster. The oculus must be unclogged, since it can be seen from the thinness of the closure that this is a recent intervention and that churches that have oculi in their frontispieces have them open to provide adequate lighting for their naves. Once open, the oculus will be sealed with pivoting glass, with metal parts applied directly to the masonry, as per the project, ensuring lighting and preventing rain from entering the interior of the Chapel.
