Pathological Manifestations and Damage Map of Historic Buildings: Case Study of the Church of Nossa Senhora do Pilar in Recife/PE**Stephany Rayane Silva Rodrigues**

Pathological Manifestations and Damage Mapping of a Historical Building: Case Study of the Church of Nossa Senhora do Pilar in Recife, Brazil

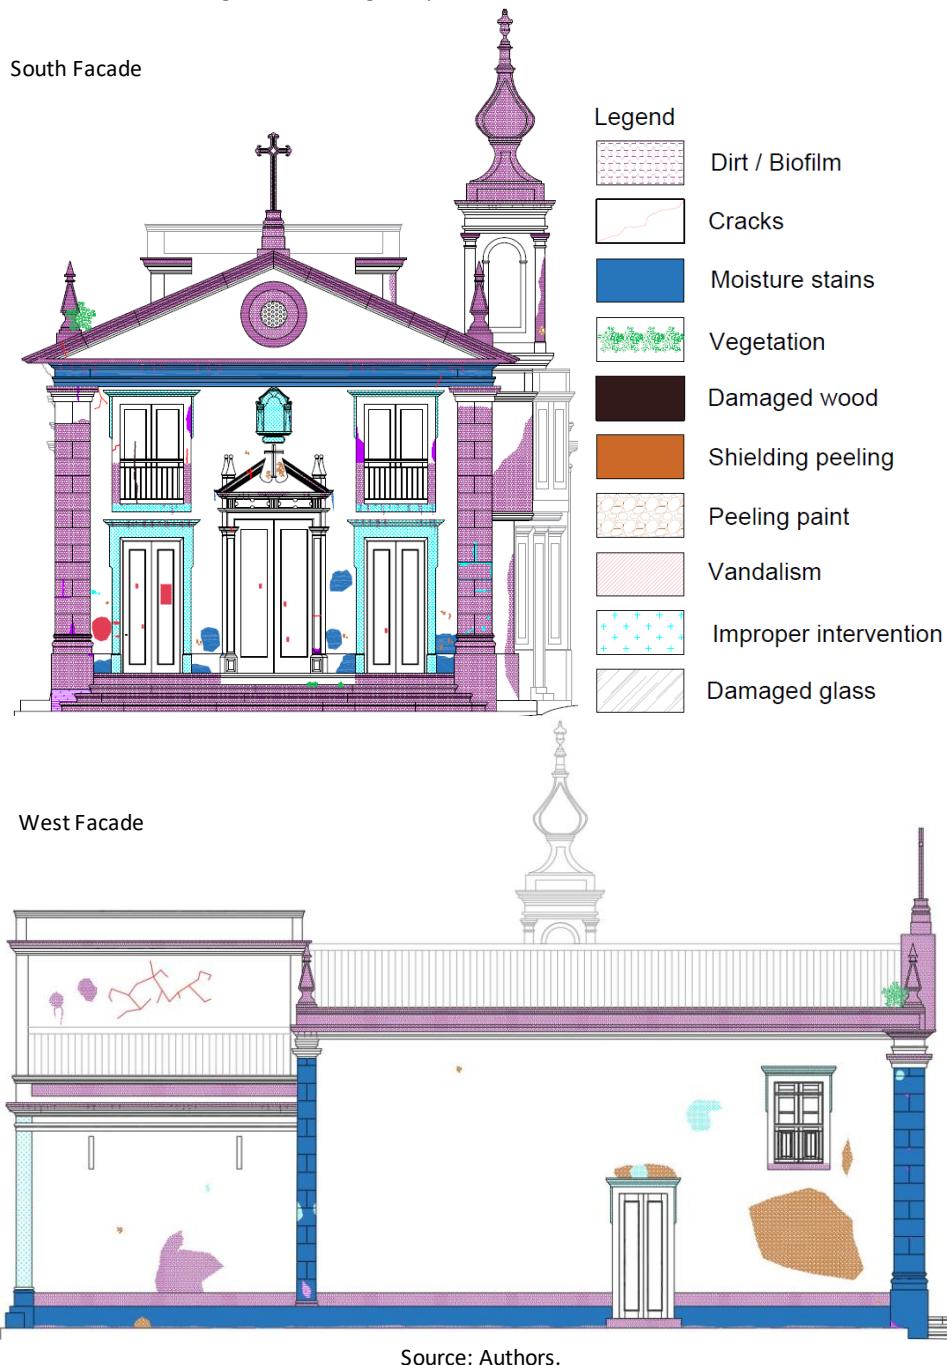
Figure 2 – Damage Maps of the South and West Facades

Analyzing the damage map and the pathological manifestations of the building's facades (Figures 2 and 3), one can notice the incidence of dirt/biofilm, mainly in the most prominent elements of the facade and in the lower and upper regions; moisture stains; and the occurrence of improper interventions.

On the North Facade, it is possible to observe the formation of dirt/biofilm resulting from the runoff of rainwater from the facade, in greater quantity in areas where there is no protruding ornament at the top. This fact proves the influence of architectural elements on the development of anomalies pointed out by Bersch *et al.* (2020), as well as their relationship with sources of humidity, rain and wind. According to Prieto *et al.* (2017), humidity is identified as the

main cause of pathological manifestation in historic buildings, and is a factor that must be controlled to contain the advance of degradation.

Improper interventions are caused by the application of paint to stonework, the apparent use of cement components, in disagreement with the recommendations in the restoration project, or holes made in stonework. Moisture stains are caused by rising damp or by the accumulation of moisture in ornaments located in the upper region, as discussed by Bersch *et al.* (2020).

As in the study by Amorim et al. (2024), the building under study did not present significant structural damage. The cracks and fissures apparent in the damage maps were identified at the meeting of materials — caused by differences in deformations — in stonework and in sections of continuous wall, the latter case being observed mainly on the North Facade. Vegetation growth can be noted near stonework elements, which must present some crack or high porosity and water accumulation, especially on the North Facade, in the lower and top left regions.

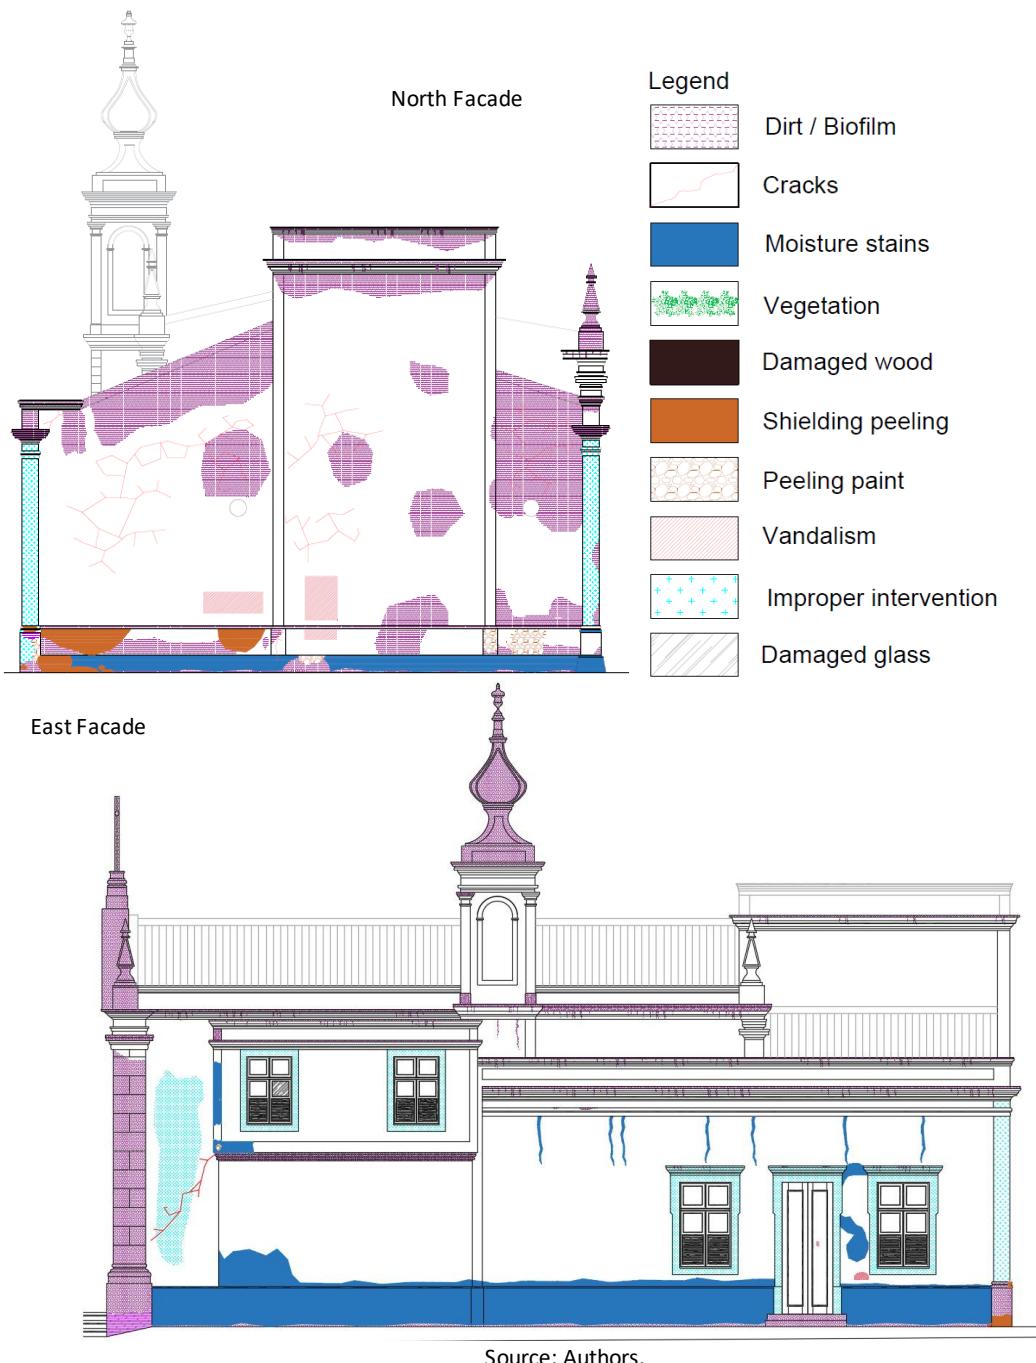
Figure 3 – Damage Maps of the North and East Facades

The damage to the wood identified corresponds to cracks or small openings in the frames. The peeling of the cladding affected the North Facade of the building most intensely, probably due to a faulty construction associated with the presence of humidity. The peeling of the paint is more evident on the West and North Facades.

Vandalism was noted in the lower regions of the facades, where drawings, political propaganda stickers and even lipstick marks were identified. Only one damaged window was identified on all four facades, located on the East Facade.

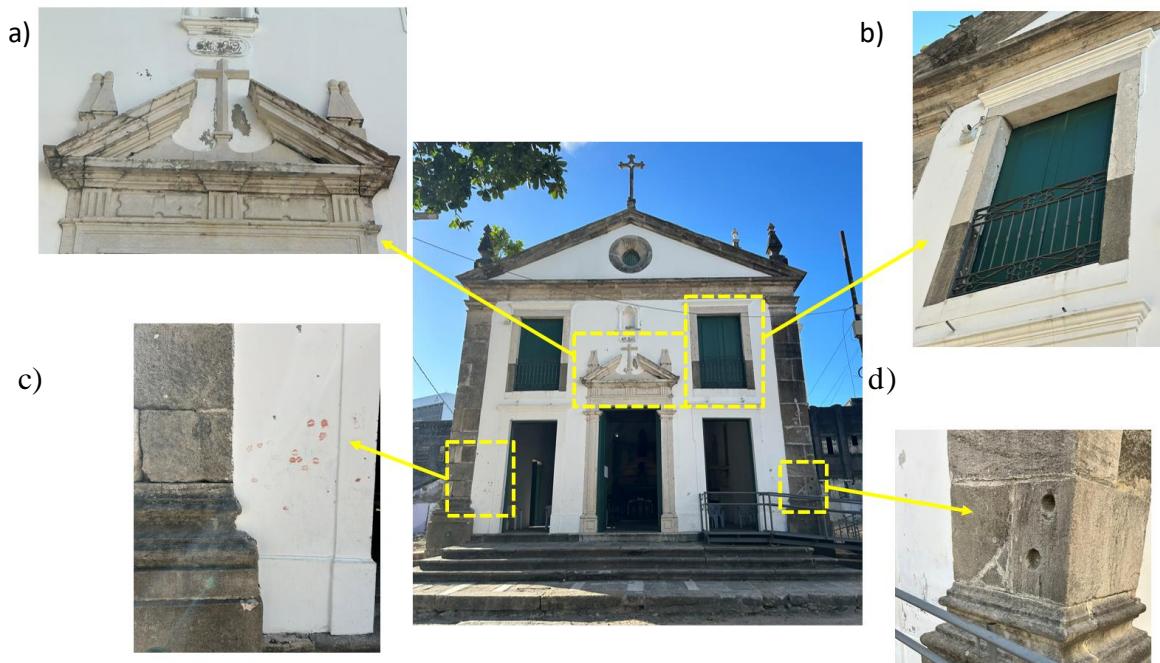
According to the calculation of damage coverage (Table 1), the most recurrent pathological manifestations in the building were dirt/biofilm, moisture stains, and improper intervention. The South facade (Figure 4) presented the highest percentage of occurrence of anomalies, 38.15%, according to the result obtained by Nascimento *et al.* (2024), followed by the North Facade (Figure 5), with a percentage of 36.54%. The most frequent pathological manifestations on these facades were the same as those identified for the building as a whole, with only the occurrence of displacement of the coating and vandalism on the North Facade being worth highlighting.

According to Bersch *et al.* (2020) e Rocha; Carneiro; Monteiro (2023), south-facing building facades are exposed to a higher incidence of rain and wind and only receive sunlight for a period of 9 months in a year, which contributes to the preservation of moisture on the facade, which, according to Prieto *et al.* (2017), is the main causative agent of anomalies in historic buildings. Mazer *et al.* (2016) highlighted the higher occurrence of infiltrations on facades exposed to higher incidence and wind speed, relating the orientation of the facade with the occurrence of damage caused by moisture. However, Costa; Silveira; Torres (2021) did not statistically demonstrate the relationship between the orientation of the facades and the occurrence of anomalies.

Figure 4 – Pathological manifestations of the South Facade: a) Dirt/biofilm, peeling paint, cracks b) Undue intervention, dirt/biofilm, material degradation c) Dirt/biofilm, vandalism d) Undue intervention, dirt/biofilm

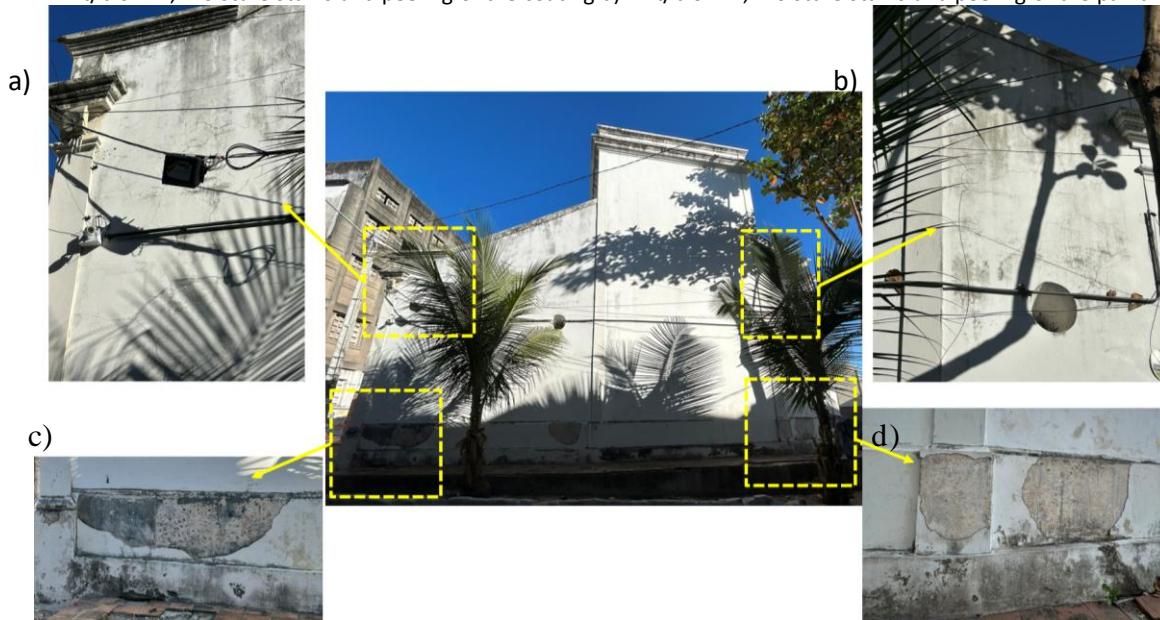
Figure 5 – Pathological manifestations of the North Facade: a) Dirt/biofilm, cracks b) Dirt/biofilm, cracks c) Dirt/biofilm, moisture stains and peeling of the coating d) Dirt/biofilm, moisture stains and peeling of the paint

As in the study by Mazer *et al.* (2016), the highest occurrence of cracks and peeling of the coating occurred on the North facade using both methods. The presence of three trees close to this facade may favor the accumulation of moisture by not allowing direct sunlight in certain regions, contributing to the emergence of pathological manifestations related to moisture, since this facade also does not receive sunlight throughout the year, making it difficult to dry.
