**The Environmental Problems of The Road of Water Black / Areal, Rural
Area of Manaus / Amazonas**

Understand the environmental degradation of the Agua Preta / Areal branch, that connects the Km 32 of the Rodovia AM-010 to Km 10 of the Rodovia BR-174, in the rural zone of the Manaus county.

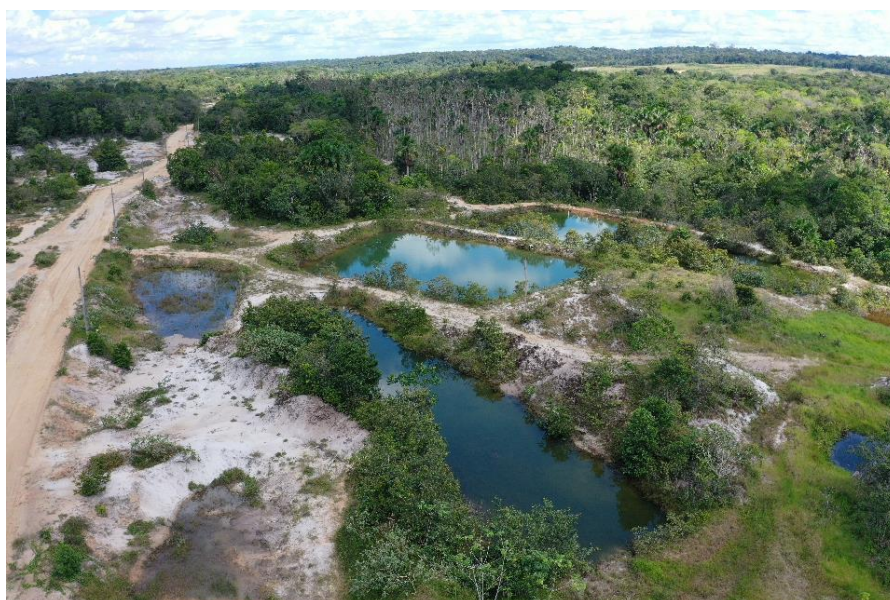
The Agua Preta/Areal branch also favored the sand extraction in the area, intensified the erosive process, the transport of sediments, siltation and dam in the water courses, due to inadequate manholes. All these factors are linked to anthropic actions. Figure 02.

Figure 2 - DJI Phantom4PRO OBSIDIAN drone image, from 07/15/2019, showing details of abandoned sand pits being used for fish farming

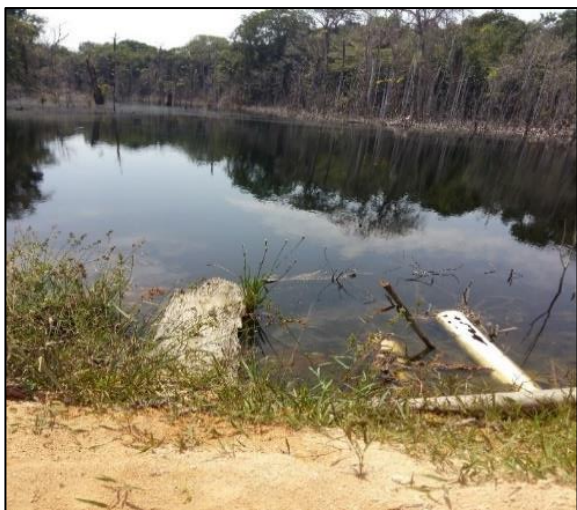
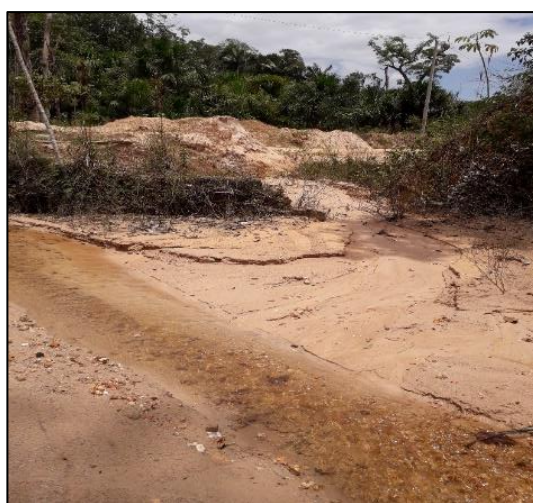
Being a cheap resource, accessible and available resource along the Água Preta/Areal branch, the sand extraction is the activity that most degrades the environment in the study area. Part of the changes that occurred in the area were due to human interventions in a disorderly way, generating consequences, many of them irreversible. Figure – 03 Watercourses in the Agua Preta Areal branch.

Figure – 03 Watercourses in the Agua Preta Areal (a) Upstream watercourse (b) Downstream silting watercourse.

Another degradation factor are the ravines, which appear along the slopes and contribute with a large amount of sediment to the siltation of these watercourses. According to the Geosciences Dictionary (2009) "silting is the technical name given to the detrital sediments deposition accelerated process in a lowered area".
