**Effects of a disordered urbanization: “the cities with their backs to the river”  
in the Cuiabá River Valley Metropolitan Region - RMVRC/MT**

The growing and disorderly Brazilian urbanization caused a series of impacts on the environment, among them the rivers pollution and the irregular banks occupations, being a characteristic phenomenon of the Cuiabá River Valley Metropolitan Region, where “the cities turned their backs to the river” developing without considering the different potentials of the existing watercourses in its territory. With this approach, this article aimed to understand this dynamic, considering that this river is responsible for the water supply of both cities, and a Pantanal Mato-Grossense affluent, making it important to identify the contradictory relationships between socio-environmental issues and the application and urban legislation supervision, by mapping PPAs, carried out in order to verify the degradation of the Cuiabá River and urban water streams in the Cuiabá-Várzea Grande conurbation. The applied methodology, based on bibliographical, documentary, and empirical research, involved studies about the theme and the region history, analyzes the legi

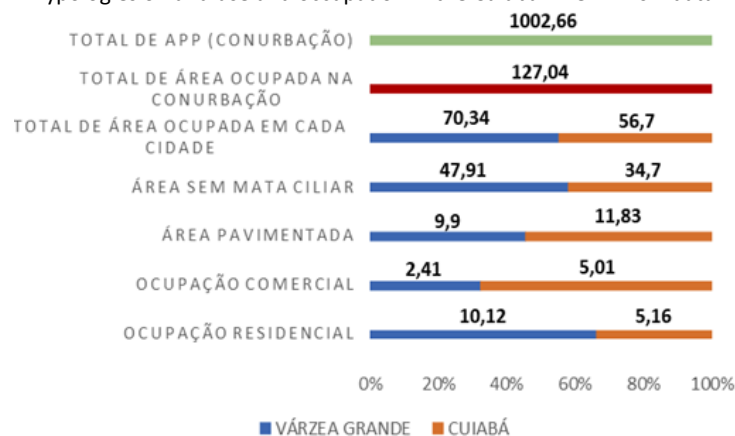
Graph 1 – Typologies of land use and occupation in the Cuiabá River APPs – data in hectares

In the Cuiabá River right bank PPAs, belonging to the Várzea Grande city, the total amount of irregular occupations in PPAs mapped and diagnosed as unsuitable for a PPA, were 70.34 hectares, which 10.12 hectares are residential and 2.41 hectares are commercial undertakings, 9.9 hectares of paved area and 47.91 hectares of areas without riparian forest, resulting from improper occupations that continually degrade the riverbanks in several ways, whether removing the riparian forest, producing garbage and sediments that end up in its bed as a result of rain or waterproofing the soil (Graph 1).

From the founded results, the appropriation by housing occupations in the PPAs in greater quantity identified on the banks of the river where Várzea Grande is located can be

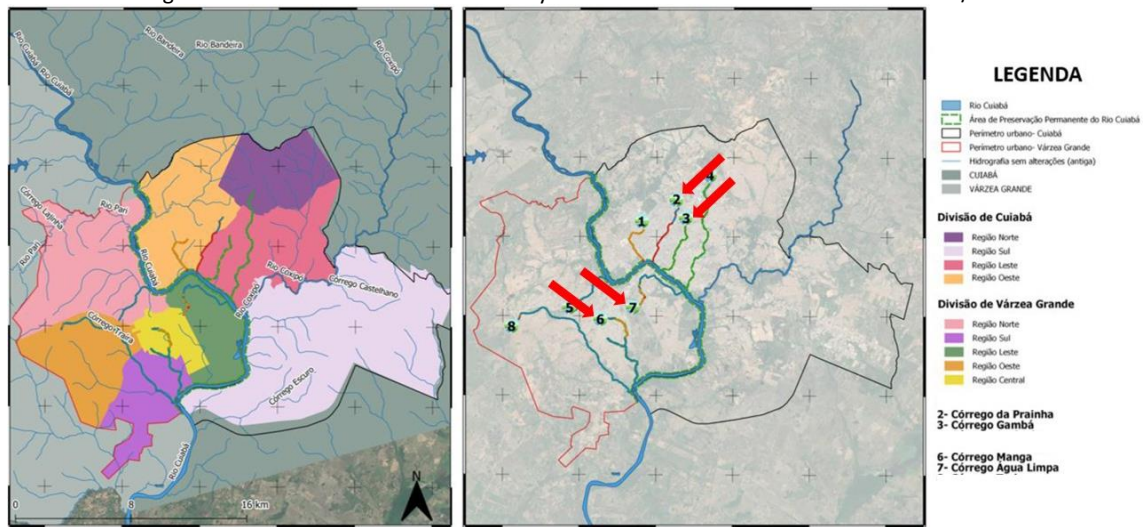
Figure 2: Location of urban streams analyzed in Cuiabá and Várzea Grande - RMVRC/MT

At Cuiabá, the Prainha and Gambá stream were chosen (Figure 2), and at Várzea Grande, Água Limpa and Manga stream were chosen.

For this study, it is important highlight that the urban streams of the two cities have their sources at higher points, thus flowing into the Cuiabá River. This water path created naturally by the topography, causes all sewage from urban areas to be directed to the Cuiabá River, compromising the water quality, which demonstrates that this type of pollution is not linked only to the precarious settlements of PPAs on their banks. but comes from other urbanized river basins.

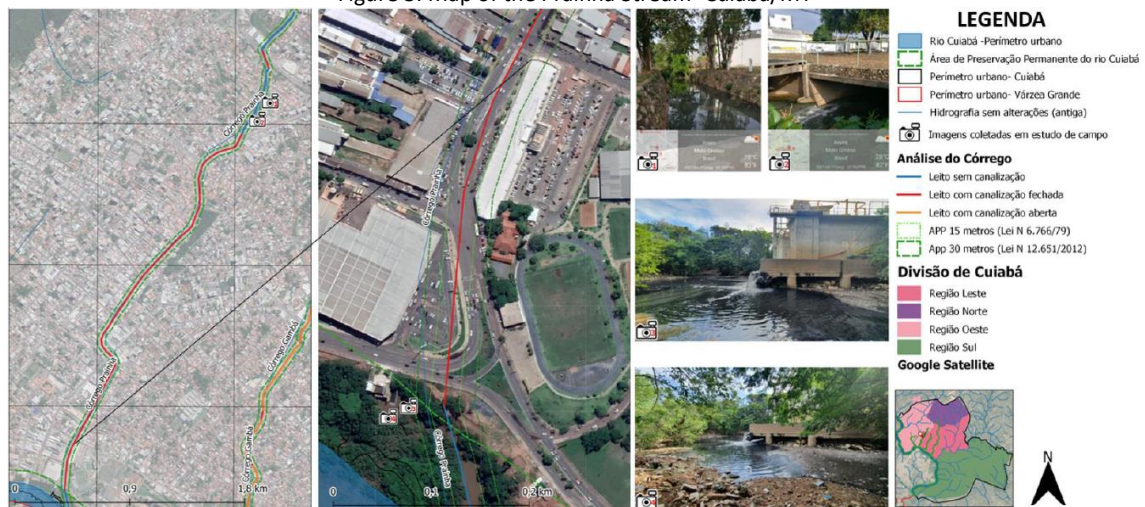
Figure 3: Map of the Prainha Stream- Cuiabá/MT

The Prainha stream (Figure 3), is a historic landmark in the Cuiabá urbanization process, its source is located at Bairro Alvorada with 13,035 inhabitants, in the East Region of Cuiabá. currently its course is channeled closed, runs through the Araés neighborhoods, with a population of 5,556 inhabitants, North Center with 2,510 inhabitants, Baú with 2,099 inhabitants, South Center with 4,062 inhabitants, Dom Aquino with 10,973 inhabitants and Tercero with 2,143 inhabitants.

With an extension of approximately 4,600 meters, of these only 100 meters are without channeling, that is, the stream is completely channeled, a small part with open channeling and about 3,500 meters of closed channeling until it flows into the Cuiabá River.

Along its length, intense urbanization can be observed, oscillating between residential occupations, commerce, and paved roads. Its PPAs are completely anthropized, not following what determines Law nº 6.766/79, nor the Forestry Code, Law nº 12.651/2012.

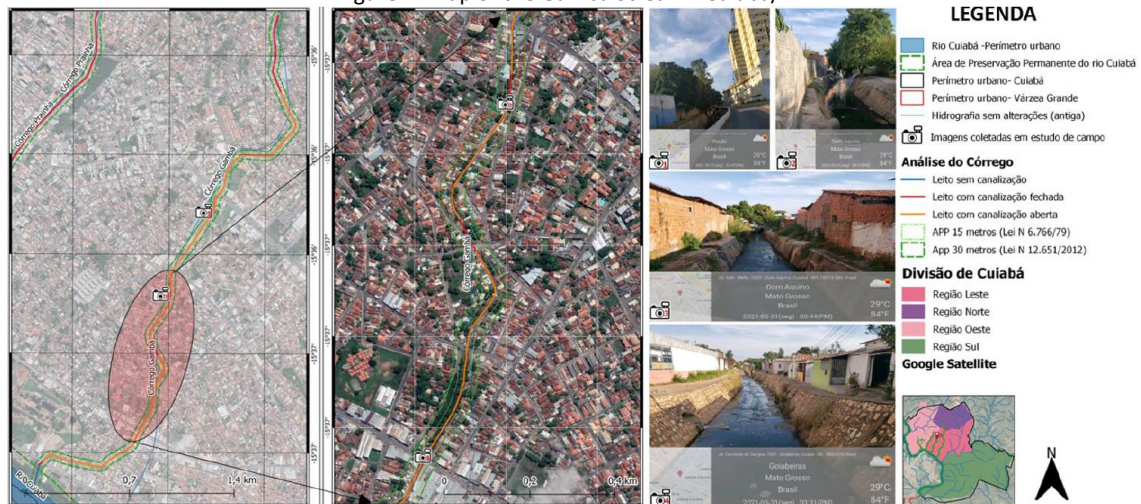
Figure 4: Map of the Gambá Stream - Cuiabá/MT

The Gambá Stream source (Figure 4), is concreted as a tank, it is located at D. Palmira Pereira Dias Plaza at Lixeira neighborhood, in the East Region of Cuiabá. The Lixeira neighborhood has 4,420 inhabitants, along its course, the stream passes through the Areão neighborhood with 5,533 inhabitants, through the Poção neighborhood with 4,442 inhabitants, Dom Aquino with 10,973 inhabitants and Terceira with 2,143 inhabitants.

With approximately 3,800 meters of total length, except for about 220 meters without channeling, the remaining stream course was completely rectified, with channels open until it flows into the Cuiabá River.

This stream is completely degraded, its banks do not have vegetation, in addition to receive diverse types of solid and liquid waste throughout its path, it not only receives rainwater, but also sewage that is sent directly from houses through clandestine pipes without treatment, causing intense unpleasant smell and disease proliferation.

In this place, the images explain critical scenarios, marked by precariousness and unhealthy conditions. It is possible to observe that the stream had its course altered at some points, so it was necessary to build a plumbing system with an energy sink to contain the water at the mouth, thus taking the contaminated water, and the various types of waste that will travel through the Cuiabá River waters, taking part of the city's waste to other places, such as the Pantanal, for example.
