Urban Environmental Quality Index Applied to the Popuca-Botinhas and Pedrinhas Watersheds in the Municipality of Guarulhos – SP

ABSTRACT

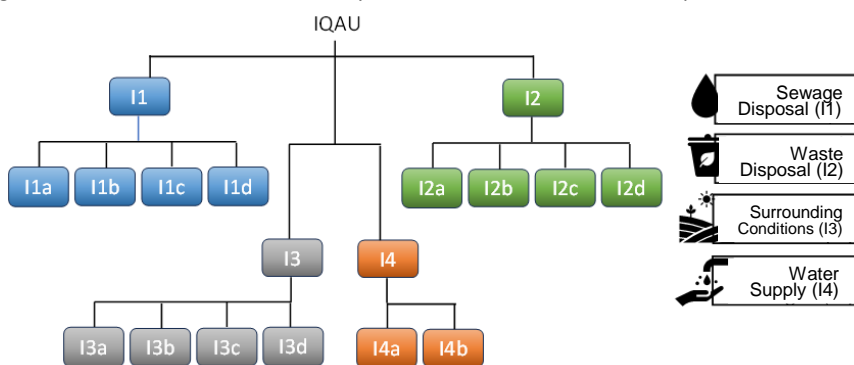
Figure 2 – Urban Environmental Quality Index with its indicators and respective sub-indicators.

conditions, infrastructure, and urban services, with different weights depending on their ability to affect surface water quality. The following indicators were selected: sewage disposal (I1), waste disposal (I2), surrounding conditions (I3), and water supply (I4). Each indicator consisted of sub-indicators (Figure 2; Table 1).

Weight 1 was assigned to households using sewage service (I1a) and weight 0 to the others. For the Destination of garbage indicator (I2), weight 1 was also assigned to households using garbage collected by a cleaning service or skip (I2a) and weight 0 to the others. A weight of 0.25 was assigned to each sub-indicator for the Indicator Conditions of the surroundings (I3). The Water Service Indicator (I4) was assigned a weight of 1 for households using the general water distribution network (I4a) and a weight of 0 for the others.

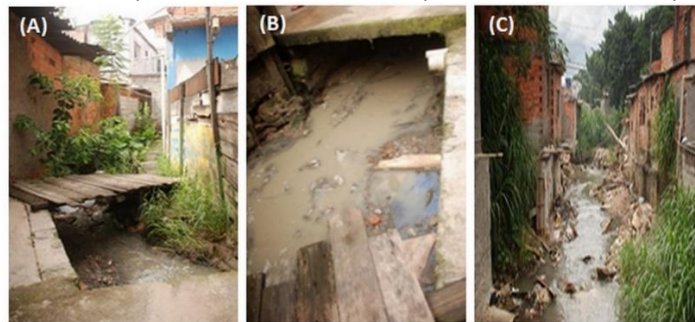
Figure 6 – A. Irregular constructions near the Tributary in Cararu Street. B. Dumping sewage directly into the Tributary in Cararu Street. C. Occupation on the banks of the Popuca stream in the vicinity of Cataguases Avenue.

The terrain here facilitates the dumping of waste into the environment. There is a slope to the land on the south side of the street, where the buildings are below street level, causing waste to be dumped at the back of the land, very close to one of the tributaries of the Pedrinhas stream. There are several irregular buildings over the water body of the tributary (Figure 6). There is also a large volume of sewage being discharged from homes into the water bodies of the tributaries in the area, and the public sewage system is not being used (Figure 6B).

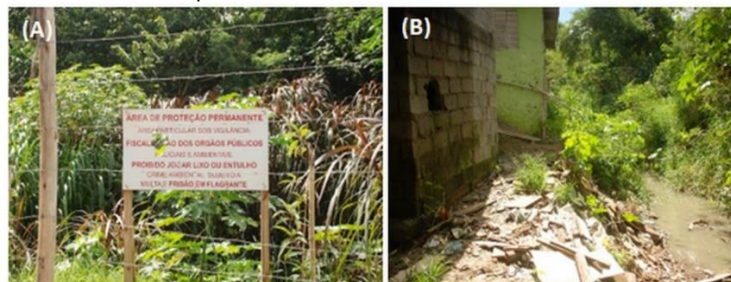
Figure 7 – A. Signposting and fencing off the riparian forest of the Pedrinhas stream. B. Irregular constructions in the riparian forest of the Pedrinhas stream.

The Water Service Indicator (Figure 5C) also shows that most of the study region is covered by the water supply network, with an excellent rating. Except for the Jardim Vermelhão neighborhood, where some households had no access to water supply or sewage collection. Possibly, at the time the information was collected by IBGE (2011), not all households had paving and a water supply and sewage network, as a field visit to the neighborhood revealed it to be new and undergoing redevelopment. Some roads have been paved and water supply points have been installed. However, many houses were built without any planning, with no means of access to public services. They are located where the riparian forest of the Pedrinhas stream used to be, despite signs prohibiting the occupation of the site and fences cordoning off the forest (Figure 7).
