The use of video borescope for inspection of piezometers in landfills

Inspect the physical integrity of the interior of piezometers installed in landfill cells regarding the occurrence of problems in monitoring with a liquid level sensor.

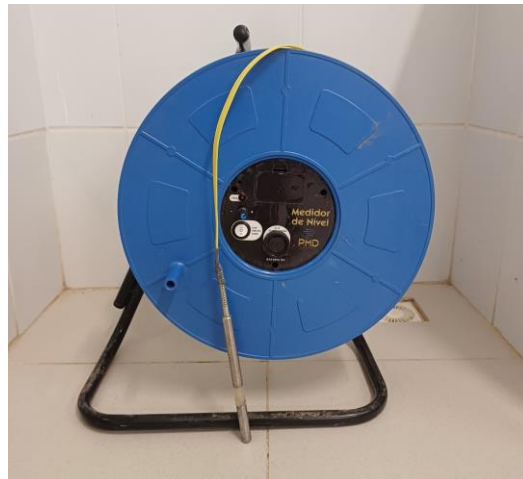
Figure 3 - Electronic piezometric level sensor.

Piezometric levels are measured through a traditional technique that utilizes an electronic sensor to emit sound and light (Figure 3). Once the sensor of the piezometer reaches the leachate, it emits both audible and visual signals. To determine the piezometric level, the height of the leachate level was measured using a measuring tape in relation to the top of the piezometer. However, inconsistencies were observed in these measurements due to several operational and technical issues. Therefore, alternative methodologies were adapted to investigate the piezometric level and the internal physical structure of piezometers.

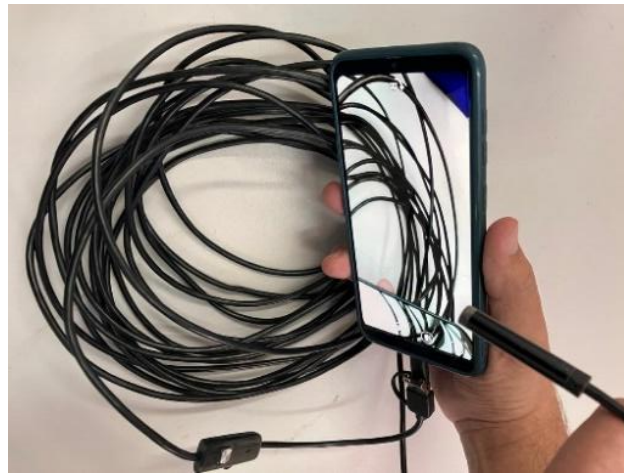
Figure 4 – Video borescope camera.

The procedure was carried out by an industrial camera, which was a generic model obtained from the *mrgo direct store*. This camera was equipped with IP 67 protection, which means it has protection against dust and water resistance to being submerged in water up to 1 meter deep for 30 minutes. Additionally, the camera has an HD resolution of 1280x720 pixels

and features an LED light that allows for high-quality recordings with satisfactory resolution and color. The video sensor was attached to a durable cable that was 8mm in diameter and 10 meters in length, which allowed for secure and deep viewing of the piezometers.

The camera cable was attached to a USB-C connector, which enabled the equipment to be connected to an Android smartphone using the *inskam* application (from *app-tools*), and this application enabled the simultaneous image processing. Figure 4 shows the video borescope equipment used in this study.
