**Walkability for utilitarian and leisure purposes: a comparative study on
an avenue located in the city of Araçatuba, São Paulo**

ABSTRACT

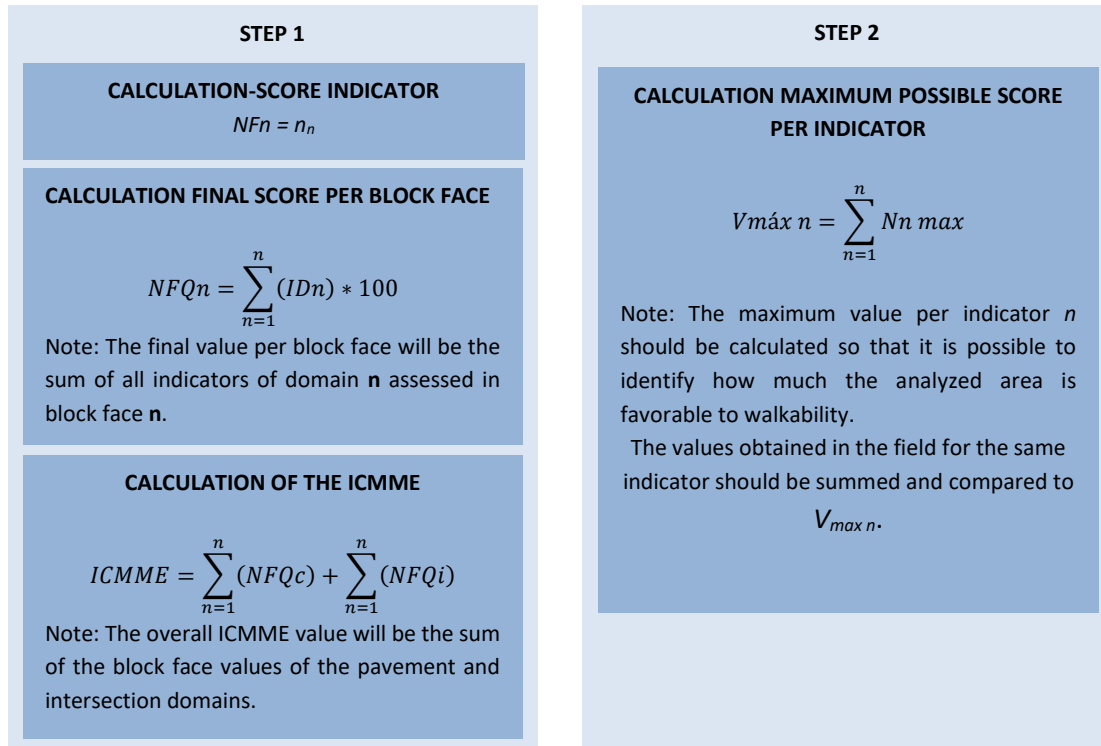
which includes two steps: i) calculation of the ICMME with scores obtained in the field and ii) calculation of the ICMME with the maximum score for the indicators (Figure 2).

Figure 2: Calculation of ICMME components.

Initially, each indicator is calculated based on the score obtained in the field for the sidewalks and intersections domains. Next, the calculations for the block faces are performed. The final index, in this paper, will be given by the sum of the scores of all the scores of the block faces. To calculate the maximum score for each indicator, it is necessary to assign the maximum value to the indicators, that is, 1.0 point. This same procedure is performed to calculate the block faces.

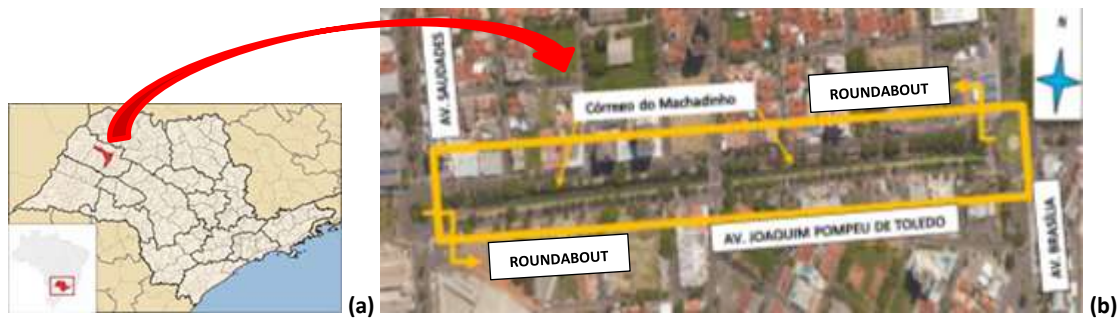
Figure 03: Location of the municipality on the map of São Paulo State (a) identification of the section chosen for analysis – section of Joaquim Pompeu de Toledo Avenue (b).

The area defined as the object of investigation is located in the southeastern region of the city of Araçatuba, São Paulo. A medium-sized city, with an estimated population of 199,210 inhabitants (IBGE, 2021) and located in the western region of the state of São Paulo (Figures 03-a, b).

The technical audit was carried out in November 2021. Based on an updated aerophotogrammetric survey (Figure 03b), provided by the Municipality of Araçatuba, a base map was produced that enabled the implementation of all urban equipment (Figure 04).

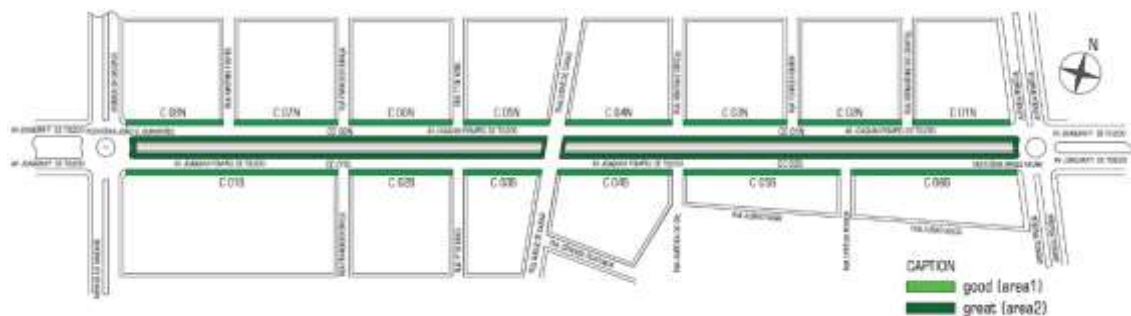
The characteristics of the sidewalks located in the central median of the avenue satisfactorily meet the objectives for the practices developed on it for the following reasons: condition of the floor, cleanliness, unobstructed surfaces, adequate slope, presence of benches, the inexistence of grilles, night lighting, adequate and present afforestation, that is, justifying the preference of the population in the daily practice of walking in the place (Figure 5).

Figure 5: Map with the ICMME evaluation by block face for the sidewalk domain referring to areas 1 and 2, without scale.

Table 4 shows that the result obtained for the *Sidewalk domain* is different for the two areas, however, both areas have infrastructure that favors walkability in the analyzed stretch, as the results ranged from "good" (area 1 - ICMME of 65.92%) and “Excellent” (area 2 – ICMME of 86.11%).

The analysis of data from area 1 (Side Sidewalks) reveals that of the 18 indicators, 12 indicators (67%) have a score considered "Good" (72.70% for the Comfort theme and 68.39% for the Attractiveness theme) due to specific physical conditions, such as floor with adequate slope, absence of surface gratings, adequate width, unobstructed lanes, among others.

Regarding the analysis of area 2 (central median street) of the 18 indicators analyzed, 5 indicators associated with the Safety theme obtained a result considered "Regular" (60.0%), while 13 indicators belonging to the themes Safety, Comfort, and Attractiveness, obtained the "Excellent" score (100.00%; 93.65% and 100.00%, respectively).

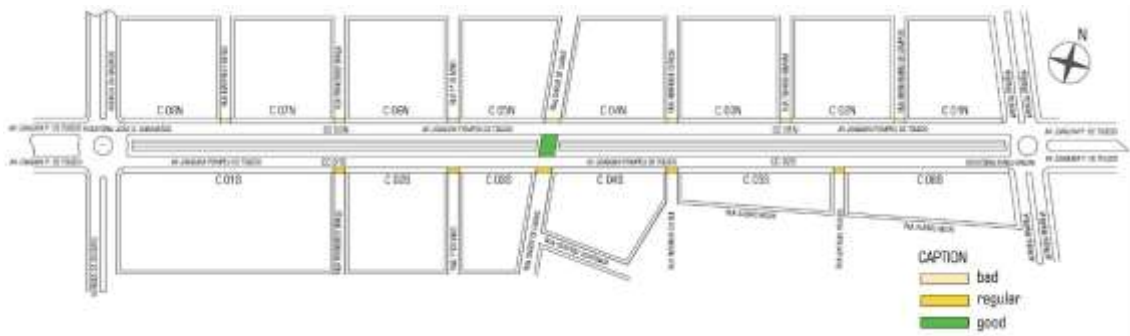
Only the crossings located in areas 1 and 2, located in the center of these areas, obtained the evaluation considered "Good", because they have adequate and correctly positioned crosswalks, accessible ramps located next to the crosswalks, signposted with tactile

flooring, pedestrian waiting space for crossing before accessible ramps, adequate crossing times and visibility, among others (Figure 6).

Figure 6: Map with the ICMME evaluation by block face, for the intersection domain referring to areas 1 and 2, without scale.

The evaluation of the *Intersection domain*, Table 4, shows a difference in the quality of space between the two areas. The global index varies from "regular" (area 1 – ICMME of 41.70%) to "good" (area 2 – ICMME of 79.38%), which means that the crossings on the opposite side of the stream need improvements so that the pedestrians can move around these blocks safely and comfortably.

At the intersections of area 1, all 13 indicators evaluated had low scores. The themes: Safety with 6 indicators (I1 - I6) and Comfort with 7 indicators (I7 - I13) obtained "Regular" and "Bad" assessments (55.28% and 30.06%, respectively). The main problems are related to the lack of painting of the pedestrian lanes and the absence of accessibility ramps, the presence of types of floors that do not favor accessibility and differences in levels on the sidewalks favoring the entry of vehicles into the properties, lack of adequate space in the front of the ramps, mainly for wheelchair users, presence of fixed obstacles (dumpsters and protective grids of urban trees royed), trees implanted in an irregular location and tree height that can compromise pedestrian safety.
