**Factors that may impair the walkability of students on the route between the Alencastro urban public transport station and the Federal Institute of Mato Grosso (Cuiabá Campus)**

This paper aims to present the results of a research that evaluated the factors that interfere with students' walkability on the route between the Alencastro urban public transportation terminal and the Federal Institute of Mato Grosso (Cuiabá Campus).

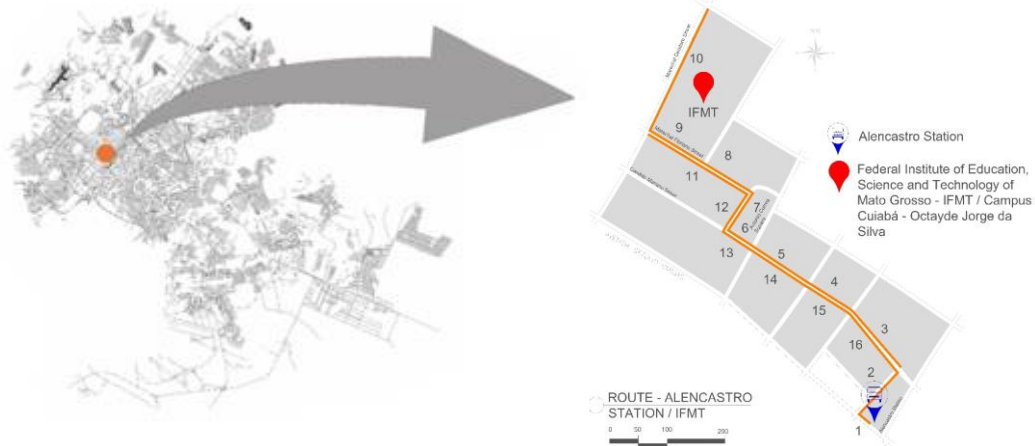
Figure 1: Location of the spatial clipping in the city of Cuiabá - MT

The case study was carried out in 2021, in the city of Cuiabá, Mato Grosso. The spatial clipping is composed of a path of approximately 750 meters, located in the region of the Historical Center. A total of 16 block faces were evaluated (Figure 1). The route starts at the Alencastro urban public transport terminal - which receives about 30,000 passengers per day, and ends at the main access to the Federal Institute of Education, Science and Technology of Mato Grosso - IFMT (Cuiabá Campus Octayde Jorge da Silva).

The urban mesh in this region is in a checkered shape, with orthogonal blocks, whose dimensions vary from 19.00 m to 197.00 m. This route was selected because it represents the route most used daily by students who use public transportation by bus, and walking, as means of transportation to go to the IFMT.

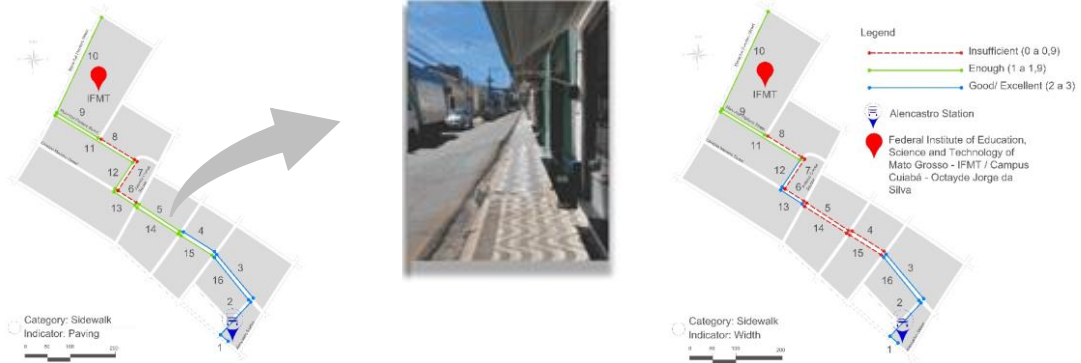
**Figure 2: Assessment of the 'Sidewalk' Category**

The analysis of the Sidewalk Category reveals that on the evaluated stretch the walkability is considered sufficient, with a total score of 1.88, that is, it needs some priority Interventions, with short-term action. The indicator that gets the highest score is the Width (2.31 points) considered good, followed by the indicator "Pavement" (1.94 points) considered sufficient (Table 3 and Figure 2).

In most of the segments analyzed near the public transportation station, the sidewalks are in good condition, the floor is non-slip, and the materials used for the sidewalk are concrete and hydraulic tile. The width in these stretches is also good, with dimensions between 2.5 m and 3.0 m. On the other hand, because it is a region belonging to the historic center of the city, some sidewalks do not have adequate width, with dimensions around 1.40 meters, considered

insufficient in the evaluation of the index. Some stretches have unevenness and holes, and even the inexistence of sidewalks, for example stretch 7, an area of unevenness between the street and Antônio Correa Square. The city has legislation on sidewalks, however, there is a lack of inspection by the municipal administrators to charge the owners for this proper maintenance in the area.

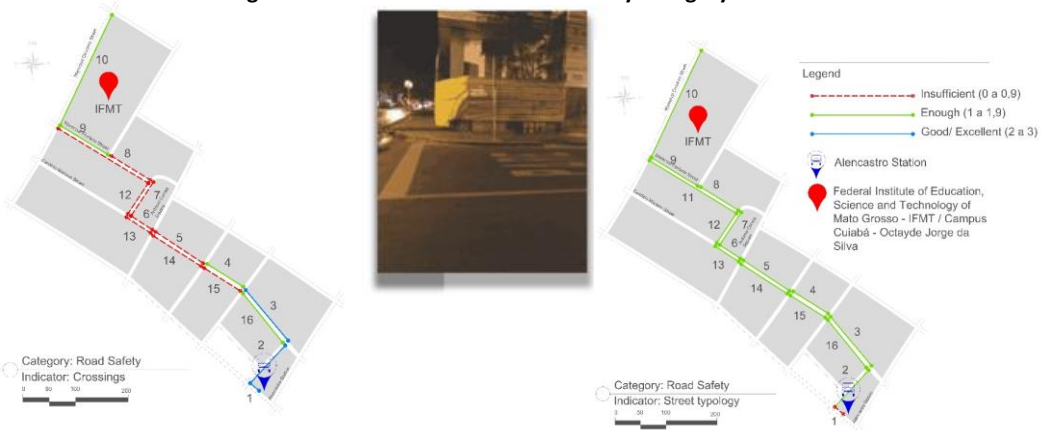
**Figure 5 - Assessment of the Road Safety Category**

The evaluation of the Road Safety Category shows that the evaluated section (sufficient, 1.44 points) needs a Priority Intervention, with short-term action. The indicators "Street Typology" (considered good, 2.00 points) and "Crossings" (considered sufficient, 1.06 points) contribute to this evaluation (Table 2 and Figure 5).

In general, the roads are local, except for the road in Section 01, which is a collector.

All sections have their uses well defined, sidewalks for pedestrians and streets for vehicles; there are no bike lanes or other exclusive access for other means of transportation. The sidewalks near the Alencastro public transportation station are well structured, with accessibility, identified by the presence of tactile flooring and ramps for people with disabilities, and there is a signalized crosswalk. However, in the other sections, there is little or no concern with these aspects, for example, section 07, which has no sidewalk.

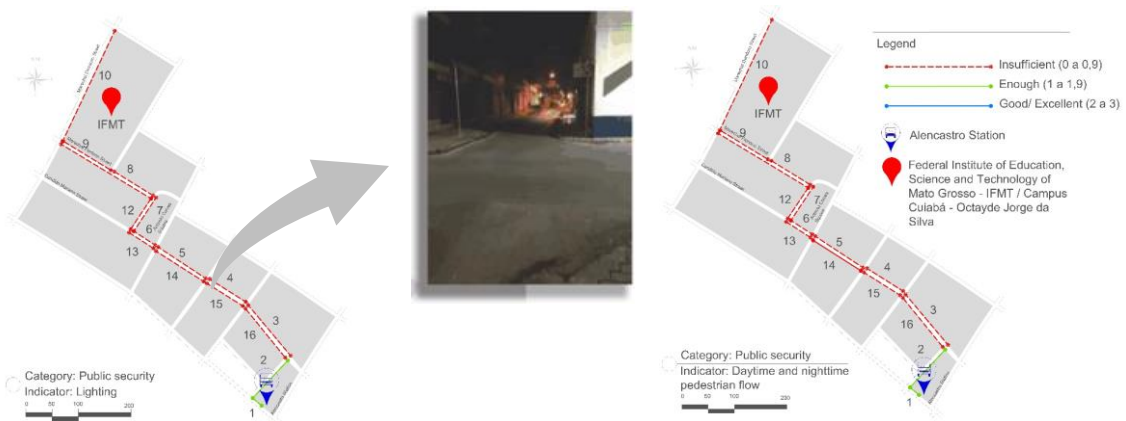
**Figure 6 - Evaluation of the "Public Security" Category**

The low score obtained in the Public Safety Category (insufficient, 0.13 points) is associated with the evaluation of the indicators "Daytime and Nighttime Pedestrian Flow" (considered insufficient, 0.06 points) and "Lighting" (considered insufficient, 0.25 points), as shown in Table 2 and Figure 6. In this category, the interventions should be a priority, with immediate actions.

One of the problems refers to lighting, which is considered bad in most of the evaluated areas, with the exception of Alencastro Square where the Urban Terminal is located. In some points, there are also light obstructions due to the presence of large trees. The Antônio Correa Square, between sections 06 and 07, is the most critical place because the treetops prevent lighting of the pedestrian space. There is a frequent presence of drug users here, requiring the presence of police monitoring and improvement of lighting.

The pedestrian flow during the day is intense, up to 10 people/minute; however, at night, this number drops sharply, with almost no pedestrian movement.

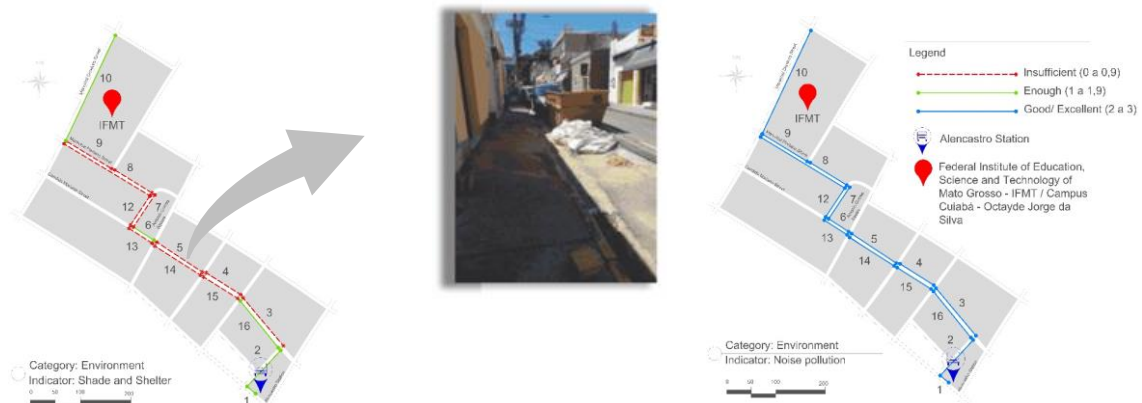
**Figure 7 - Assessment of the 'Environment' Category**

The analysis of the Environment Category shows that the evaluated stretch has a score considered sufficient by ICAM (1.50 points); that is, it needs priority intervention, with short-term action. Contributing to this score are the results of the indicators "Shade and Shelter", with an evaluation considered insufficient (0.88 points); "Noise Pollution" with a score of "excellent" (3.00 points) and "Garbage Removal and Cleanliness" with a score considered sufficient (1.88 points), (Table 2 and Figure 7).

Despite the presence of a large flow of vehicles (cars and buses) and the existence of commerce on the site, the area remains within the parameters of noise comfort. With respect to shading, there is little presence of trees along the entire path. In some stretches, due to the width of the sidewalk, the planting of trees is not possible. Some buildings are on the front of the lot, which prevents the planting of trees. The analysis of the indicator for garbage removal and cleanliness reveals that the analyzed area, in great part, is kept clean, with proper places for the deposit of garbage, there is no occurrence of toxic waste and debris without the correct destination.
