Air-conditioning supports for buildings: Challenges for a sustainable city

This study addresses the pathological manifestations of reinforced concrete supports in a case study of a building located in a coastal region, characterized by higher levels of environmental aggressiveness.

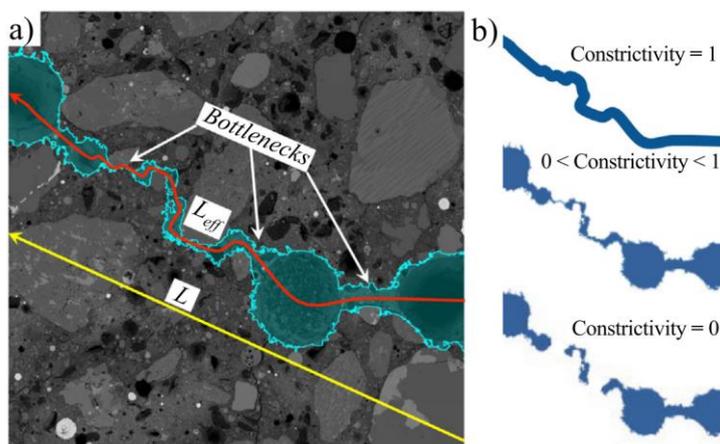
Many factors are associated with ionic transport such as geometry, pore distribution and connectivity, chemical reactions due to ion bonds the walls of the pores, chemically active and the effect of electrical potential, because the walls charged negatively, enabling the effect of membrane potential, affecting ion diffusion. The aging of concrete and the result of chemical reactions over time, reflects in the decrease of porosity and the consequent tortuosity. For more the increase of the temperature interferes in all the mentioned processes, conceiving more binding capacities (ZHANG; LUZIO; ALNAGGAR, 2021), as Figure 1.

Figura 1 – Porous microstructure of concrete showing a) tortuous trajectory of pores and b) different conditions of constrictivity

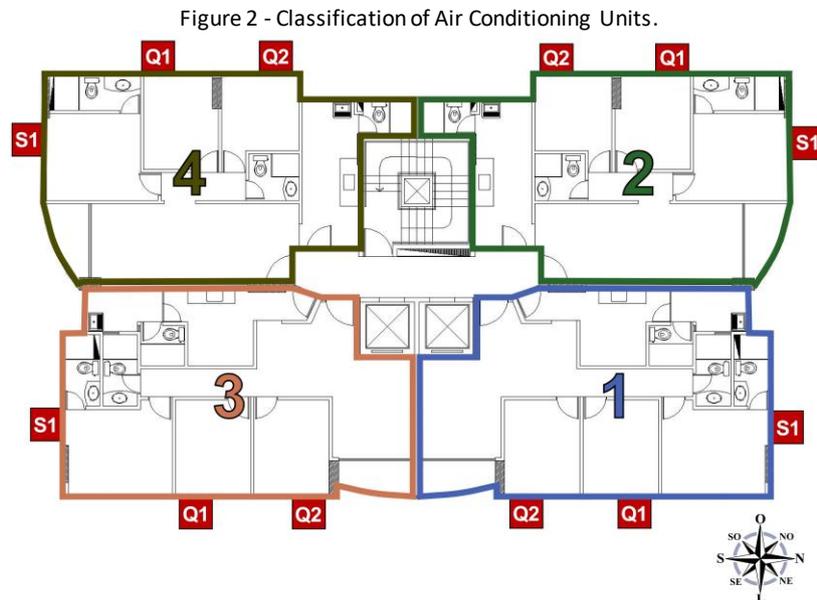
The separation of the two blocks was carried out according to the condominium's plans, with the designation of blocks A and B, and the separation by Residential Unit with the endings 1 to 4. Furthermore, the three-bedroom units were classified as S1, Q1, and Q2, based on the reinforced concrete supports for air conditioning for each of them, as depicted in Figure 2.

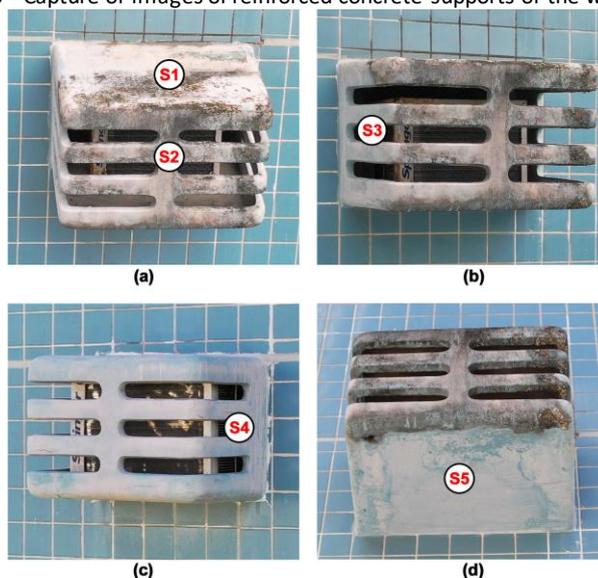
To determine the state of deterioration of each box, flights were performed with Unmanned Aerial Vehicle (UAV), model MAVIC 2 Pro of the DJI manufacturer, aiming to capture images for the upper faces, front and side and with a digital camera model COOLPIX P520 from Nikon for image capture on the lower face. With a total of 336 concrete boxes, 3 per apartment, totaling 1,344 images captured.

Figure 3 shows how the images were captured: S1 - upper face; S2 - front face; S3 - left face; S4 - right face and put an end to S5 - lower face.

Figure 3 - Capture of images of reinforced concrete supports of the window type.

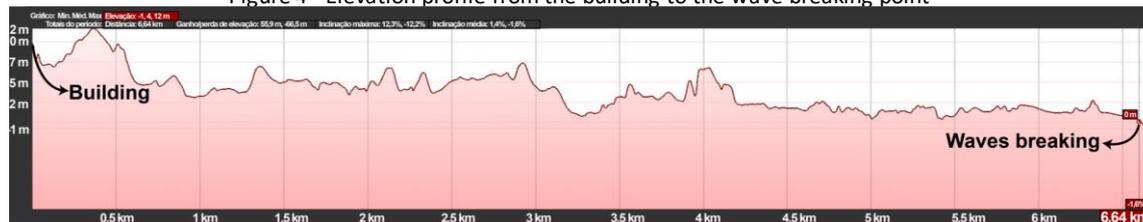
Regarding the local topography, an elevation profile was obtained, identifying altitudes ranging from sea level to a maximum of 12 meters at the elevation of Parque Arraial do Bom Jesus, and 10 meters at the building site, as shown in Figure 4.

Figure 4 - Elevation profile from the building to the wave breaking point

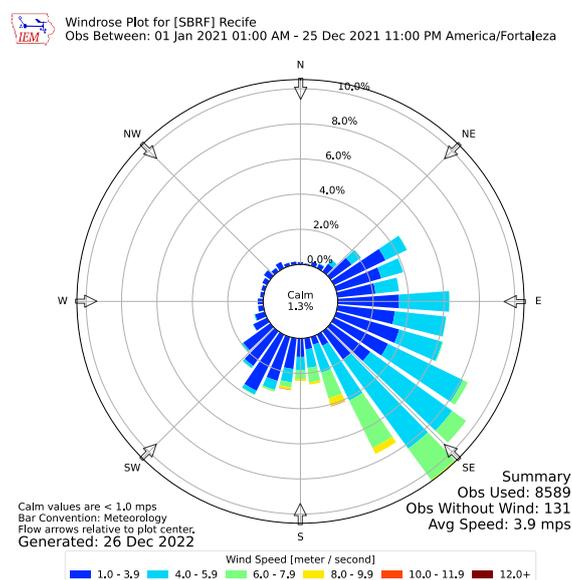
In order to gather information about wind direction, a Wind Rose map was generated for the city of Recife, covering the period from the completion of the building in 2010 to 2022. This map provides wind direction and speed data, indicating predominant directions and the speeds of the strongest winds. The highest wind speeds are from the SE direction, reaching speeds of over 12 m/s. Wind speeds are considered calm, with speeds less than 1 m/s, for only 2% of the year, as shown in Figure 5.

Figure 5 – Wind direction and speed (Wind rose) from 2010 to 2022

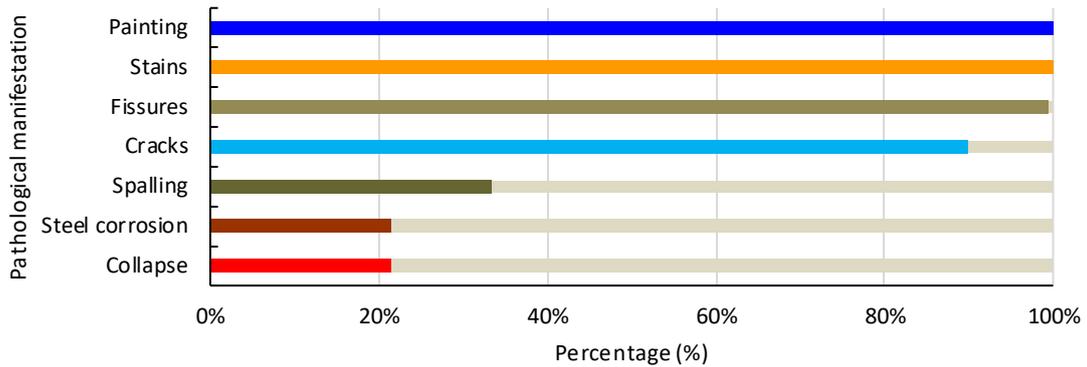
After identifying the pathological manifestations of reinforced concrete supports, it was possible to detect paint deterioration and the presence of stains in 100% of the concrete supports. Surface cracks were found in almost all cases, at 99%, followed by fractures at 90%. Among the more severe manifestations of deterioration, concrete spalling was observed in 33% of cases, followed by corrosion of exposed reinforcement at 21%, and finally, partial collapse at 21%, where parts of the structure are missing, as shown in Figure 6.

Figure 6 - Pathological manifestations of reinforced concrete supports

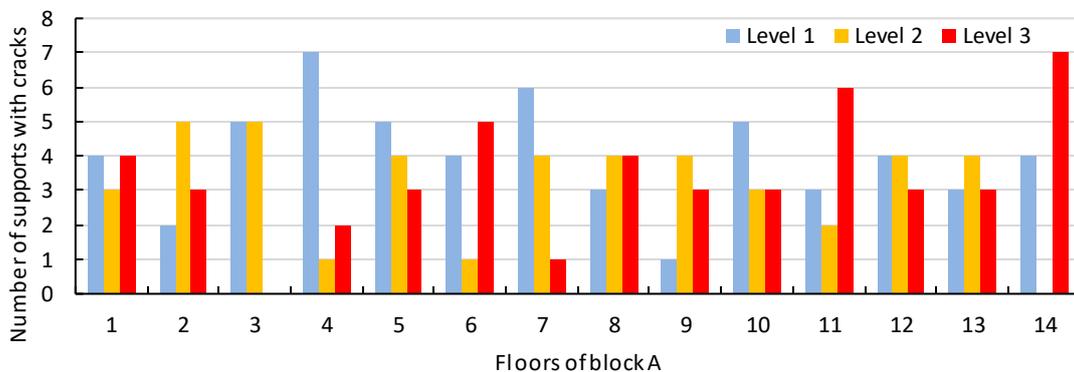
With this classification, it was possible to inspect the images of the air conditioning supports on the façade and categorize them by floor, with each floor having 12 reinforced concrete supports. Except for those classified as level 1, those at level 2 and level 3 are in a state of moderate to high deterioration. In Block A, the most advanced deterioration of supports was observed on the upper floors, such as the 11th and 14th floors, specifically concerning level 3 cracks, as shown in Figure 7.

Figure 7 - Classification of cracks by level of deterioration in Block A

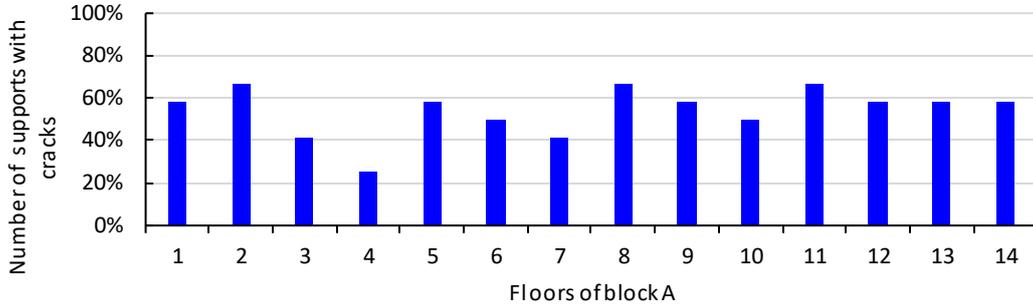
When the supports in level 2 and level 3 conditions are combined, an average of 54% of the supports are in this situation, reaching 67% on some floors. It's noticeable that although some

supports are in a more damaged state on the lower and higher floors, the difference for the floors with median height is not significant, as shown in Figure 8.

Figure 8 - Deteriorated supports in levels 2 and 3 per floor

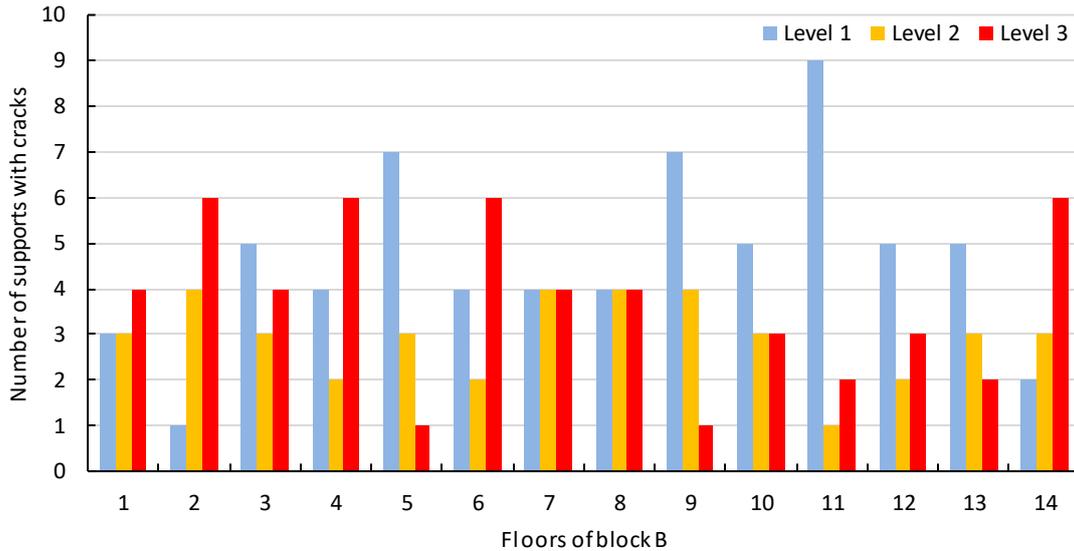
For Block B, the supports with higher level 3 deterioration were observed on the lower floors, such as the 2nd, 4th, and 6th floors, as well as one higher floor on the 14th floor, as shown in Figure 9.

Figure 9 - Classification of cracks by level of deterioration in Block B

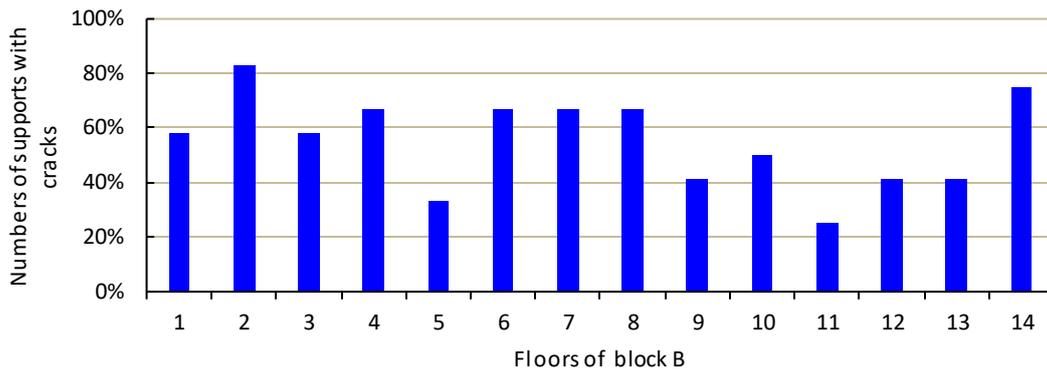
When the supports in level 2 and level 3 conditions are combined, an average of 55% of the supports are in this situation, which is quite similar to Block A, reaching a peak of 83% on the 2nd floor. In the case of Block B, there is a disproportion among the floors, with some peaks and lower quantities among adjacent floors, as shown in Figure 10.

Figure 10 - Deteriorated supports in levels 2 and 3 per floor

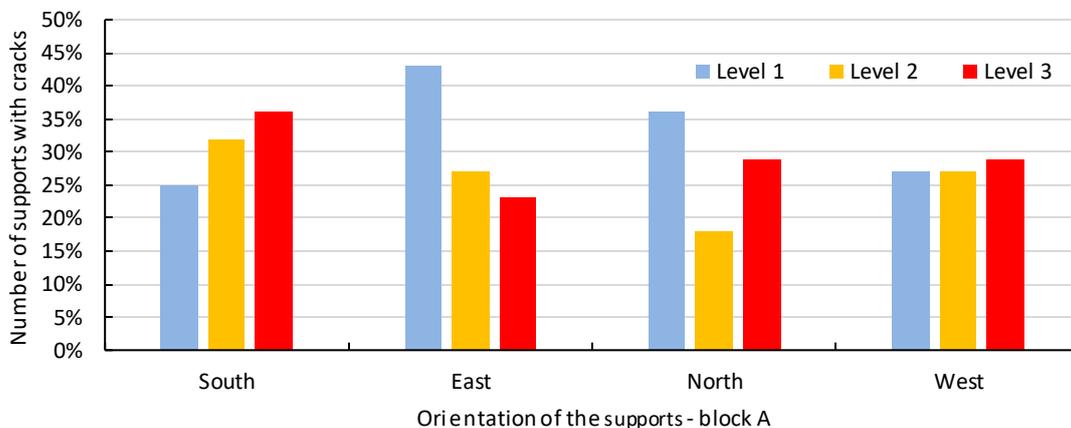
Another analysis correlated the deteriorations with the orientations of the cardinal points to identify correlations with wind direction, rainfall, and chloride ions. The supports with cracks were separated according to the level of deterioration and their respective directions: south, east, north, and west. In Block A, the results showed that 36% of the supports with level 3 deterioration are on the south side, followed by 29% on the north and west sides, and finally, 23% on the east side, as shown in Figure 11.

Considering that the prevailing wind is in the Southeast direction it is expected that the South and East facades have greater predominance of reinforced concrete supports in an advanced state of deterioration. In the South facade it is possible to verify this condition, but it is not seen in the East facade where it has more supports in the condition of cracks of level 1.

Figure 11 - Levels of crack deterioration in supports according to the cardinal directions in Block A

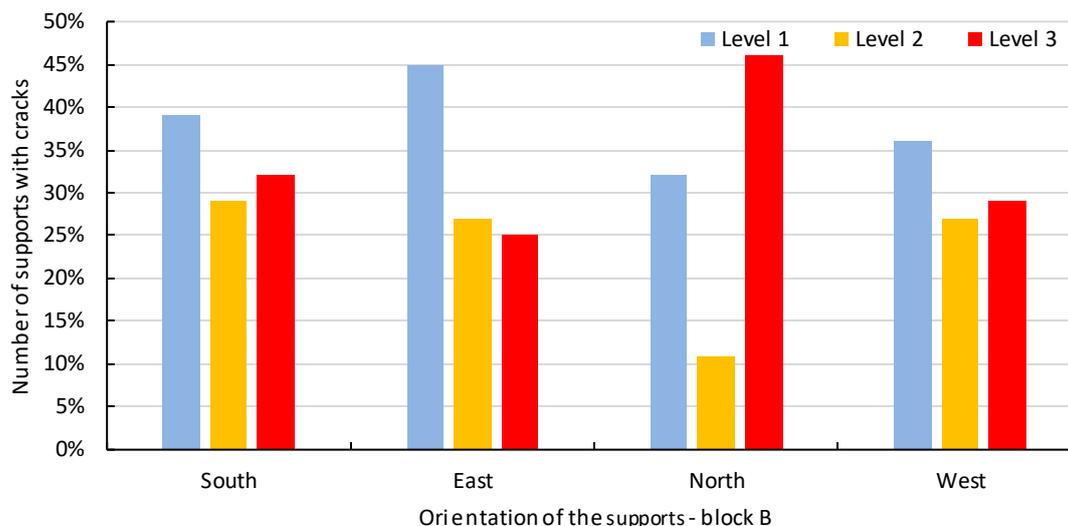
For Block B, there was a higher prevalence of supports deteriorated to level 3 in the north orientation at 46%, followed by 32% in the south, 29% in the west, and 25% in the east, as shown in Figure 12.

The situation in Block B is similar to Block A, and the prevailing wind direction is Southeast. In this case, the southern and eastern facades would be more affected by adverse environmental conditions, favoring the prevalence of reinforced concrete supports in an advanced state of deterioration. It was observed that the northern facade had the highest rate of widespread cracks, while the southern, eastern, and western orientations had similar values.

Figure 12 - Levels of crack deterioration in supports according to the cardinal directions in Block B

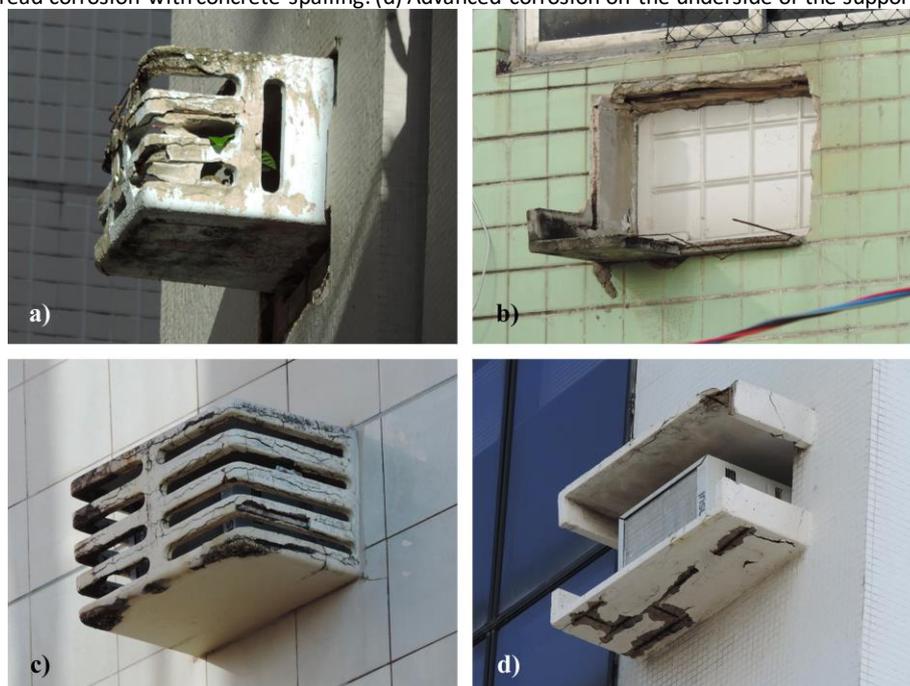
Inspections were carried out on reinforced concrete supports in the neighborhood of Boa Viagem, an area located just a few meters from the breaking waves of the sea and directly influenced by chloride ion attack. The deterioration of the supports is evident, as can be seen in Figure 13.

Figure 13 - Reinforced concrete supports for air conditioning in the Boa Viagem neighborhood in an advanced state of deterioration. (a) Advanced corrosion and presence of vegetation. (b) Almost complete collapse of the support. (c) Widespread corrosion with concrete spalling. (d) Advanced corrosion on the underside of the support.

Understanding the issue and taking preventive action are essential to mitigate the dangers associated with the fall of support components. Depending on their size and height, these components can impact the ground with forces in the order of tons, potentially causing harm to people or objects. It emphasizes the need for using materials that are more resistant to environmental factors, such as aluminum, engineering plastics, and stainless steel. It's important to note that no material is entirely immune to deterioration over the years.

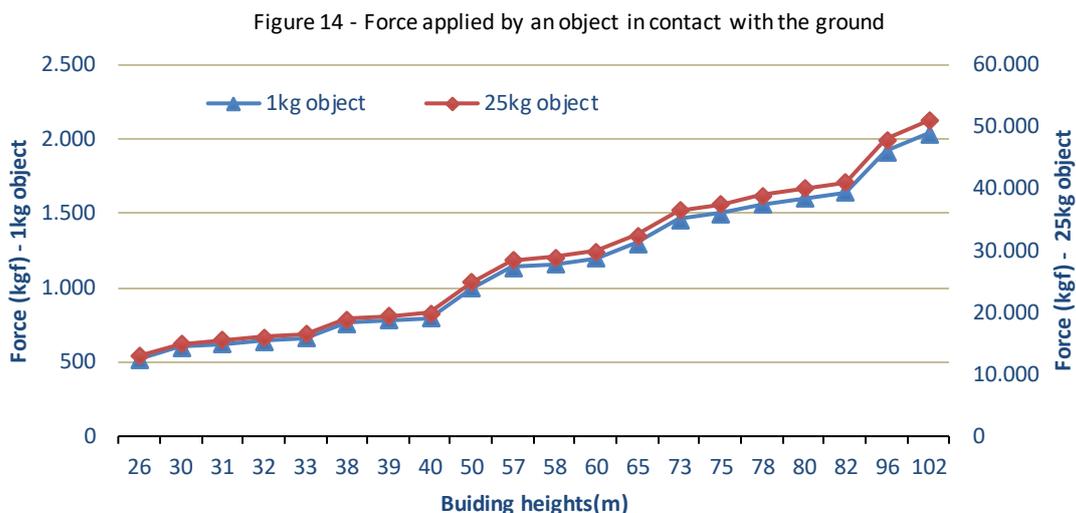
In a study by Silva and Monteiro (2020) on air conditioning unit supports, they calculated the force (kgf) exerted by parts of a concrete support when they fall to the ground

for objects weighing 1 kg and 25 kg, falling from heights ranging from 26 m to 102 m. This can be seen in Figure 14.
