**Walkability assessment: a comparative study between two
neighborhoods in João Pessoa - PB**

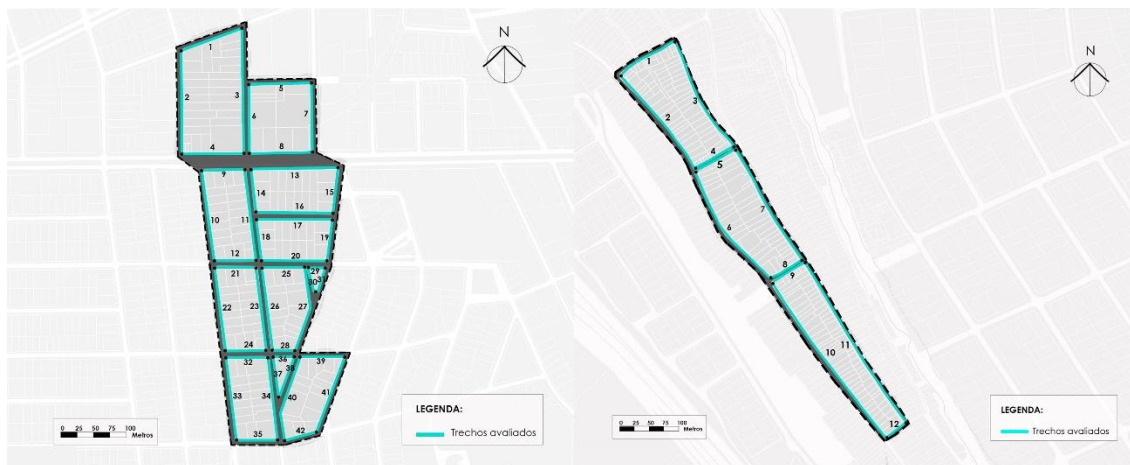
Figure 2 - Sections evaluated in the Miramar and São José neighborhoods

In the urban area selected in the Miramar neighborhood, there are relevant roads for the city, such as Rua Tito Silva and Av. Pres. Epiácio Pessoa, where it is possible to see a diverse use of land, with the presence of gas stations, pharmacies, stores and gyms. The area also includes Praça das Muriçocas, Praça Rotary Club, the Eco Business Center building and the building where the Miramar Baptist Church operates, important points of reference for the neighborhood. In some other roads in the area, typical residential use is observed. The urban area of the São José neighborhood comprises a section of the neighborhood's main road, Rua Edmundo Filho, the only one where public transport runs and which has diverse uses, including

commercial points, churches and mechanic workshops. The other roads within the São José neighborhood are typically used for residential purposes.

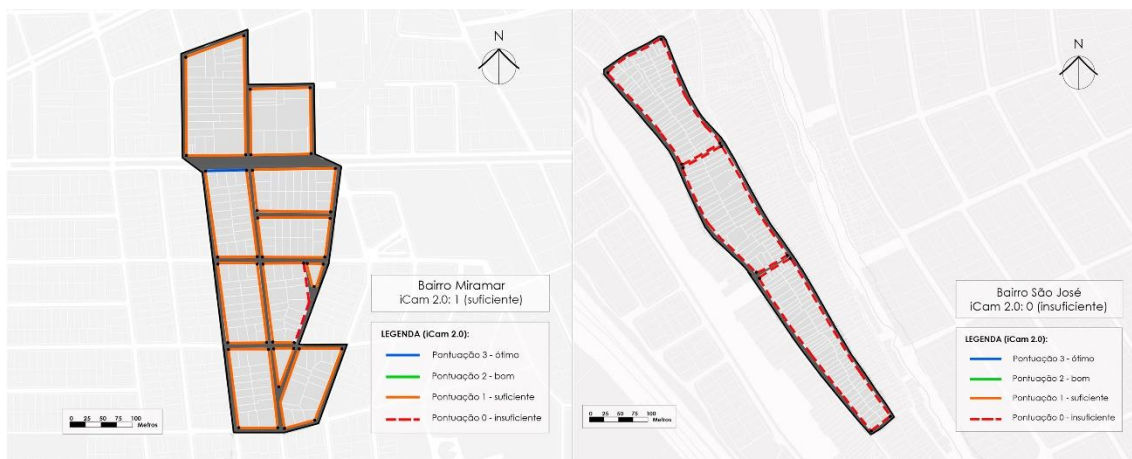
Figure 3 - Walkability result in the Miramar and São José neighborhoods according to iCam 2.0

After applying iCam 2.0 in the study areas, better walkability was identified in the Miramar neighborhood, which was classified as sufficient for achieving a score of 1.49; The São José neighborhood obtained a score of 0.84, considered insufficient. The maps with the results of each section analyzed in the neighborhoods can be seen in Figure 3. Table 1 shows the summary of the results obtained in the study areas for the six categories that make up the iCam, where the scores ranged from insufficient to good.

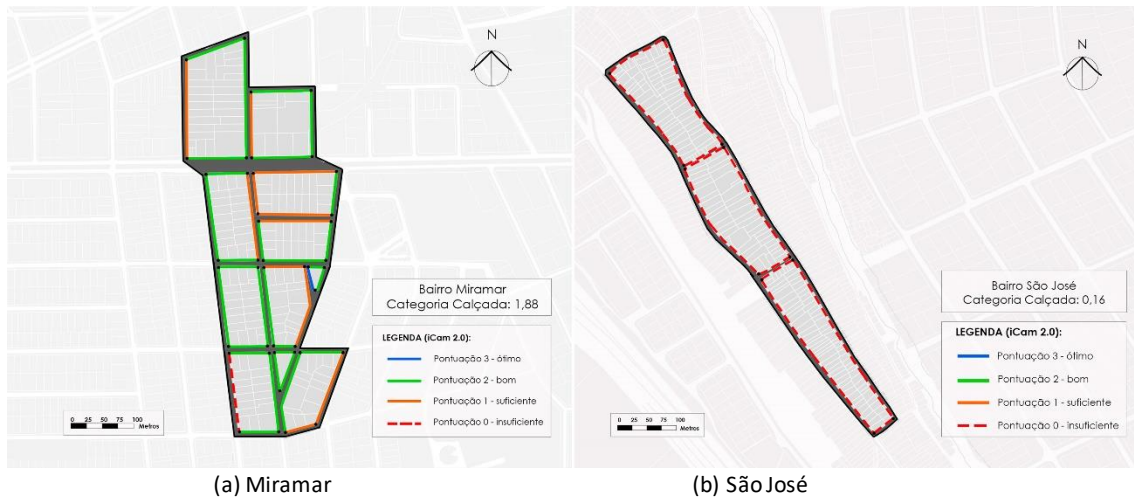
Figure 4 - Sidewalk category results

The score given to the Sidewalk category is the result of the arithmetic average between the scores of the two indicators that make it up: paving and width. In the evaluated area of the Miramar neighborhood, the sidewalk obtained a score of 1.88, considered sufficient, where the paving indicator reached a score of 1.65 and the width indicator 2.10. On the other hand, the São José neighborhood presented a score close to zero and classified as insufficient. In this neighborhood, both indicators presented low scores: width (0.00) and paving (0.32).

Of the 42 sections analyzed in Miramar, 69.0% obtained a good score (2) and 26.2% a sufficient score (1). The extreme scores, 0 and 3, were observed in only one section each, corresponding to 4.8% of the segments. In the São José neighborhood, 100% of the sections evaluated received an insufficient score. From Figures 4a and 4b it is possible to identify the sections with the worst and best walkability conditions and thus concentrate efforts on improving the segments that obtained the lowest scores, thus guaranteeing the comfort and safety of pedestrians.

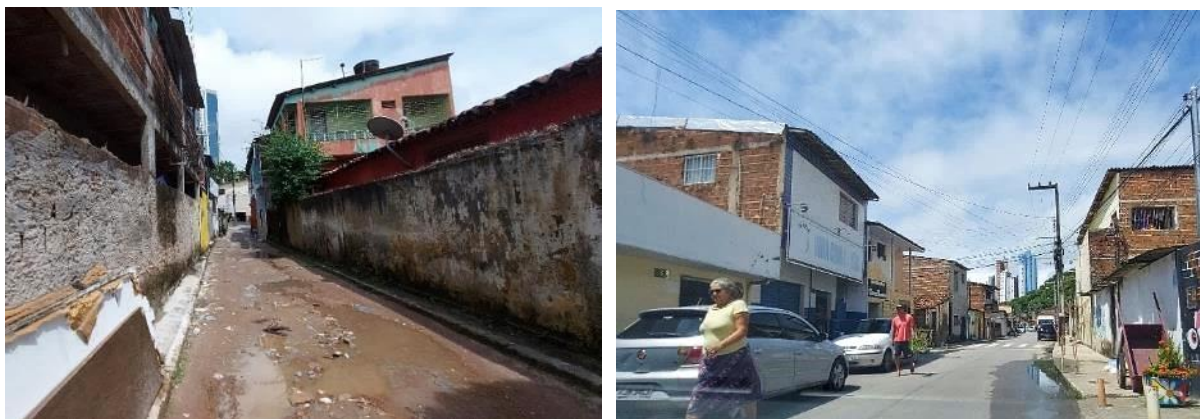
Figure 5 - Sections located in the São José neighborhood

The results from the São José neighborhood draw attention to the precariousness of the area's pedestrian infrastructure, which in some segments, such as sections 4 and 5 shown in Figure 5a, is non-existent. In sections 2, 6 and 10, located on Rua Edmundo Filho, one of the main roads in the neighborhood, the sidewalks are insufficiently wide to accommodate the flow of local pedestrians. The little space allocated to walkers is commonly occupied by vehicles of different sizes or by "puxadinhos" from local traders. Furthermore, the high number of differences in level to access the garages in the segments makes walking even more difficult. Given all the problems mentioned, walking along the side of the streets of the São José neighborhood has become a frequent habit for its residents, as captured in Figure 5b.

(a) Section 4 and 5

(b) Section 2

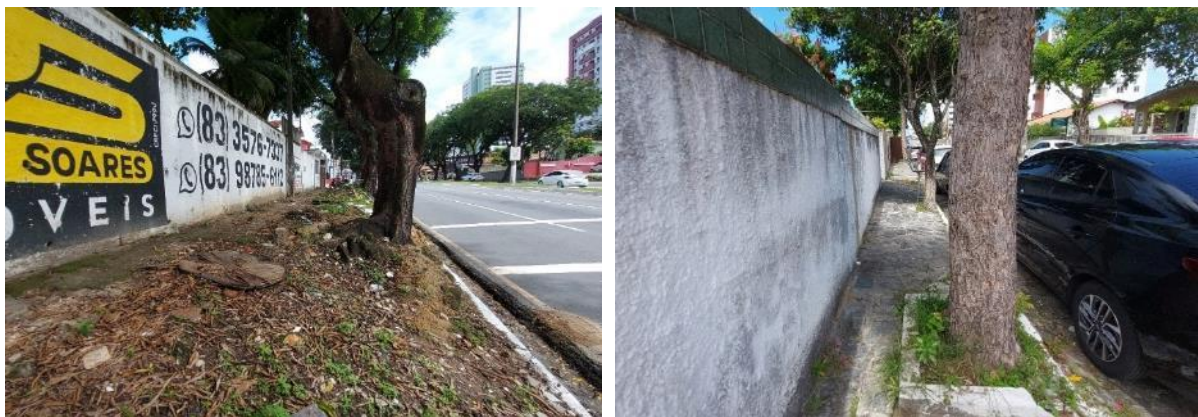
Figure 6 - Sections located in the Miramar neighborhood

The sidewalks in the Miramar neighborhood presented better conditions, both in terms of dimensions and in terms of conservation, than the sidewalks in São José. Only section 33 was scored as insufficient. Although the segment was entirely paved, there are many gaps in the area built to facilitate car access to residential garages, which make walking uncomfortable and dangerous for those with reduced mobility. Another problem identified in section 33 was the width of the sidewalks. Despite being a section with low pedestrian flow, in places where there are trees, the already narrow sidewalk is still occupied by tree trunks, making it difficult for people to pass through the area, as seen in Figure 6b.

The presence of trees is a positive point in the segments, as they provide shelter and comfort on hot days, however they need to be planted appropriately so as not to create an obstacle for pedestrians. Section 13, located on Avenida Epitácio Pessoa, one of the main roads in the city of João Pessoa, presents precarious paving conditions due to the invasion of tree roots

into the local pavement, as can be seen in Figure 6a. This problem is commonly observed in several sections along the avenue, the advanced age of the trees combined with the lack of maintenance in some sections contributes to the deterioration of the sidewalk surface .

(a) Section 13

(b) Section 33

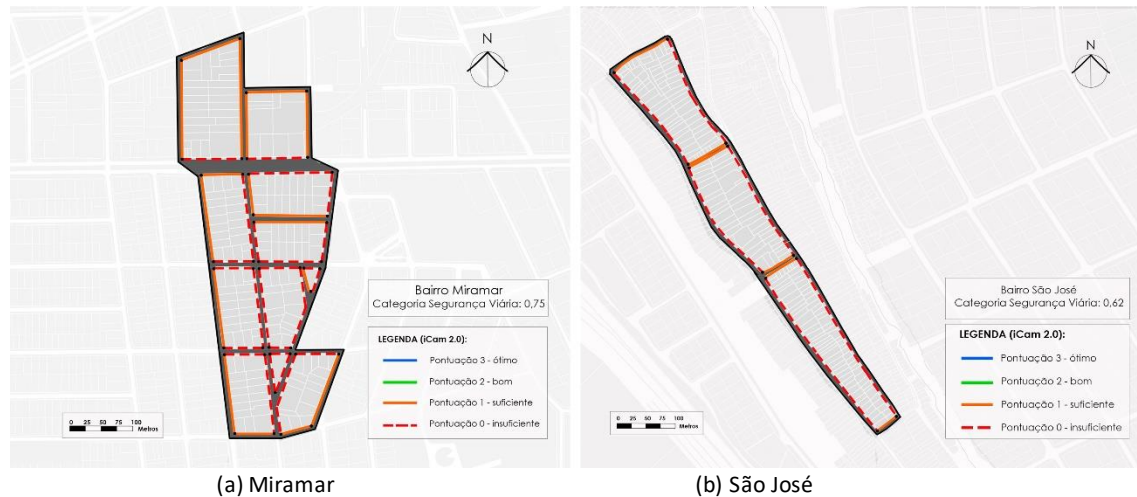
Figure 8 - Road safety category results

Figures 8a and 8b illustrate the Road Safety situation for each section assessed by iCam 2.0 in the two neighborhoods in question. Of the 42 segments evaluated in Miramar, 40.5% obtained a sufficient score, while the remaining 59.5% obtained scores below 1 and were classified as insufficient. In São José, 50% of the passages achieved a sufficient score and 50% an insufficient score.

The low scores obtained in the “crossings” indicator were the determining factor for the Road Safety category to be classified as insufficient. Few crossings, only in the Miramar neighborhood, referring to segments 6, 9 and 14, met the minimum prerequisites to be considered sufficient, presenting minimally acceptable conditions for the safe crossing of pedestrians. No crossings with directional tactile flooring were found in any section. Pedestrian crossings and ramps with an appropriate slope for wheelchairs, or crossings at sidewalk level, were identified in a few segments.

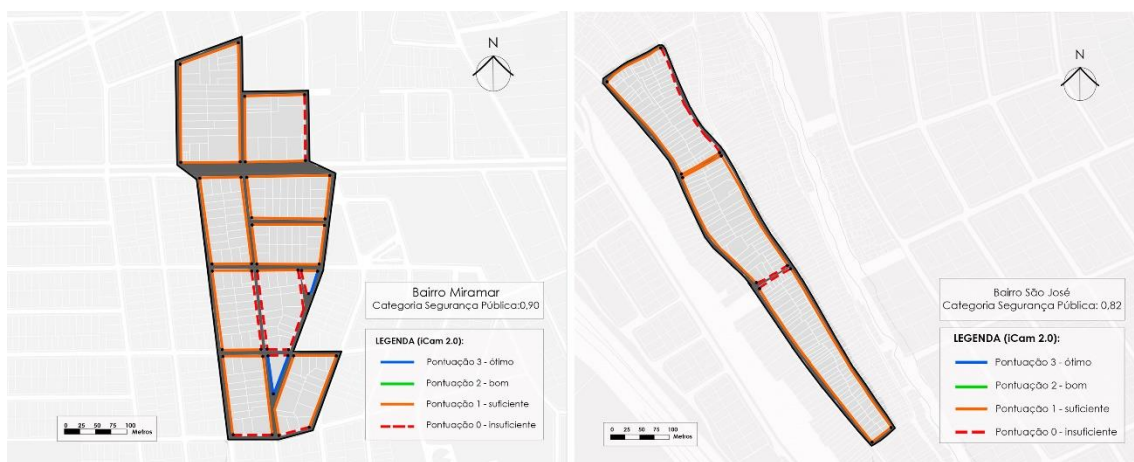
Figure 9 - Public safety category results

The neighborhoods' scores were close, and both were classified as insufficient in this regard: Miramar scored 0.90 and São José scored 0.82. The map in Figure 9a reveals that of the 42 stretches evaluated in Miramar, 71.4% of these were classified as sufficient, 21.4% were considered insufficient and only 7.2% obtained an excellent score. The situation in the São José neighborhood is shown in Figure 9b, where 75% of the segments obtained a sufficient score and the remaining 25% received an insufficient score.

It is important to highlight that in segments of typically residential use, such as section 35 in Miramar and section 3 in São José, where there are no other sources of lighting, such as light from night-time shops, it is essential that public lighting is adequate and sufficient so that pedestrians feel safe walking at night, highlighting the need for interventions in stretches with these characteristics.

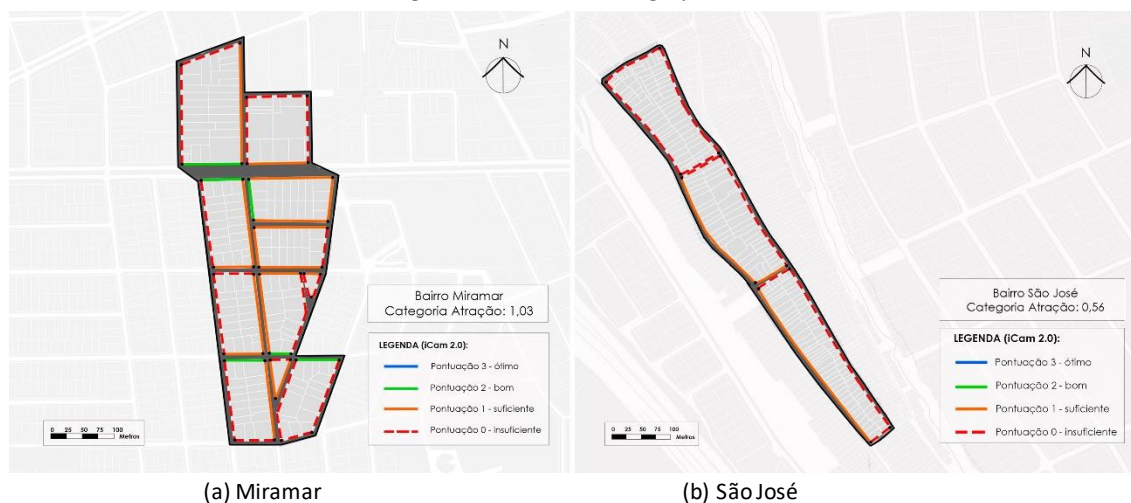
Figure 10 - Attraction category results

Observing the final score for the attraction category, in the São José neighborhood, many sections (75%) were identified as insufficient and the remaining 25% as sufficient, as shown in Figure 10b. Figure 10a shows the results in the Miramar neighborhood, where 42.9% of the analyzed segments were classified as insufficient, 42.9% as sufficient and 14.2% obtained a good score.

In Miramar, the sections with the best scores are located on streets and avenues with the greatest number of commercial points, such as Rua Tito Silva and Avenidas Presidente Epitácio Pessoa and José Liberato. In these locations, more diverse land use, with the presence of commercial locations that have more permeable and more active facades, make the stretches more attractive to pedestrians. On the other hand, the segments located on streets with predominantly residential land use, such as Rua Otávio Novais and Avenida Carlos Barros, for example, have block faces with high walls, making it impossible to create a visual connection between the interior and exterior of buildings, which contributes so much to the pedestrian's sense of safety.

Only three sections (6, 8 and 10) obtained a sufficient score in the São José neighborhood, two located on Rua Edmundo Filho, the main street in the neighborhood, and on Rua Prof. José Carlos de Almeida. These stretches stand out from the others because they have a good number of commercial points, such as grocery stores and bakeries, which have physically permeable facades, and due to the diverse use of land, such as section 10, which has residences and a Catholic church with day and night use. For the rest of the neighborhood, the situation is typically residential, with facades that make visual contact between those outside and inside the residences and lots that are not accessible to the public impossible.

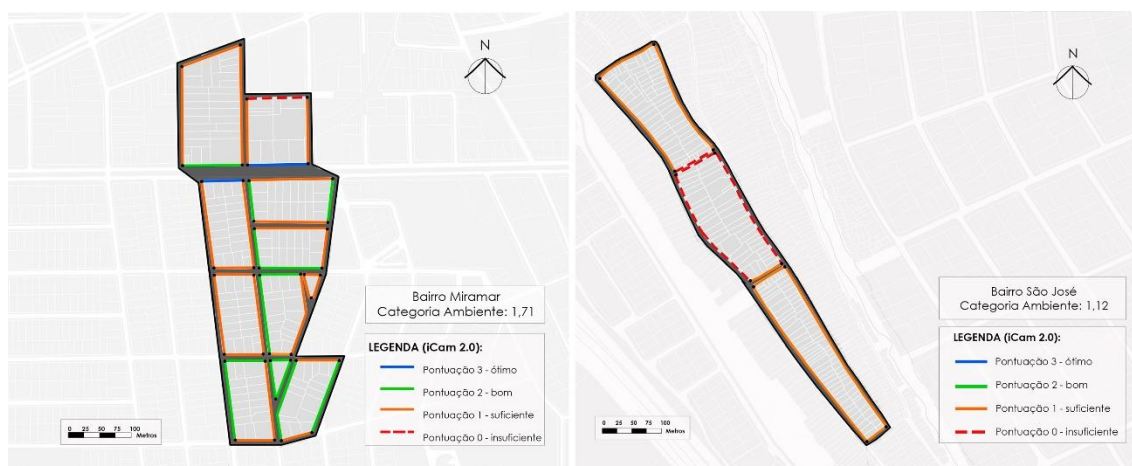
Figure 11 - Environment category results

Figure 11a reflects the situation of each segment analyzed in Miramar. 59.5% of the

42 sections evaluated in the neighborhood received a sufficient score for the category in question, 33.3% obtained a good score and 4.8% achieved an excellent score. Only section 5 was classified as insufficient, representing 2.4% of the sections analyzed in the area. In the São José neighborhood, 58.3% were categorized as sufficient, and the remaining 41.7% were insufficient, as can be seen in Figure 11b.

The garbage collection and cleaning indicator obtained good scores in most sections of both neighborhoods. In Miramar, only two sections (7 and 9) obtained a sufficient score (1), due to the presence of irreversible assets (debris in the section, antlers or tires) in certain points of the segments, for all the other 40 sections analyzed in the neighborhood, garbage collection and cleaning conditions were evaluated as excellent. Despite having obtained a good score for the indicator, when compared to Miramar, São José presented unhealthy conditions in more sections: in sections 4, 5, 6, 7 and 12 there was the presence of irreversible goods, and in sections 4, 5 and 12, there was visibly more than one piece of debris every meter.

On the other hand, the shade and shelter indicator prevented better results for this category. All sections of the São José neighborhood received a score of 0, justified by the small number of shelter elements, such as marquees, along the evaluated segments. The lack of
