## **Correlation analysis of pathological manifestations on facades of box buildings: case study in Jaboatão dos Guararapes-PE**

The box-shaped building known as Block 89 is located in the Curado 4 neighborhood in Jaboatão dos Guararapes. The block was built in 1978 by the Popular Housing Company of the State of Pernambuco (COHAB-PE), now called CEHAB (State Housing and Public Works Company) (Davidson, 2018). Located in the western part of the Metropolitan Region of Recife, it is

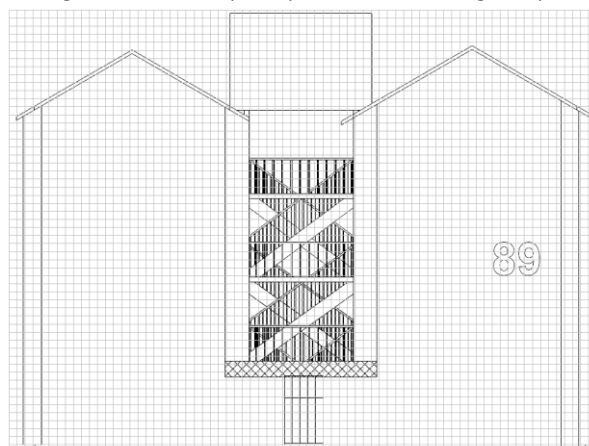
Figure 2 – Mesh superimposed on the damage maps

A 0.25x0.25m mesh was superimposed on the damage maps prepared, with the aim of quantifying the occurrence of each pathological manifestation on the facades (Figure 2). The density of the mesh was determined based on the scale of the manifestations on the map, aiming to obtain adequate precision in data collection. Thus, the ratio between the quadrants

containing a manifestation and the total mesh resulted in the percentage of the manifestation per facade.

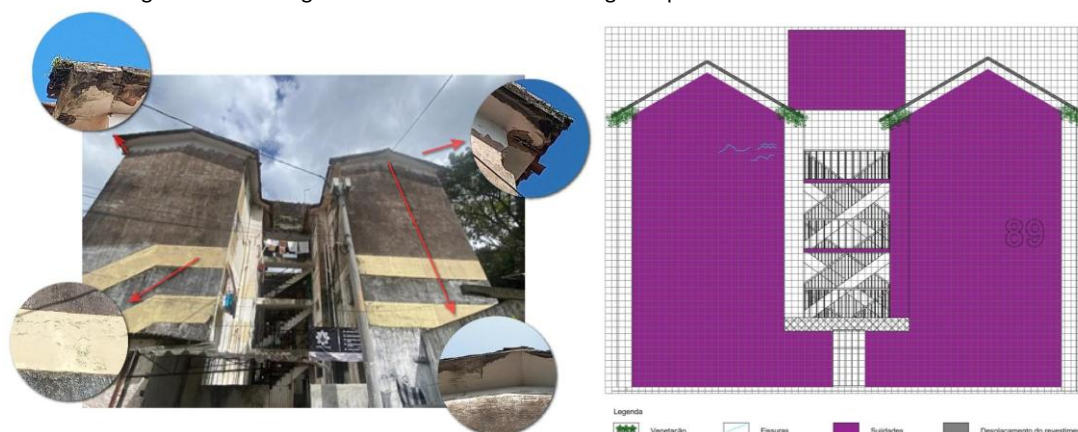
Figure 4 – Pathological manifestations and damage map of the east facade of Block 89

The pathological manifestations found on the east facade are now analyzed, as can be seen in Figure 4.

The images show that the east facade contains more pathological manifestations compared to the west facade. Due to its position, dirt is present in almost the entire area, as it receives more sunlight, wind and rain. Geometrically, the facades are the same and have the same manifestations, differing only in quantity.

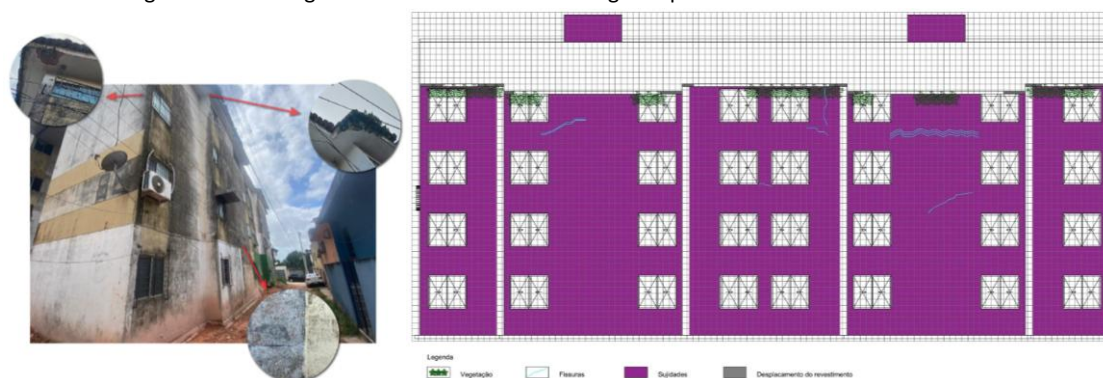
Figure 5 – Pathological manifestations and damage map of the south facade of Block 89

The pathological manifestations found on the south facade of the building can be seen in Figure 5 below. The image shows that this facade is significantly affected by the same pathological manifestations as the previous ones, starting with a large area of dirt over a large part of its area due to moisture from rainwater. The contrast of the upper part, which is protected by the roof, can be noted. There is also vegetation on the roof and displacement in the same area with the exposure of the structure's reinforcement.

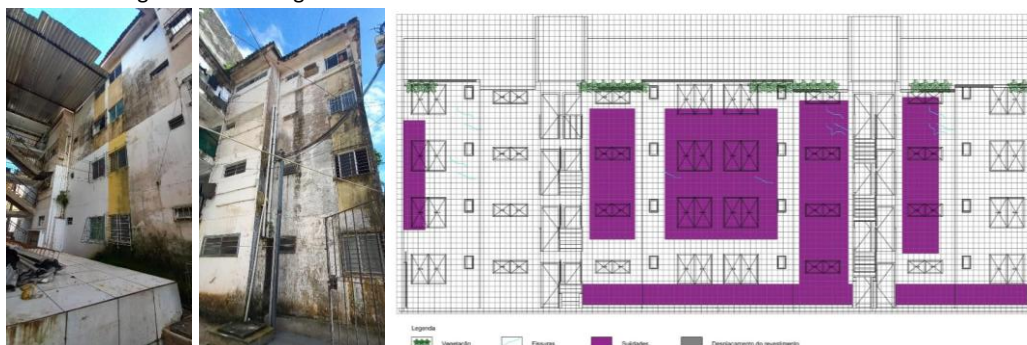
Figure 7 - Pathological manifestations of the northern internal facade of Block 89

The pathological manifestations found on the building's northern internal facade can be seen in Figure 7 below. Since it is a facade with a large area, it is arranged in four compiled images. It can be seen in the images that the pathological manifestations found on the other facades are repeated, with the presence of dirt, displacement, vegetation and cracks.
