Analysis of environmental conditions in the Baixotes stream, in the lower Tietê river basin, in Birigui (São Paulo, Brazil)**Stephanie Campos Gonçalves**

Análise das condições ambientais no Ribeirão Baixotes, na bacia hidrográfica do baixo Tietê, em Birigui (São Paulo, Brasil)

Objetivo - analisar as condições ambientais de trechos do Ribeirão Baixotes de Birigui/SP.

Metodologia - aplicação de um Protocolo de Avaliação Rápida (PAR), em dois períodos climáticos distintos: um no período de estiagem e o outro na época das chuvas regulares do ano de 2023, na região.

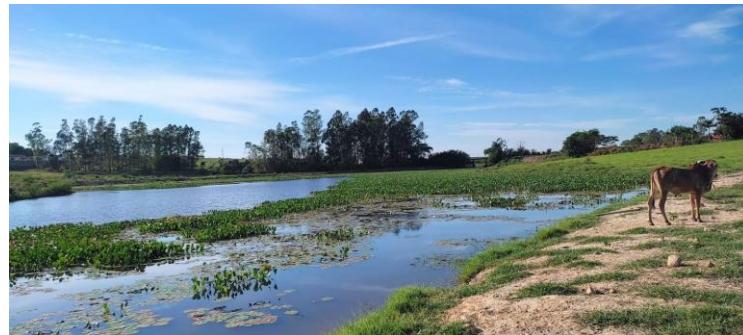
Image 6 – Picture of the Baixotes Stream at the section under study in the area before catchment during the second application of the RAP

Image 6 shows the section in the second period. The increase in the watercourse channel due to the dredging carried out is evident. However, despite the intervention, there was little change in relation to the previous protocol score, except for the significant increase in macrophytes, as shown in Image 6.

Another condition highlighted in Image 6 that deserves to be highlighted is the absence of vegetation in the Permanent Preservation Area (PPA) and the presence of pastures and livestock, which reach the edge of the water source.

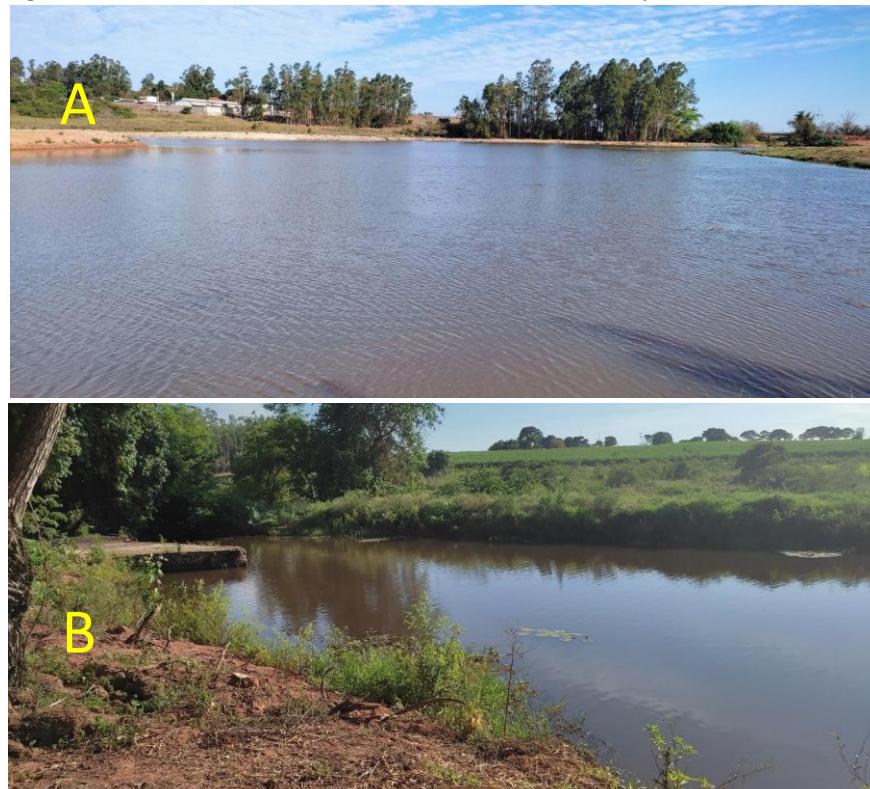
Image 7 – Picture of the Baixotes Stream at the section under study in the area of catchment.

At the collection point for the municipality's supply (Catchment), a score of 60 points was obtained for the two periods analyzed, which resulted in the classification of the site as an "Impacted Section". This condition is mainly due to the lack of PPA, changes in the river course and the instability of the banks, as shown in Image 7, which presents the two sampling moments.

Source: authors' own photographs (Caption: Photo A shows the stretch of the Baixotes Stream, where the catchment point for supplying the municipality is located, in the sampling carried out in September 2023. Photo B shows the same stretch, in December 2023.).

In the image, it is possible to identify some seedlings to recover the PPA. These actions have been carried out by the Birigui Department of the Environment and were publicized by the digital journalism page "*Hoje Mais*" (*Hoje Mais*, 2024).

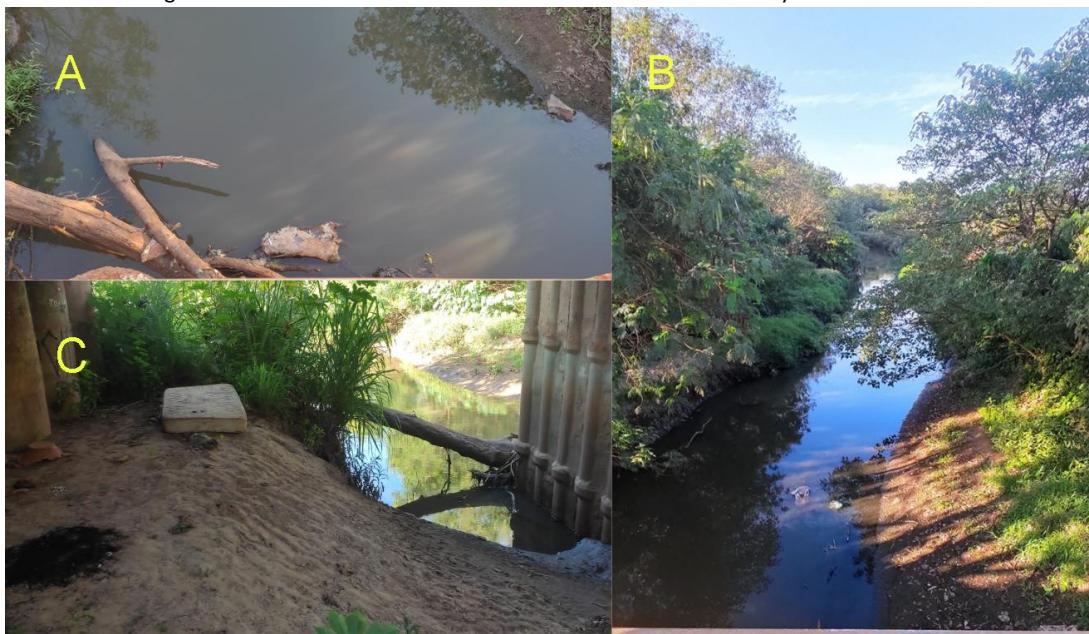
Image 8 – Picture of the Baixotes Stream at the section under study in the Urban Area

The third section of the Baixotes Stream that was analyzed, called Urban Area (UA), is in the João Crevelaro neighborhood, near a state school. Its score was forty for both samples taken in 2023. This is an "Impacted Section," which is the lowest score observed by the RAP, indicating the most compromised area of the four. A lot of debris was found at the site, which reveals that this point is treated by the population as a solid waste dumping site. In addition, dead animals and a sewage odor were noticed in this area.

The most significant parameters for classifying this location were the bad smell, color of the water and debris, silting of the bed, the lack of diversity of bottom habitats, the extent of the permanent preservation area, the condition of the water depth and erosion of the banks showing a very critical situation as shown in Image 8.

Source: authors' own photographs, 2024 (Caption: Photo A and B were taken during the first sampling, while photo C was taken during the second sampling).

Photo A highlights the dark color of the water in the area, and a dead animal can be seen. Photo B shows the condition of the banks and the water depth. Photo C shows that the waste problem persisted during this period, in addition to indicating the lack of stability of the banks and the silting of this stretch of the stream.

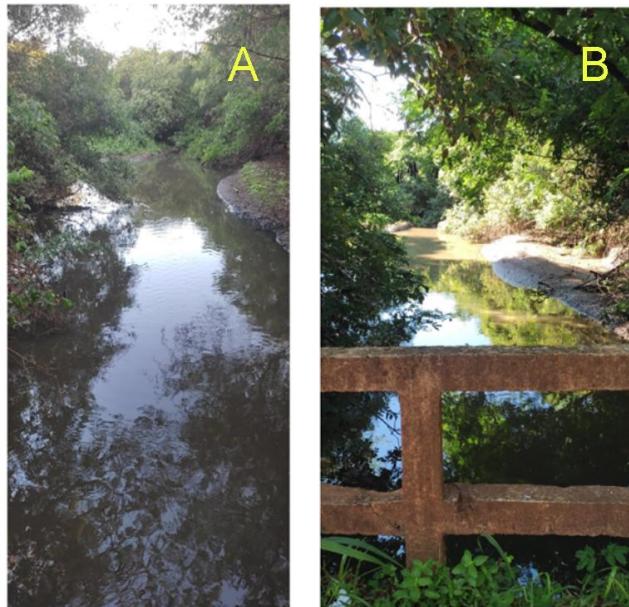
Image 9 – Picture of the Baixotes Stream at the section under study in an area after sewage treatment

The fourth section analyzed, called After Sewage Treatment (AST), also received a similar score for both periods. The score of 105 points resulted in the classification as a "Natural Section". The section is in a rural area. It is possible to notice some presence of vegetation in the permanent preservation area, in relation to the other sections analyzed. Improvements were also observed in the parameters related to habitat diversity, due to the presence of gravel and rocks, in addition to greater stability of the banks and less presence of solid waste in the

environment, as shown in Image 9. However, there is the presence of an odor, which can be compared to the smell of sewage; this fact influenced the score, despite its classification as a natural section.

Source: authors' own photographs, 2024 (Caption: photo A shows the section during the first analysis, and photo B shows the section during the second analysis).

The very similar conditions observed at this collection point in both periods of the year are evident - the first collection on the left and the second collection on the right. In addition, it is possible to observe only the positive aspects of the parameters, such as the condition of the water depth, the presence of riparian vegetation, the stability of the banks and the absence of residues.
